Contract #: 04-0120F4Cty: SF/ALA Rte: 80 PM: 13.2/13.9File #: 69.25B**QUALITY ASSURANCE -- NON-CONFORMANCE REPORT****Location:** Changxing Island, Shanghai, P.R. China**Report No:** NCR-000515**Prime Contractor:** American Bridge/Fluor Enterprises, a JV**Date:** 13-Nov-2009**Submitting Contractor:** Zhenhua Port Machinery Company, Ltd (ZPMC), Changxing Island**NCR #:** ZPMC-0488**Type of problem:**

Reference Description: T-stiffener Web Flatness, OBG Segment 5BW, Side Panel, Crossbeam Side**Description of Non-Conformance:**

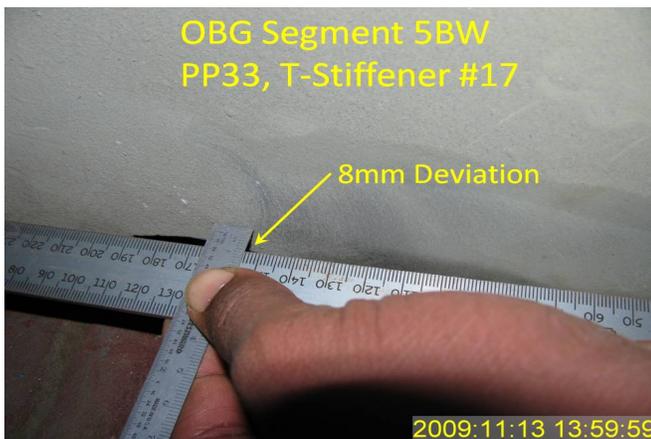
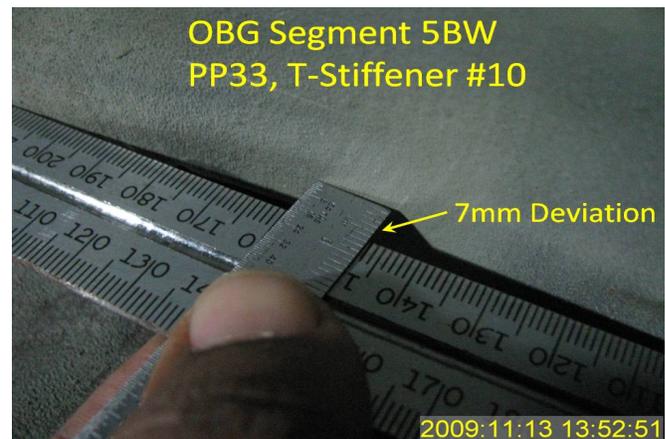
During dimensional inspection of OBG Segment 5BW, Caltrans Quality Assurance (QA) observed out-of-tolerance flatness on the webs of side panel T-stiffeners at Panel Point PP33 (crossbeam side). The flatness measurements were taken using a 300mm straight edge conforming to the requirements of AASHTO section 11.4.13.1. The following deviations were observed:

7mm at stiffener #10 (from working point W4)

8mm at stiffener #17 (from working point W4)

The maximum allowable deviation from detailed flatness is 5mm.

Repair damage according to the approved retrofit RFI to be submitted by ABF.

Reference Resolution: The T stiffener web flatness has been repaired and is now acceptable and has been removed from the punchlist. ZPMC is providing the NDT records to show that the welds are acceptable.

Retrofit plates were added at said locations and are in conformance with provisions listed in RFI 2004.

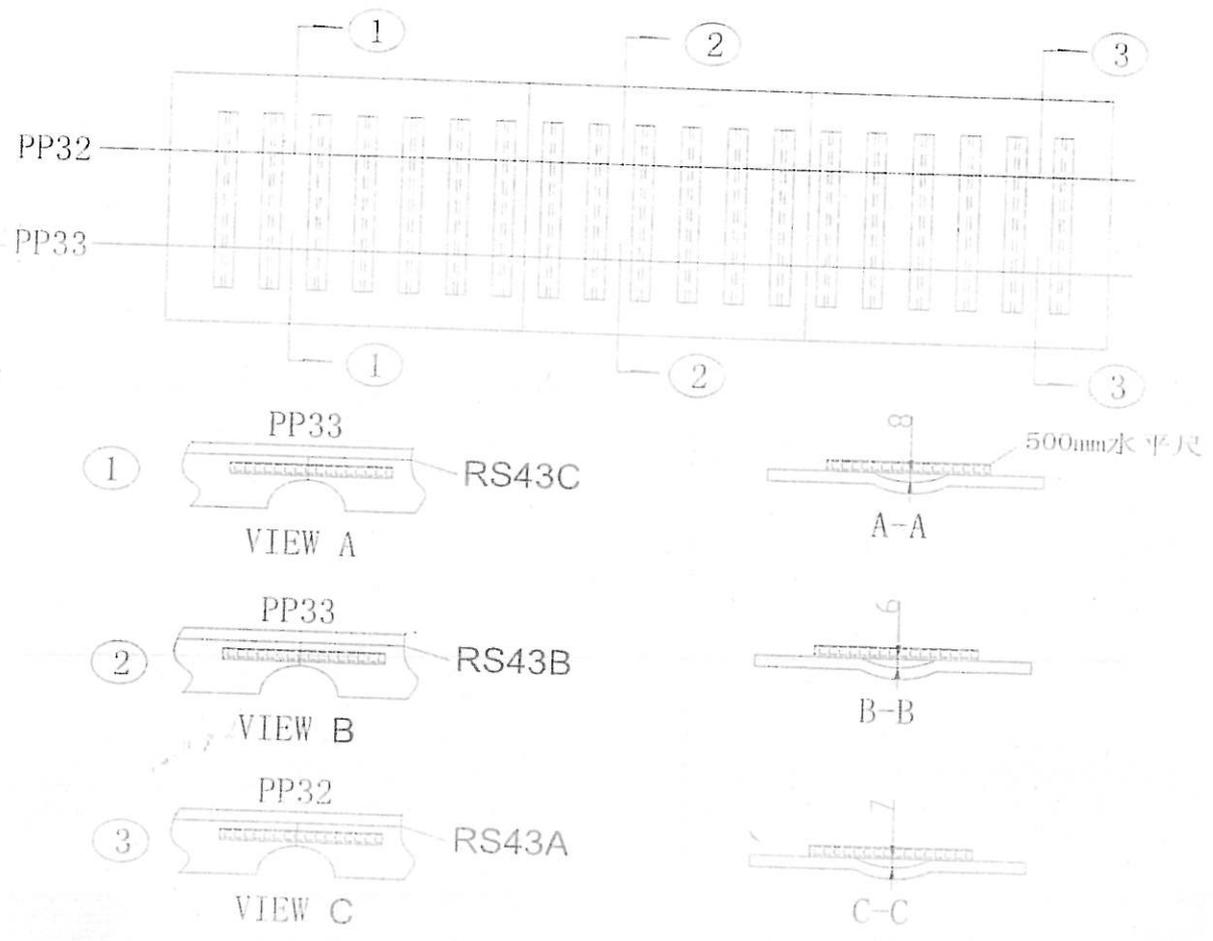
5BW 斜底板近联系梁侧, T 肋连接板螺栓拧紧后, 测量 T 肋筋板平整度。发现 pp32, pp33 处 T 肋筋板平整度超标, 最大 8mm, 具体数据见附页:

After bolt T-rib connect plate at 5BW side plate face strut plat, the flatness exceeded requirement, maximum 8mm, the detail sees the following attachment.

焊接变形和制作误差。

Weld distortion and fabricate error.

1. Remove the welds between distorted web plates of T-Ribs mentioned above and SP by gouging or flame cutting. Preheat according to approved WPS.
2. Heat straighten those distorted web plates to make their flatness meet requirement, then tack weld them to SP.
3. Preheat and weld in accordance with approved WPS.
4. Grind the area to a smooth finish.
5. Perform relevant NDT inspection to the welds according to work drawings.
