Contract #: 04-0120F4
 Cty: SF/ALA Rte: 80 PM: 13.2/13.9
 File #: 69.25B

QUALITY ASSURANCE -- NON-CONFORMANCE REPORT

Report No: NCR-000516

Reference Description: Excessive weld pass width on North Tower Lift 3 to 4 Interior Splice Plate weld

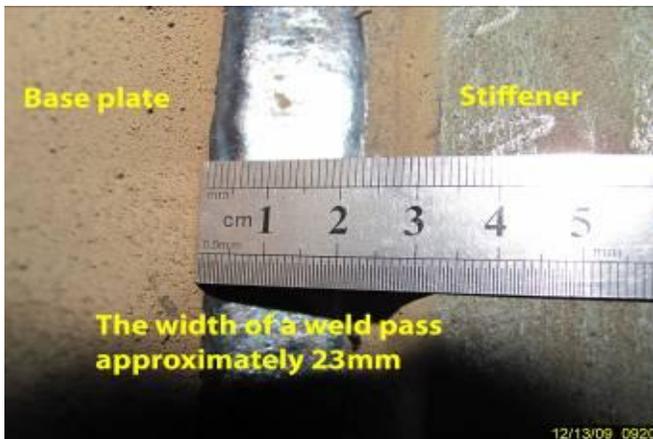
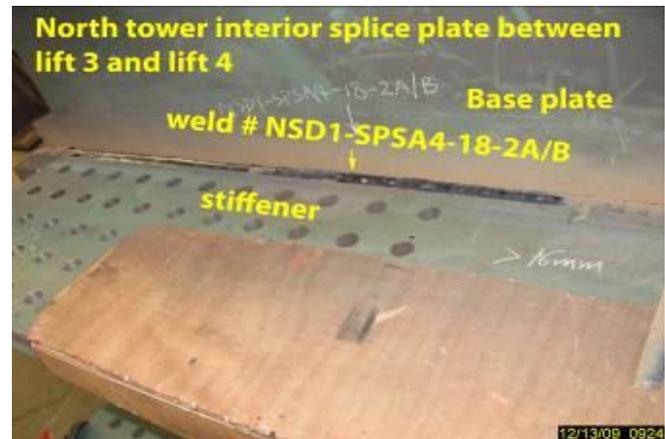
During in-process Visual Inspection (VT), QA observed a 23mm FCAW weld pass, performed in the flat position, on CJP weld NSD1-SPSA4-18-2A/B. The maximum FCAW weld pass width allowed in the flat position for groove welds is 16mm.

AWS D1.5-2002, Section 4.14.1.5 - FCAW: "When the width of a layer of a groove weld in the flat, horizontal, or overhead position is 16 mm [5/8 in.] or greater, a multiple-pass split-layer technique shall be used."

ZPMC has verified the nonconformance with the CT inspector on site and has taken the appropriate action to remove the over width weld pass, make the correct weld and inspect. The weld has been completed and green tagged. Attached are the corresponding UT reports. ZPMC requests closure of this NCR.

The Department's inspector verified that the over width weld pass has been corrected, but NSD1-SPSA4-18 has not been green tagged. However, the Department accepts the attached UT report for NSD1-SASA4-18-2A/B as the evidence of acceptability for this non-conformance. Please address the failure of Quality Control to identify this non-conformance and steps taken by the QCM to prevent future occurrences.

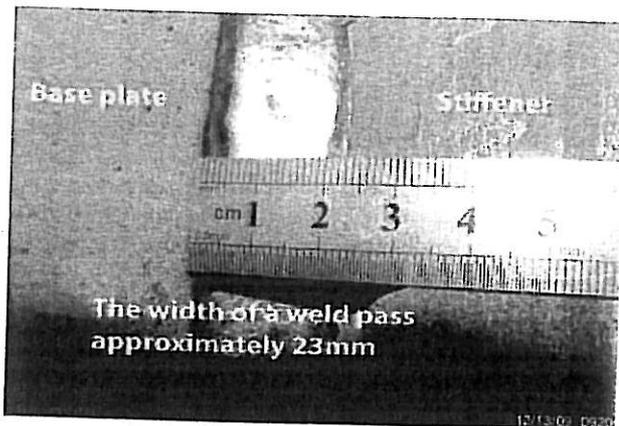
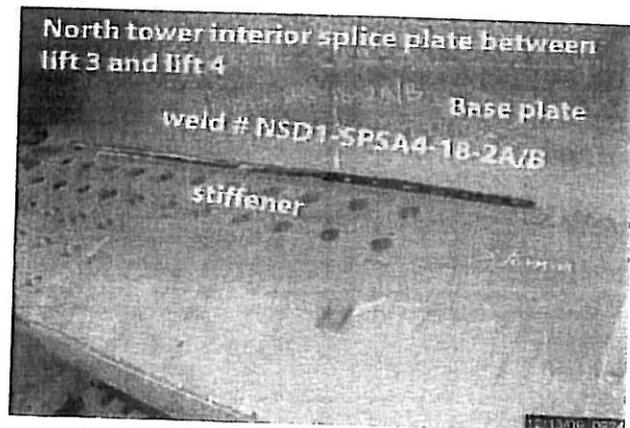
During in-process Visual Inspection (VT), QA observed a 23mm FCAW weld pass, performed in the flat position, on CJP weld NSD1-SPSA4-18-2A/B. The maximum FCAW weld pass width allowed in the flat position for groove welds is 16mm.

AWS D1.5-2002, Section 4.14.1.5 - FCAW: "When the width of a layer of a groove weld in the flat, horizontal, or overhead position is 16 mm [5/8 in.] or greater, a multiple-pass split-layer technique shall be used."

The overwidth weld pass was removed and repaired; documentation was provided (T787-UT-2574). To prevent reoccurrence, the ABF QCM discussed this issue with ZPMC QC and reinforced the importance of continuous inspection.
