Contract #: 04-0120F4Cty: SF/ALA Rte: 80 PM: 13.2/13.9File #: 69.25B**QUALITY ASSURANCE -- NON-CONFORMANCE REPORT****Location:** Changxing Island, Shanghai, PRC**Report No:** NCR-000517**Prime Contractor:** American Bridge/Fluor Enterprises, a JV**Date:** 21-Dec-2009**Submitting Contractor:** Zhenhua Port Machinery Company, Ltd (ZPMC), Changxing Island**NCR #:** ZPMC-0490**Type of problem:**

**Reference Description:** Base metal repair without Engineer approval on Tower Spare Strut ND1-A6002-9**Description of Non-Conformance:**

**Subject:** NCR No. ZPMC-0490

项目名称 Project Name	美国海湾大桥 SFOBB	部件图号 Drawing No	ND1-A6002-9	报告编号 Report No.	T-WR3025
合同号 Contract No.:	04-0120F4	部件名称 Items Name	备用连系梁 Strut plate	NDT报告编号 Report No.of NDT	NA
项目编号 Project No.:	ZP06-787

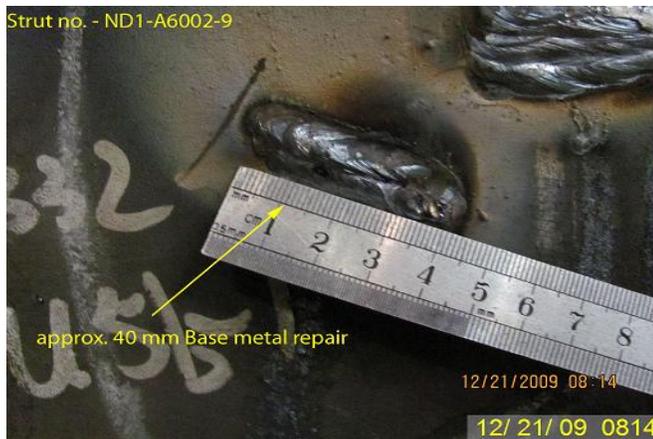
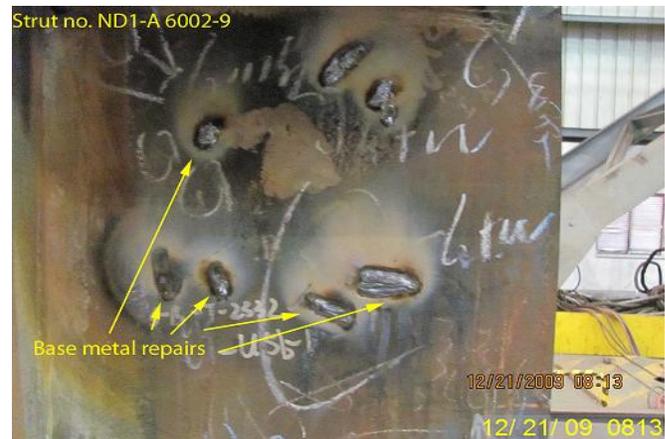
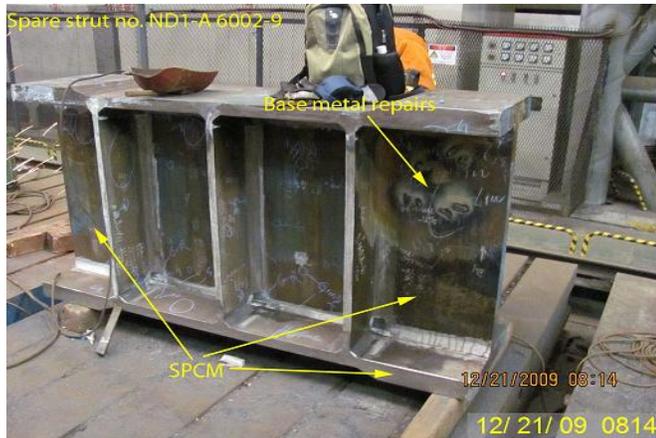
During in-process Visual Testing (VT), QA observed base metal repairs on spare strut ND1-A6002-9 without Engineer approval. The base metal repairs were performed with Shielded Metal Arc Welding (SMAW) at eight (8) locations from 10 to 40 mm in length.

Propose a resolution for the identified non-conformance, documenting that the repaired weld is in compliance with the contract requirements. Documentation provided for the Engineer's review of the acceptability of the weld repair shall at a minimum include the procedure utilized/WRR and the NDT results.

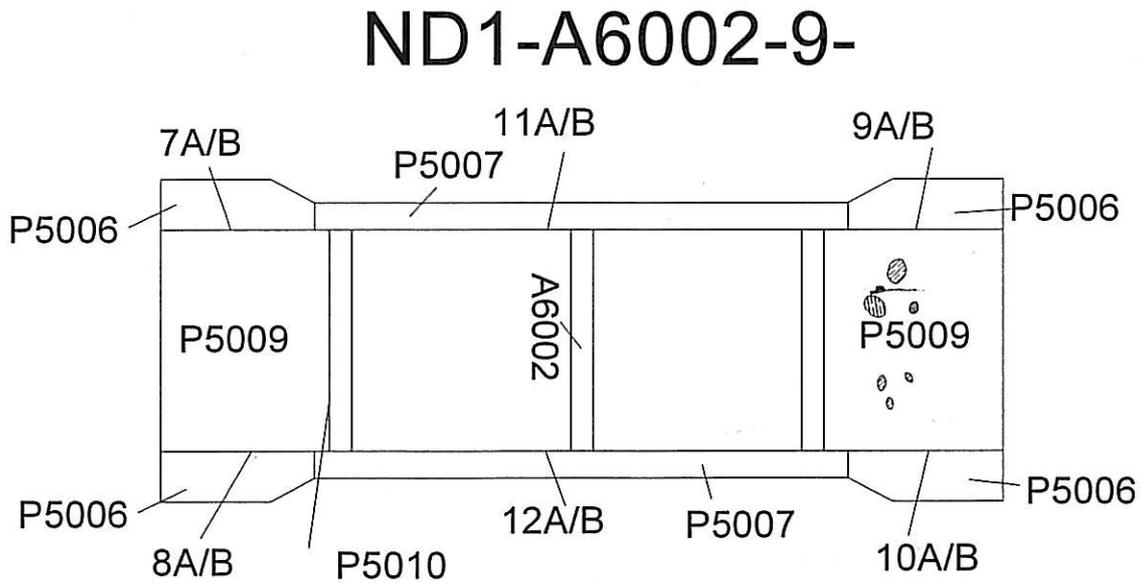
Draft of welding discontinuity:

The base metal was gouged after grinding, maximum 5mm in depth, part No.: ND1-A6002-9-. (P5009)

Remark: repair area in shadow.

Worker operated error caused base metal gouged.

1. QC shall monitor gouging/grinding/welding
2. Gouge defects & grind smoothly
3. Verify that defects have been removed with VT
4. Welding shall be in accordance with WPS
5. QC shall ensure all slag is removed prior to deposition of subsequent weld passes
6. Blend repair area with adjacent base metal
7. Perform VT, MT, & UT to repaired area

纠正措施:  
**Correction action to prevent re occurrence:**  
 培训和教育操作工, 提高操作水平。  
**Train and educate operation to improve operation skill.**
