Contract #: 04-0120F4
 Cty: SF/ALA Rte: 80 PM: 13.2/13.9
 File #: 69.25B

QUALITY ASSURANCE -- NON-CONFORMANCE REPORT

Report No: NCR-000518

Reference Description: ZPMC welder was observed welding in the downhill progression that is not in compliance with the approved WPS for Lift 12

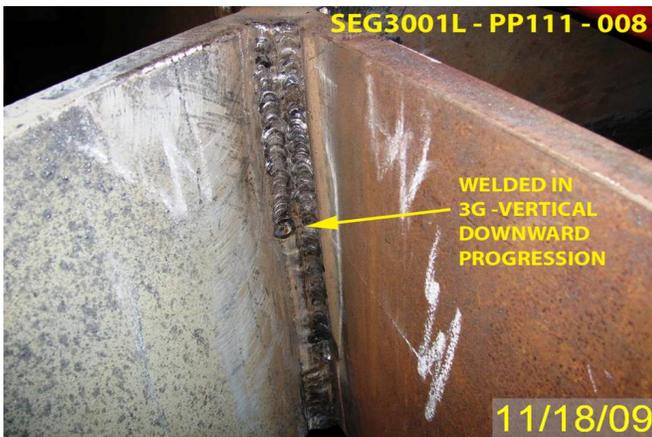
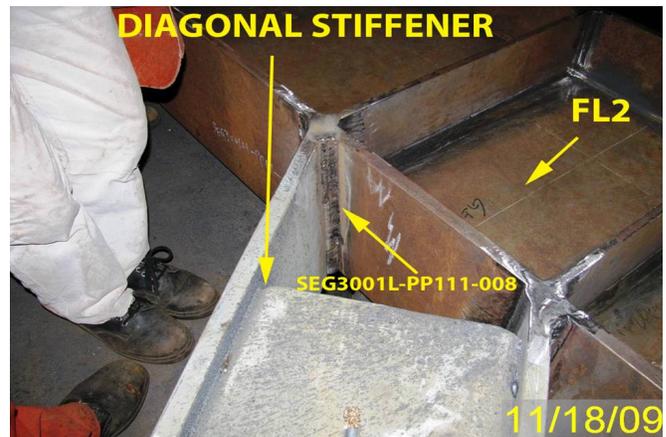
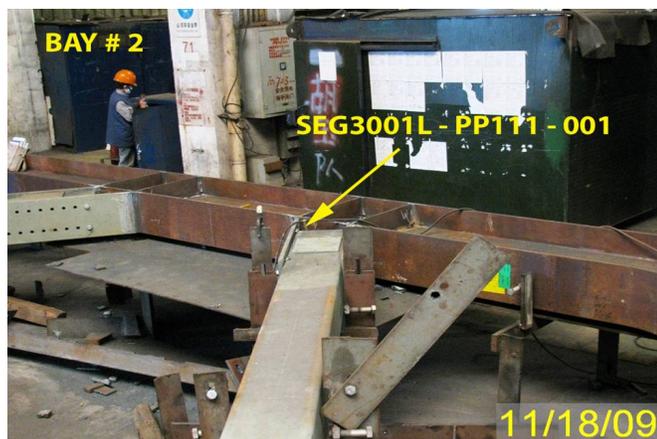
During random in-process visual inspection on Orthotropic Box Girder Floor Beams in Bay # 2, this Caltrans Quality Assurance (QA) Inspector observed ZPMC personnel performing Shielded Metal Arc Welding (SMAW) repair of weld joint identified as Complete Joint Penetration (CJP) SEG3001L-PP111-008 (Lift 12). Welding was observed being performed in the 3G position with a vertical downward progression which does not comply with the applicable repair Welding Procedure Specification WPS-345-SMAW-3G (3F)-Repair.

-AWS D1.5 2002 section 4.6.8: “The progression for all passes in the vertical position shall be upward, unless a downward progression is qualified by tests approved by the Engineer”.

-Approved Repair WPS # WPS-345-SMAW-3G (3F)-Repair: “Welding Progression – Vertical – Up Direction”

Submit a repair procedure to the engineer for approval.

Reference Resolution: ZPMC issued an NCR which the corrective action was to completely remove the weld and re-weld it. ZPMC is attaching NDT documentation to show that the weld is acceptable.

Replace weld following the WPS disposition and perform the required NDT.

Weld was replaced and NDT documentation was submitted to verify the weld is in conformance with Contract specifications.

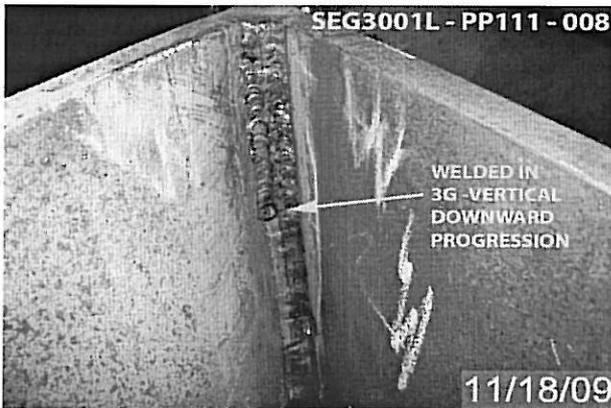
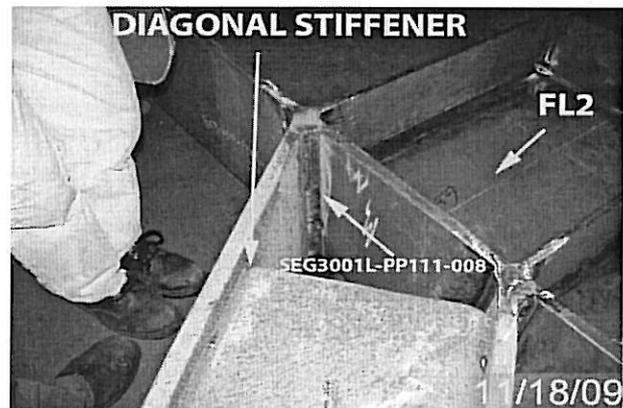
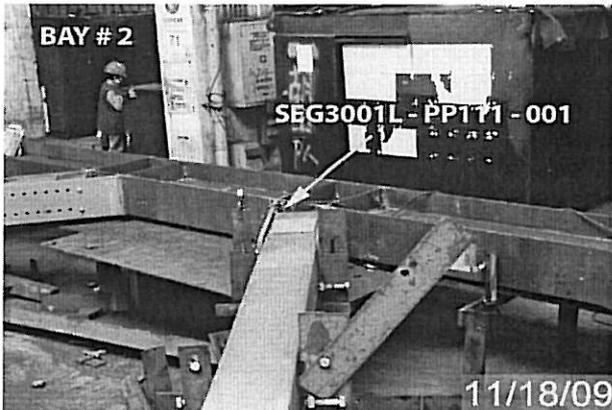
During random in-process visual inspection on Orthotropic Box Girder Floor Beams in Bay # 2, this Caltrans Quality Assurance (QA) Inspector observed ZPMC personnel performing Shielded Metal Arc Welding (SMAW) repair of weld joint identified as Complete Joint Penetration (CJP) SEG3001L-PP111-008 (Lift 12). Welding was observed being performed in the 3G position with a vertical downward progression which does not comply with the applicable repair Welding Procedure Specification WPS-345-SMAW-3G (3F)-Repair.

-AWS D1.5 2002 section 4.6.8: "The progression for all passes in the vertical position shall be upward, unless a downward progression is qualified by tests approved by the Engineer".

-Approved Repair WPS # WPS-345-SMAW-3G (3F)-Repair: "Welding Progression – Vertical – Up Direction"

将此焊缝去除重新焊接,
 Remove weld and re-weld.
