Contract #: 04-0120F4
 Cty: SF/ALA Rte: 80 PM: 13.2/13.9
 File #: 69.25B

QUALITY ASSURANCE -- NON-CONFORMANCE REPORT

Report No: NCR-000519

Reference Description: ZPMC performed base metal weld build-up without the Engineer's approval or an approved Critical Weld Repair procedure for CB14

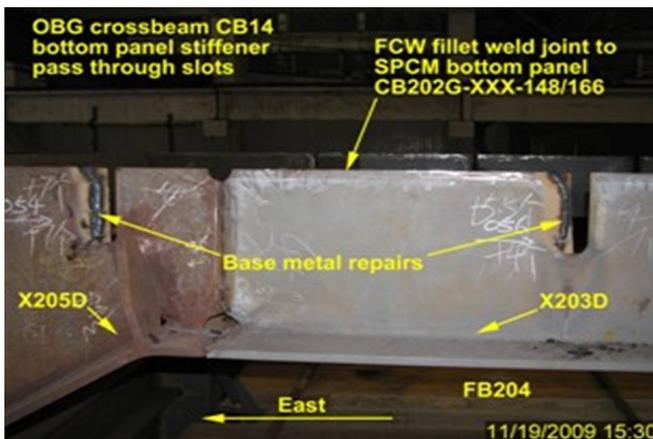
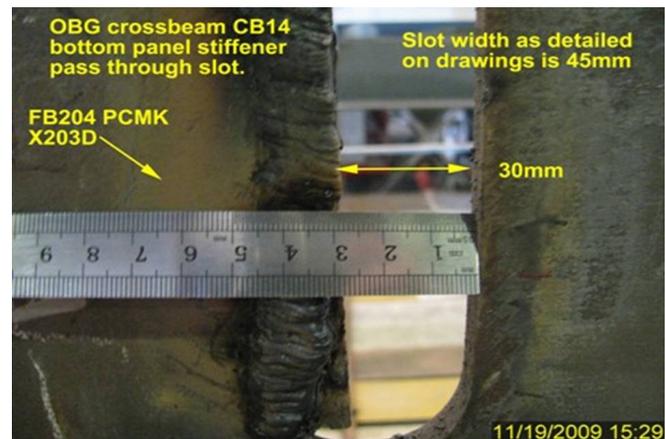
This Quality Assurance (QA) inspector observed ZPMC welding personnel building up additional base metal weld to correct the dimensional/fit-up issue of the intermediate diaphragm slot holes, where the bottom panel stiffeners go through. The slots are located in the web plates of floor beam diaphragms identified as FB204 and FB205 at CB14. Piece Mark (PCMK) numbers affected are X203D, X205E, X205D and X205F at all four diaphragm locations. Weld numbers affected are as follows: CB202G-041-055, 056, 057, 058, 061 and 062; CB202G-042-053~062; CB202G-043-053~058, 061 and 062; CB202G-044-053~062; CB202G-041-051 and 052; CB202G-042-051 and 052; CB202G-043-051 and 052; CB202G-044-051 and 052. These base metal build-up were performed without the Engineer's approval or an approved critical weld repair procedure (CWR).

Submit a repair plan to the engineer for approval.

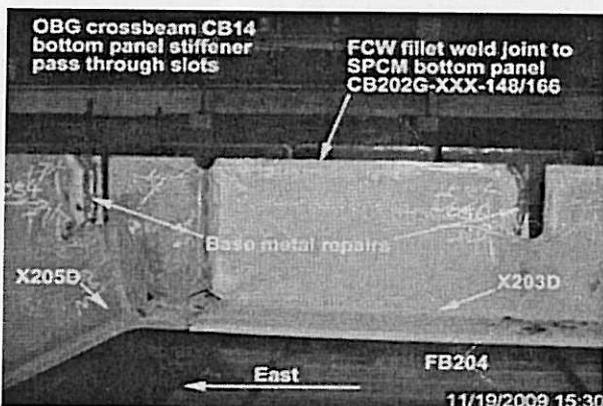
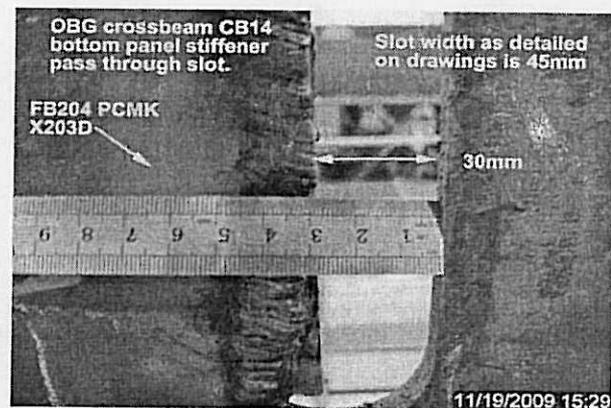
Reference Description: ZPMC performed base metal weld build-up without the Engineer's approval or an approved Critical Weld Repair procedure for CB14

This Quality Assurance (QA) inspector observed ZPMC welding personnel building up additional base metal weld to correct the dimensional/fit-up issue of the intermediate diaphragm slot holes, where the bottom panel stiffeners go through. The slots are located in the web plates of floor beam diaphragms identified as FB204 and FB205 at CB14. Piece Mark (PCMK) numbers affected are X203D, X205E, X205D and X205F at all four diaphragm locations. Weld numbers affected are as follows: CB202G-041-055, 056, 057, 058, 061 and 062; CB202G-042-053~062; CB202G-043-053~058, 061 and 062; CB202G-044-053~062; CB202G-041-051 and 052; CB202G-042-051 and 052; CB202G-043-051 and 052; CB202G-044-051 and 052. These base metal build-up were performed without the Engineer's approval or an approved critical weld repair procedure (CWR).

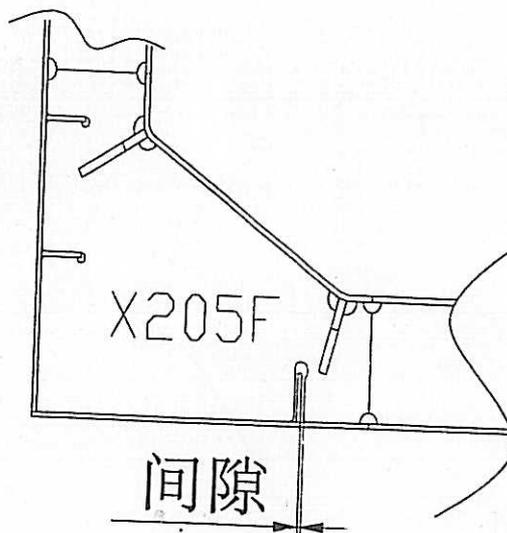
Gap

横梁CB14底板预装配发现X205D, X205E, X203D, X204B与I肋间隙偏大。经测量最小间隙4mm最大14mm。
After inspection CB14 bottom plate gap at X205D, X205E, X203D, X204B and I-ribs, minimum 4mm and maximum 14mm.

Weld distortion and fabricate error.

1. Grind the edge of the repair area cleanly
2. Prepare an right joint according to the approved WPS;
3. Add steel backing on one side, preheat and weld according to the approved repair WPS, perform sur fing to item X205F to make its gap with I-Rib meets the requirement;
4. Grind the repair area flush with the metal base;
5. Perform relevant NDT inspection to repair area according to the working drawing.

Train and educate operator to improve operation skill

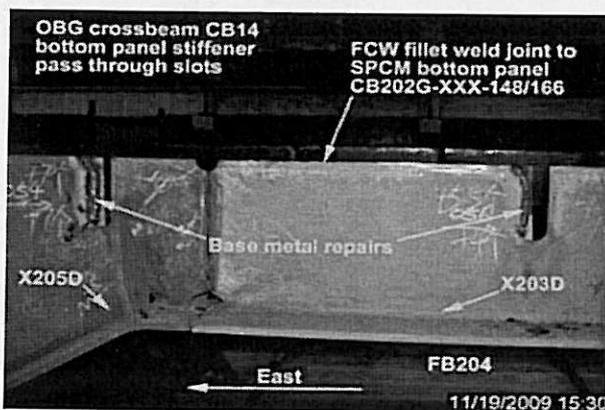
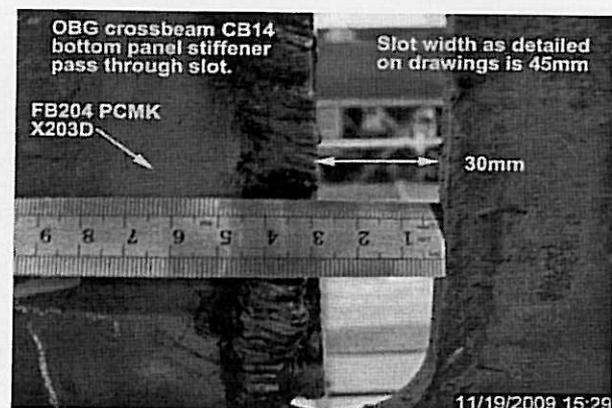
Reference Description: ZPMC performed base metal weld build-up without the Engineer's approval or an approved Critical Weld Repair procedure for CB14

This Quality Assurance (QA) inspector observed ZPMC welding personnel building up additional base metal weld to correct the dimensional/fit-up issue of the intermediate diaphragm slot holes, where the bottom panel stiffeners go through. The slots are located in the web plates of floor beam diaphragms identified as FB204 and FB205 at CB14. Piece Mark (PCMK) numbers affected are X203D, X205E, X205D and X205F at all four diaphragm locations. Weld numbers affected are as follows: CB202G-041-055, 056, 057, 058, 061 and 062; CB202G-042-053~062; CB202G-043-053~058, 061 and 062; CB202G-044-053~062; CB202G-041-051 and 052; CB202G-042-051 and 052; CB202G-043-051 and 052; CB202G-044-051 and 052. These base metal build-up were performed without the Engineer's approval or an approved critical weld repair procedure (CWR).

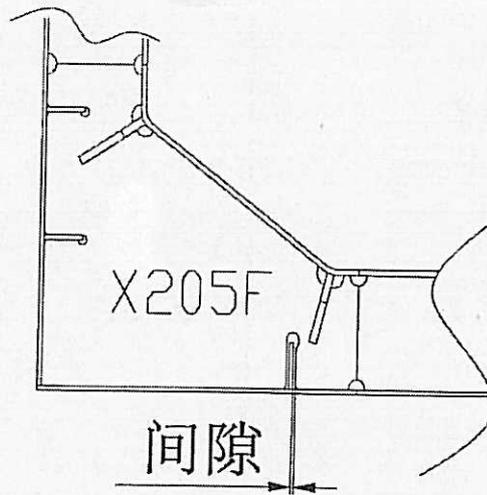
Gap

After inspection CB14 bottom plate, gap was found at X205F and I-ribs, minimum 4mm and maximum 14mm.

1. Grind the edge of the repair area cleanly
2. Prepare an right joint according to the approved WPS;
3. Add steel backing on one side, preheat and weld according to the approved repair WPS, perform sur fing to item X205F to make its gap with I-Rib meets the requirement;
4. Grind the repair area flush with the metal base;
5. Perform relevant NDT inspection to repair area according to the working drawing.
