Contract #: 04-0120F4  
 Cty: SF/ALA Rte: 80 PM: 13.2/13.9  
 File #: 69.25B

**QUALITY ASSURANCE -- NON-CONFORMANCE REPORT**

**Location:** Changxing Island, Shanghai, P.R. China **Report No:** NCR-000520  
**Prime Contractor:** American Bridge/Fluor Enterprises, a JV **Date:** 25-Nov-2009  
**Submitting Contractor:** Zhenhua Port Machinery Company, Ltd (ZPMC), Changxing Island **NCR #:** ZPMC-0493

**Reference Description:** Transverse Linear indication discovered with MT after the contractor's NDT acceptance for Segment 12CW

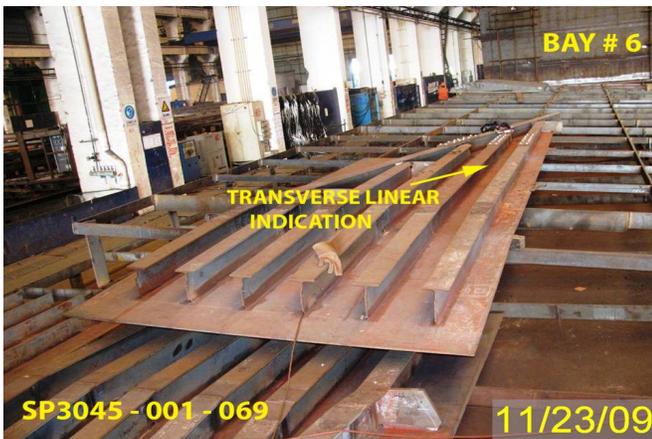
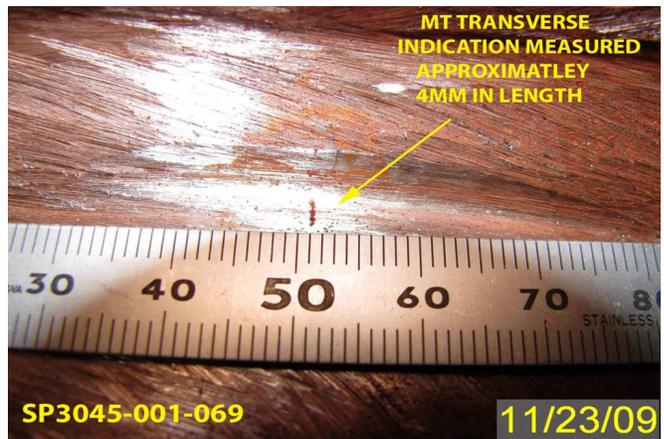
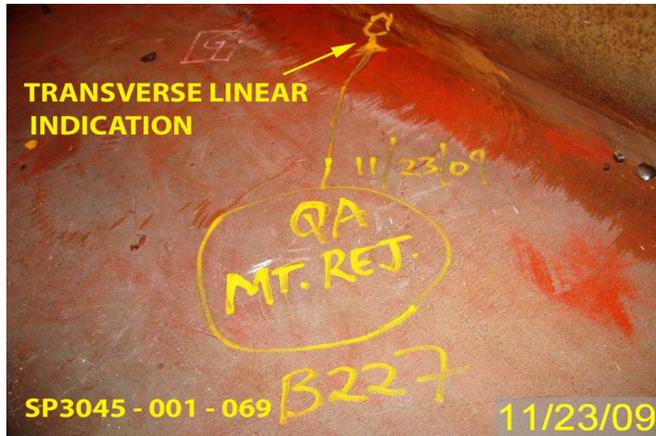
During random verification Magnetic Particle Testing (MT) of the OBG Side Plate (Segment 12CW) located in Bay # 6 as per the "NDT Inspection Notification Sheet" # 004714 submitted by ZPMC, this Caltrans Quality Assurance Inspector (QA) observed One (1) Transverse linear indication located in the fillet weld joining the T-rib to plate. The indication length measured approximately 4mm in length. The Side Plate is identified as SP3045-001-069. This indication was discovered within the area previously tested and accepted by ZPMC.

-AWS D1.5 (02) Section 6.26.2 – “Welds that are subject to MT in addition to visual inspection shall have no cracks.

Submit a repair procedure to the engineer for approval. Missed MT indications by ZPMC technicians are a chronic problem. Provide training to the MT technician and provide documemation of proficiency. A response for the resolution of this issue is expected within 7 days.

**Reference Resolution:** The indication was immediately removed by small amount of grinding in the presence of the CT inspector, re-inspected and accepted by all parties.

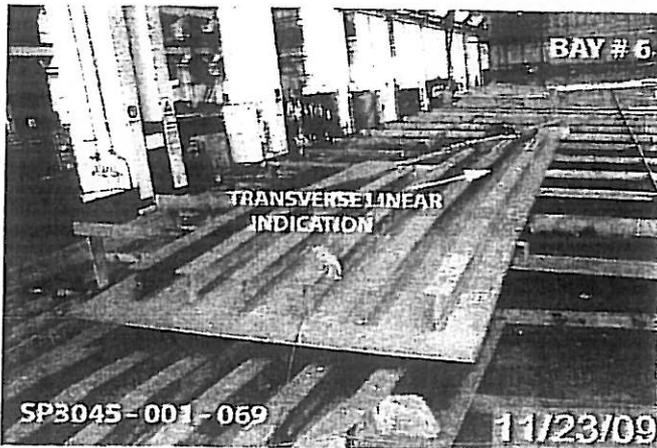
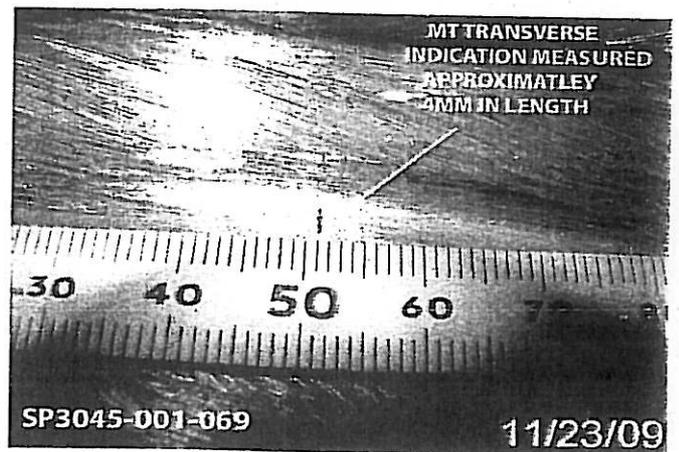
During random verification Magnetic Particle Testing (MT) of the OBG Side Plate (Segment 12CW) located in Bay # 6 as per the "NDT Inspection Notification Sheet" # 004714 submitted by ZPMC, this Caltrans Quality Assurance Inspector (QA) observed One (1) Transverse linear indication located in the fillet weld joining the T-rib to plate. The indication length measured approximately 4mm in length. The Side Plate is identified as SP3045-001-069. This indication was discovered within the area previously tested and accepted by ZPMC.

-AWS D1.5 (02) Section 6.26.2 – “Welds that are subject to MT in addition to visual inspection shall have no cracks.

Submit a repair procedure to the engineer for approval. Missed MT indications by ZPMC technicians are a chronic problem. Provide training to the MT technician and provide documemation of proficiency. A response for the resolution of this issue is expected within 7 days.

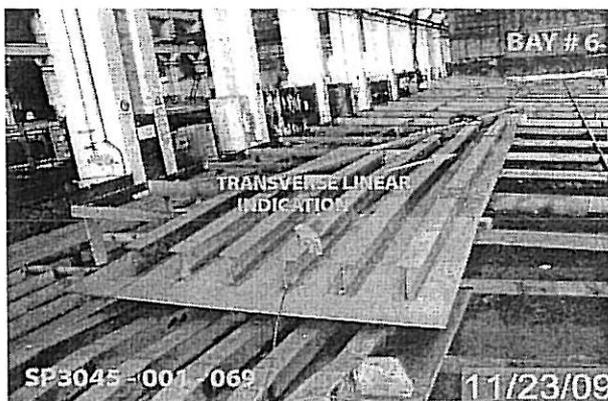
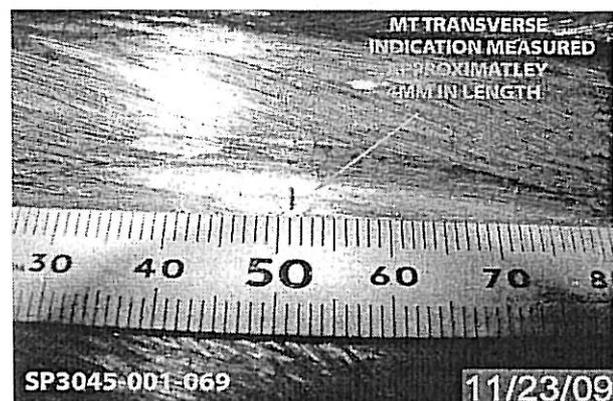
During random verification Magnetic Particle Testing (MT) of the OBG Side Plate (Segment 12CW) located in Bay # 6 as per the "NDT Inspection Notification Sheet" # 004714 submitted by ZPMC, this Caltrans Quality Assurance Inspector (QA) observed One (1) Transverse linear indication located in the fillet weld joining the T-rib to plate. The indication length measured approximately 4mm in length. The Side Plate is identified as SP3045-001-069. This indication was discovered within the area previously tested and accepted by ZPMC.

-AWS D1.5 (02) Section 6.26.2 – “Welds that are subject to MT in addition to visual inspection shall have no cracks. \_

Submit a repair procedure to the engineer for approval. Missed MT indications by ZPMC technicians are a chronic problem. Provide training to the MT technician and provide documentation of proficiency. A response for the resolution of this issue is expected within 7 days.

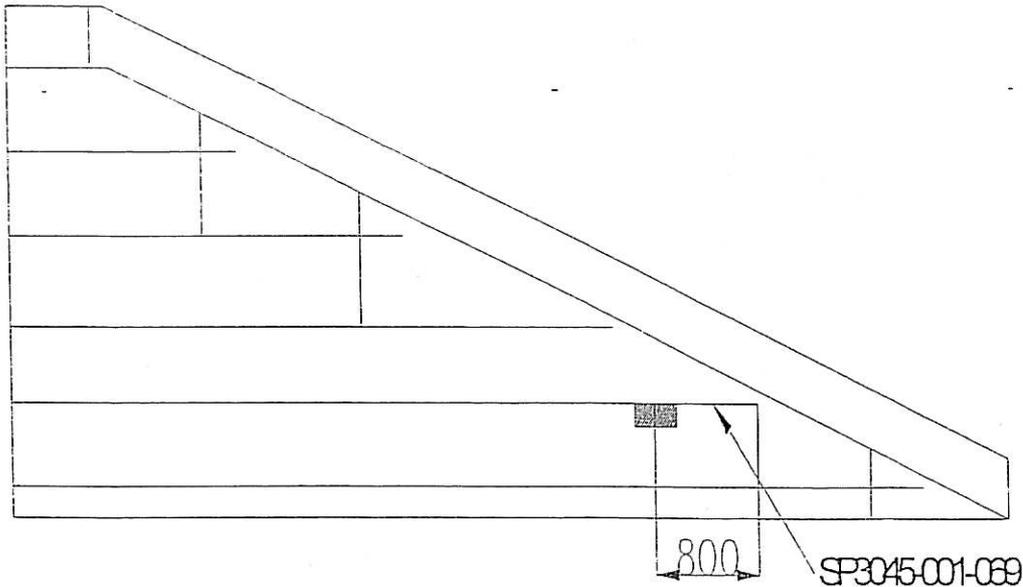
#### Draft of welding discontinuity:

Worker operated error caused base metal gouged.

1. Remove all the defects according to the approved repair WPS by means of grinding.
2. Verify with MT and VT no defects remain in the repair area prior to-weld;
3. Preheat and weld according to the relevant WPS.
4. Grind the weld flush with base metal after welding.
5. Perform VT and MT inspection of the repaired area.
