## QUALITY ASSURANCE -- NON-CONFORMANCE REPORT

**Report No:** NCR-000523

<b>Welding</b>	<b>Concrete</b>	<b>Other</b>	
<b>Welding</b>	<b>Curing</b>	<b>Procedural</b>	<b>Bridge No:</b> 34-0006
<b>Joint fit-up</b>	<b>Coating</b>	<b>Other</b>	<b>Component:</b> Lift 12 FL1 OBG Floor Beams
<b>Procedural</b>	<b>Procedural</b>	<b>Description:</b>

**Reference Description:** Cope holes verified in Lift 12 were not in compliance with the approved contract drawings.

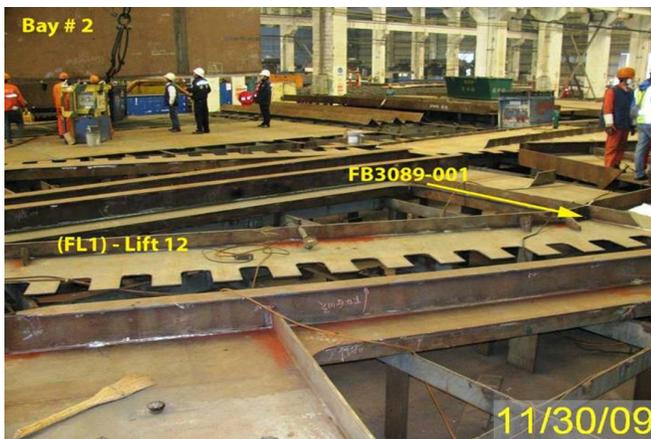
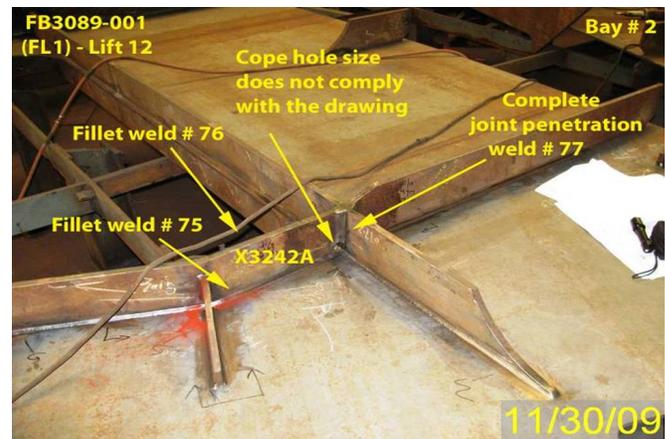
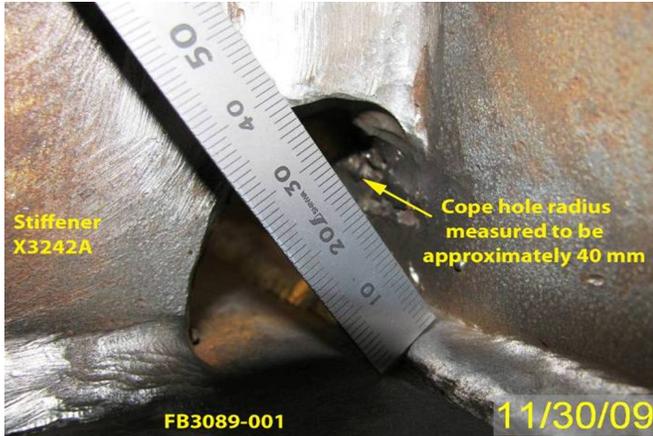
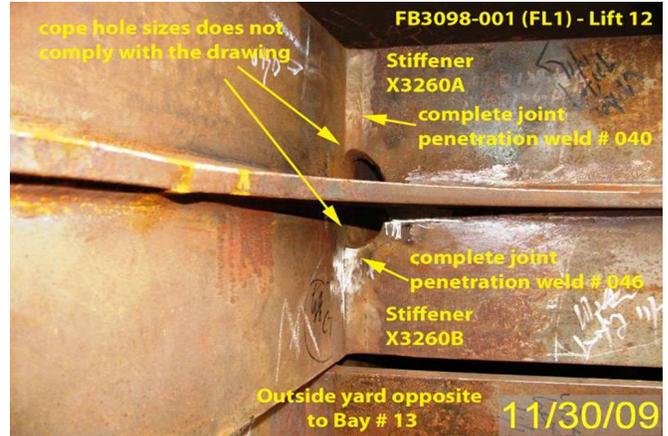
During random in process visual inspection of lift 12 FL1 OBG floor beam components this Quality Assurance Inspector (QA) observed five (5) stiffener cope-hole radii on four (4) floor beams that did not appear to comply with the dimensions specified on the approved shop drawings. The radii as measured by this QA appeared to be approximately 35 mm to 40 mm. According to the approved shop drawings the cope-hole radii should be 25mm.

FB3089-001 – Stiffener X3242A – Located at Bay # 2

FB3046-001 – Stiffener X3116A – Located outside yard opposite to Bay # 14

FB3023-001 – Stiffener X3120B – Located outside yard opposite to Bay # 14

FB3098-001 – Stiffeners X3260A & X3260B – Located outside yard opposite to Bay # 13

These holes are outside the additional 5mm tolerance approved by design. Submit a repair procedure to the engineer (prior to the start of repair) for approval. A response for the resolution of this issue is expected within 7 days.

**Reference Resolution:** ZPMC is attaching the approved shop drawings for the floorbeams which shows that the radius of the cope holes is 50mm. ZPMC believes that cope holes measured are acceptable.

CT inspector was misreading the drawing. After confirmed with ZPMC technique department, these cope holes are not designed to be 25mm size. According to the FVT acceptance criteria what is been using now. These cope holes are all acceptable. Further, these panels are all green tagged at this moment. Attached is the designed drawing for these components, ZPMC hope CT engineer could take a review and withdraw this NCR.

After review, the cope holes were found to be fit for purpose as is

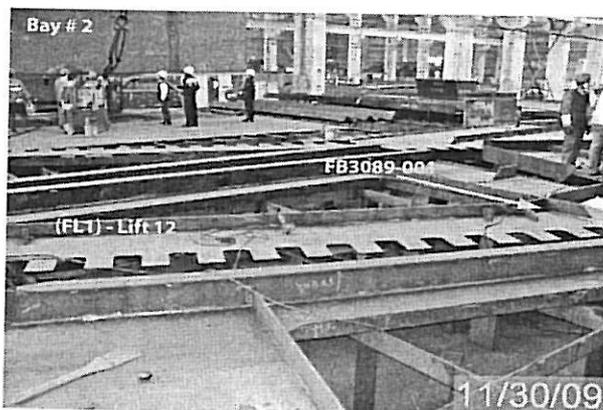
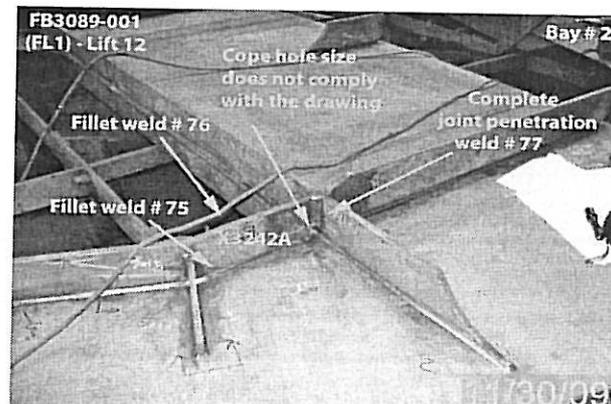
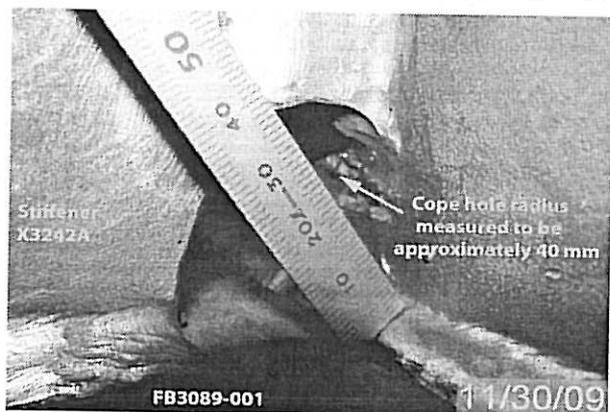
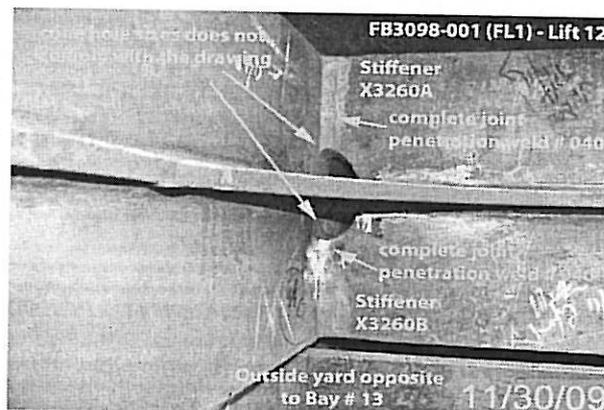
During random in process visual inspection of lift 12 FL1 OBG floor beam components this Quality Assurance Inspector (QA) observed five (5) stiffener cope-hole radii on four (4) floor beams that did not appear to comply with the dimensions specified on the approved shop drawings. The radii as measured by this QA appeared to be approximately 35 mm to 40 mm. According to the approved shop drawings the cope-hole radii should be 25mm.

FB3089-001 – Stiffener X3242A – Located at Bay # 2

FB3046-001 – Stiffener X3116A – Located outside yard opposite to Bay # 14

FB3023-001 – Stiffener X3120B – Located outside yard opposite to Bay # 14

FB3098-001 – Stiffeners X3260A &amp; X3260B – Located outside yard opposite to Bay # 13
