Contract #: 04-0120F4Cty: SF/ALA Rte: 80 PM: 13.2/13.9File #: 69.25B**QUALITY ASSURANCE -- NON-CONFORMANCE REPORT****Location:** Changxing Island, Shanghai, P.R. China**Report No:** NCR-000524**Prime Contractor:** American Bridge/Fluor Enterprises, a JV**Date:** 03-Dec-2009**Submitting Contractor:** Zhenhua Port Machinery Company, Ltd (ZPMC), Changxing Island**NCR #:** ZPMC-0497**Type of problem:**

Reference Description: Longitudinal indications were discovered with MT after the contractor's acceptance on Segment 7BW

Dear: Mr. Charles Kanapicki
Job Name: SAS Superstructure

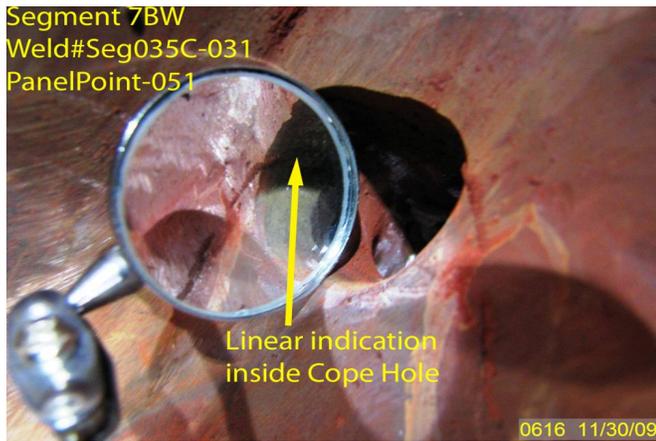
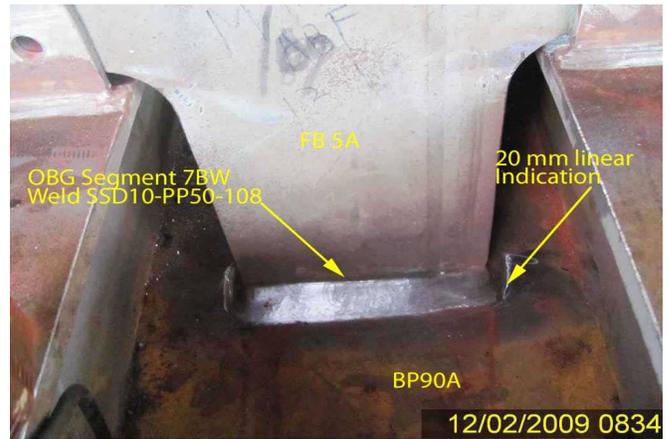
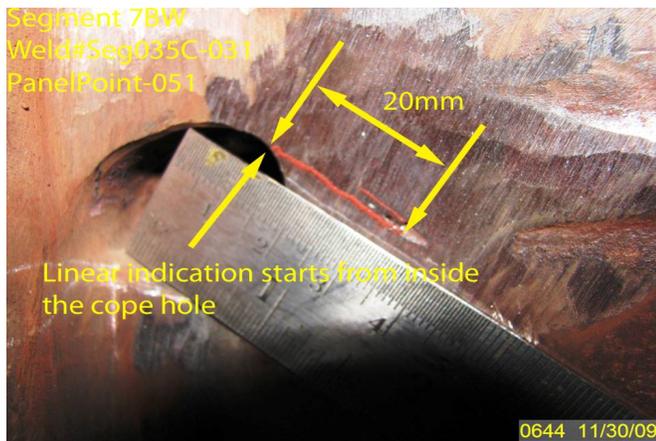
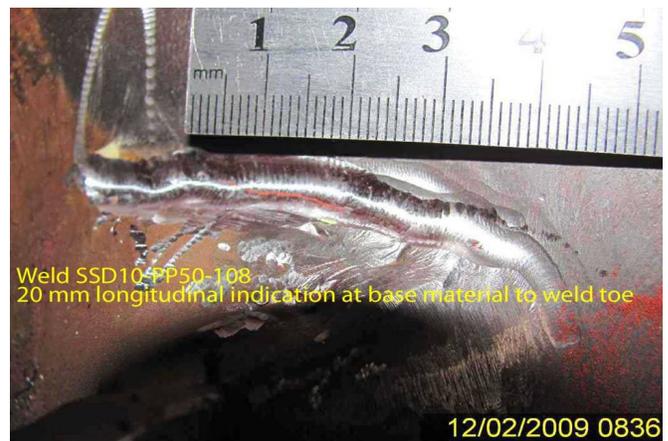
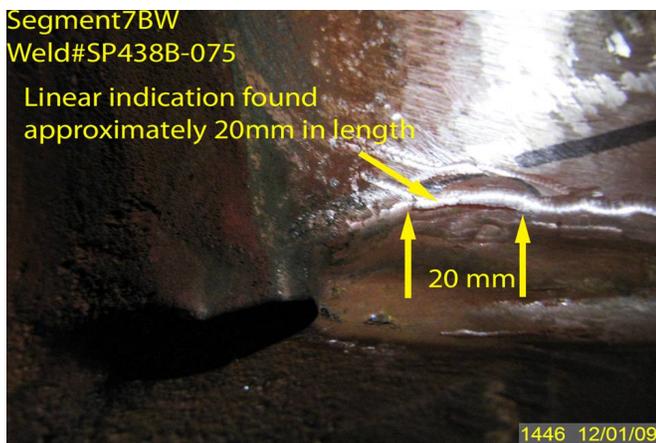
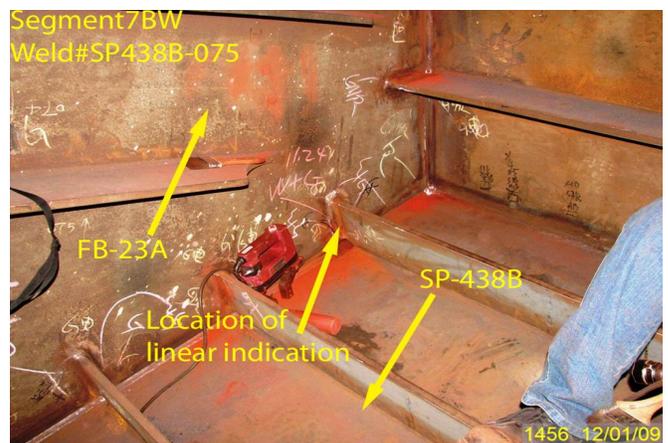
-One (1) Longitudinal linear indication measuring approximately 20mm in length.

The weld is identified as SEG-035C-031 @ Panel Point (PP) 51.

The Weld is a Complete Joint Penetration (CJP) butt weld joining the Longitudinal Diaphragm (LD) identified as LD-04A to Floor Beam (FB) identified as FB-023A.

The indication is located in an area that has not been previously tested and accepted by ZPMC Quality Control (QC) personnel.

The weld is identified as SP438B-075 @ Panel Point (PP) 051.

The Weld is a Fillet Weld joining the Side Plate, SP438B I rib to Floor Beam, FB23A (FL3) joint.

The Notice of Witness Inspection Number (NWIT) is 004768. The indication is located in an area that has been previously tested and accepted by ZPMC Quality Control (QC) personnel.

-One (1) Longitudinal linear indication measuring approximately 20 mm in length.

The weld is identified as SS10-PP50-108 @ Panel Point (PP) 050.

This weld is a fillet weld joining the floor beam to the bottom panel.

The indication is located in an area that has been previously tested and accepted by ZPMC Quality Control (QC) personnel.

Submit a repair plan to the engineer for approval. A response for the resolution of this issue is expected within 7 days.
