## QUALITY ASSURANCE -- NON-CONFORMANCE REPORT

**Report No:** NCR-000525

**Reference Description:** Base Metal damage in SPCM material during the weld repair process in Lift 12 Floorbeam

**Job Name:** SAS Superstructure

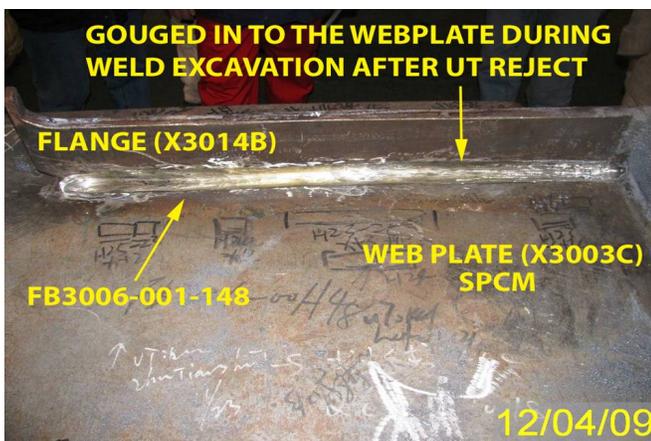
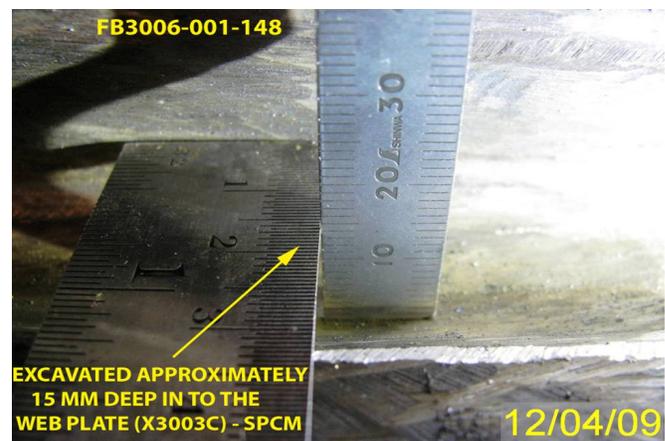
During random in process visual inspection at Bay #2, the Quality Assurance Inspector (QA) observed an OBG FL3 lift 12 Floor Beam web plate-X3003C had been arc-gouged approximately 15 mm in depth into the base material and 670 mm in length during the excavation of complete joint penetration (CJP) web to flange T-weld joint. The excavation was supposed to be for the weld reject that was found by ZPMC Ultrasonic Testing (UT) technician.

FB3006-001-148 (Web to flange)

Complete Joint Penetration (CJP) T- joint

Web Plate – X3003C, SPCM

Flange – X3014B

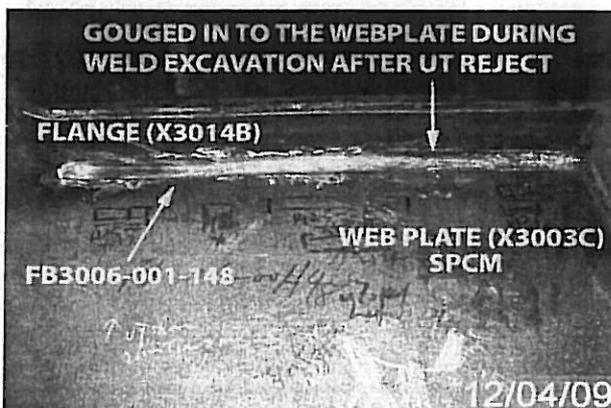
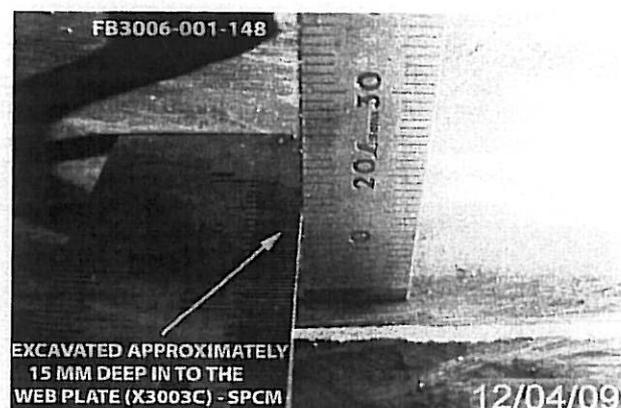
During random in process visual inspection at Bay #2, the Quality Assurance Inspector (QA) observed an OBG FL3 lift 12 Floor Beam web plate-X3003C had been arc-gouged approximately 15 mm in depth into the base material and 670 mm in length during the excavation of complete joint penetration (CJP) web to flange T-weld joint. The excavation was supposed to be for the weld reject that was found by ZPMC Ultrasonic Testing (UT) technician.

FB3006-001-148 (Web to flange)

Complete Joint Penetration (CJP) T- joint

Web Plate - X3003C, SPCM

Flange - X3014B

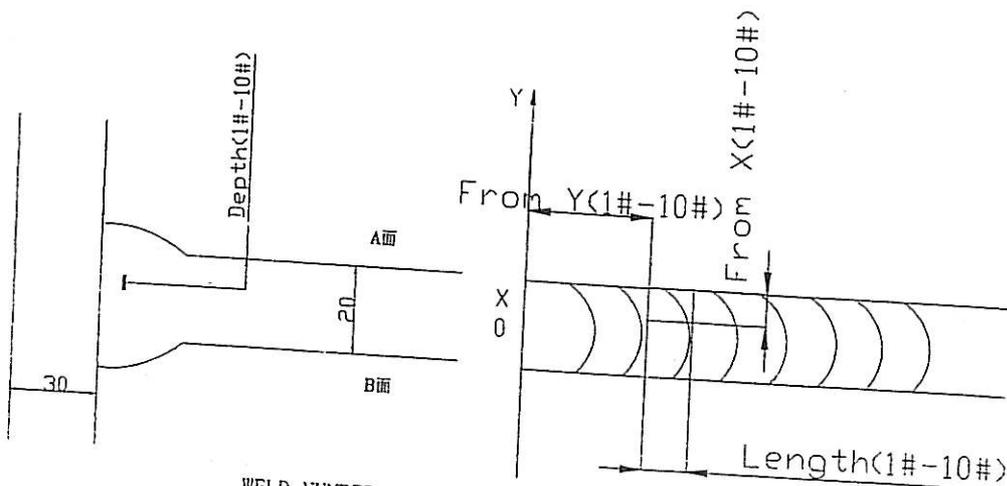
WELD NUMBER: FB3006-001-148  
Please see the detail data from UT report!

Rejected indication found by ultrasonic inspection is less than the maximum allowance aggregate length.

1. 焊道未及时处理干净。
1. Did not clear the weld pass completely in time.

1. 从缺陷距离端面较近一侧 ( $D \leq 0.65T$ ,  $D$ 为缺陷深度,  $T$ 为板厚) 采用碳刨或打磨的方法去除焊缝缺陷;
  2. 参照返修焊接工艺规程 (WPS) 准备正确的接头型式, 预热和焊接;
  3. 焊前对修补区域进行VT检测保证缺陷完全被清除;
  4. 将修补区域打磨到与母材或邻近焊缝平齐;
  5. 根据批准的车间图纸检查焊缝.
- 
1. Gouge or grind from nearer side from metal edge ( $D \leq 0.65T$ , "D" is depth of defects, "T" is thickness of metal) to remove all defects;
  2. Follow repair WPS for joint preparation, preheat, and weld deposit;
  3. Verify with VT no defects remain in the weld joint prior to welding;
  4. Grind the repaired area flush with base metal or the adjacent weld;
  5. Check the welds according to the working drawings.

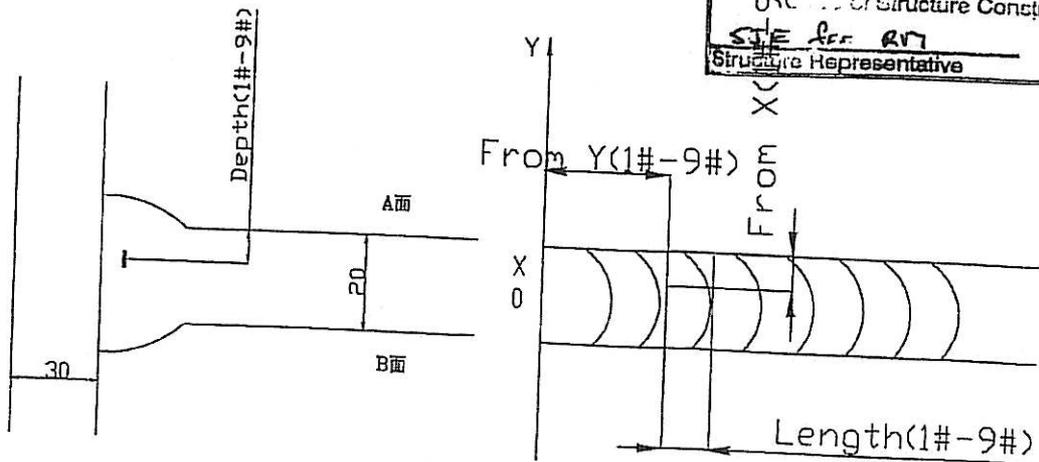
WELD NUMBER: FB3006-001-148  
Please see the detail data from UT report!

Rejectable indications were found by ultrasonic inspection for a second repair on the SPCM plate.

1. The weld defect location may not have been properly identified prior to grinding, i.e. the X and Y location was incorrect or the excavation was not centered on the defect, therefore the excavation did not encompass the whole defect.

1. QC and a Lead CWI shall be present and direct all gouging, grinding and welding operations during this repair.
2. QC and a Lead CWI shall have a copy of the CWR in hand and shall be at the repair location prior to the repair.

3. QC and the Lead CWI shall direct the repair to ensure the repair is per the disposition requirements.
4. Clean excavation area of all loose debris including UT powder, and preheat according to the Table 1 of the New Repair Procedure prior to gouging. ~~No preheating is required if grinding is only being used.~~ PREHEAT TO 650

5. Gouge and/or grind accurately from nearer side from metal edge ( $D \leq 0.65T$ , "D" is depth of defects, "T" is thickness of metal) to remove all defects. PREHEAT TO 650

6. Prepare a right joint according to approved WPS.
7. Grind repair area smooth to a shiny finish with tapered ends to ensure staggered stops and starts, and perform VT and MT to ensure the defects have been removed.

8. Clean the excavation area of all loose debris including MT powder and UT gel.
9. QC and a Lead CWI shall verify and document all defects have been removed prior to repair welding.

10. Preheat and weld according to the Table 1 of the New Repair Procedure.
11. QC and a CWI shall enforce interpass cleaning by performing a visual inspection prior to the disposal of each pass.

12. Perform post weld heating according to the Table 1 of the New Repair Procedure.
13. Allow the weld to cool to ambient temperature gradually. Grind the repaired area flush with base metal or the adjacent weld after post weld heating.

14. Wait 48 hours after the repair area has cooled to ambient temperature before performing NDT.
15. Check the weld by performing VT, MT and UT to the repair area according to the drawings. Additional NDT in accordance with the applicable notes in Special Provisions Section 10-1.59 'Steel Structure', subsection 'Inspection and Testing'.
