Contract #: 04-0120F4  
 Cty: SF/ALA Rte: 80 PM: 13.2/13.9  
 File #: 69.25B

## QUALITY ASSURANCE -- NON-CONFORMANCE REPORT

**Report No:** NCR-000527

**Reference Description:** Longitudinal Indications discovered with MT after the contractor had tested and accepted the welds in Segment 8AE

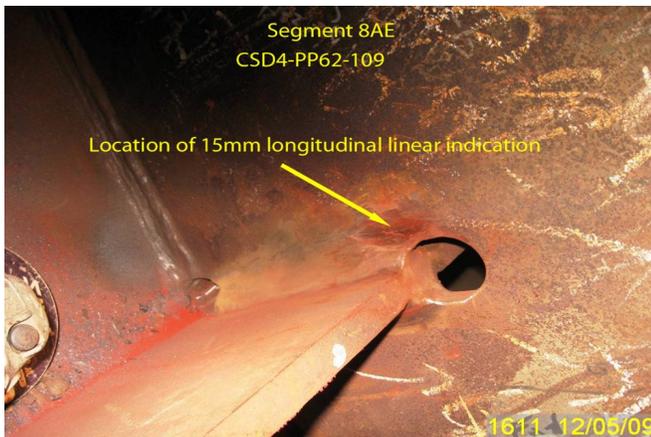
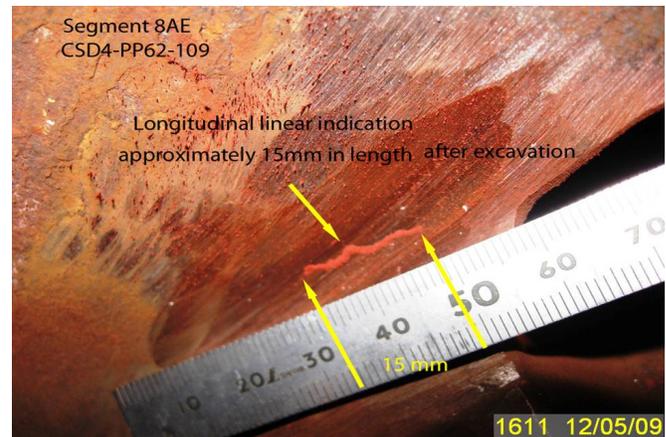
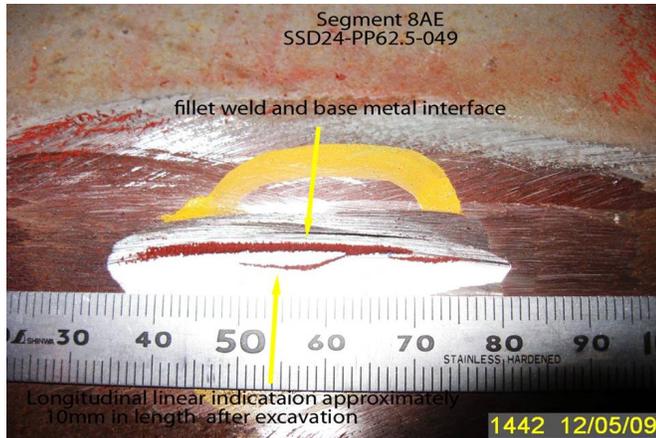
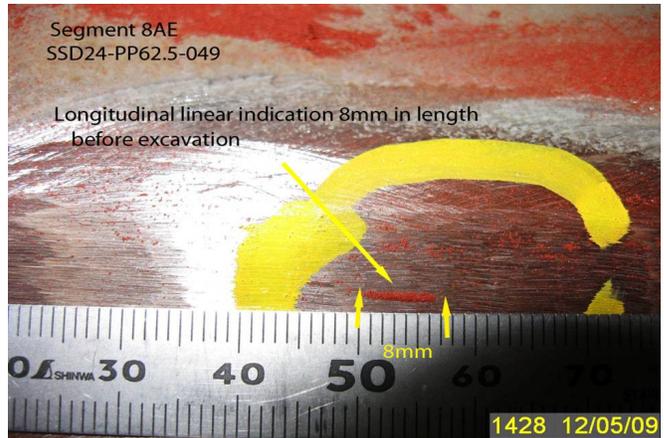
During Quality Assurance Magnetic Particle Testing (MT) review of welds located on Segment 8AE, this Quality Assurance Inspector (QA) discovered the following issues:

-Two (2) Longitudinal linear indications measuring approximately 8mm and 15mm in length. The welds are identified as:

1. SD24-PP62.5-049 @ Panel Point (PP)-062.5 (8 mm indication)
2. CSD4-PP62-109 @ Panel Point (PP)-062 (15 mm indication)

-The Notice of Witness Inspection Number (NWIT) is 004796. The indication is located inside the area that has been previously tested and accepted by ZPMC Quality Control (QC) personnel.

Submit a repair procedure to the engineer for approval. Missed MT indications by ZPMC QC are a chronic problem. Perform training with MT technicians and test for competency to ensure the quality of MT inspection can achieve consistently accurate results. A response for the resolution of this issue is expected within 7 days.

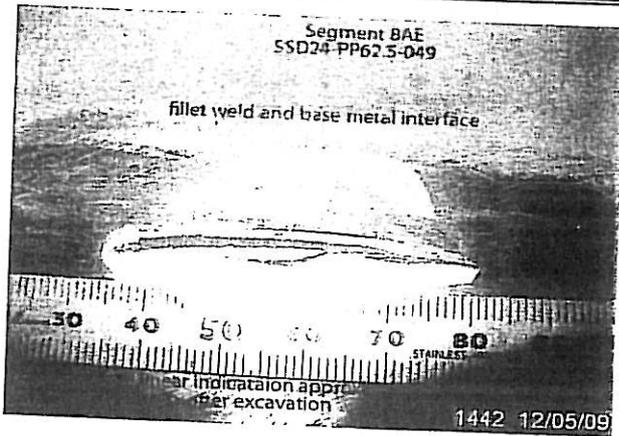
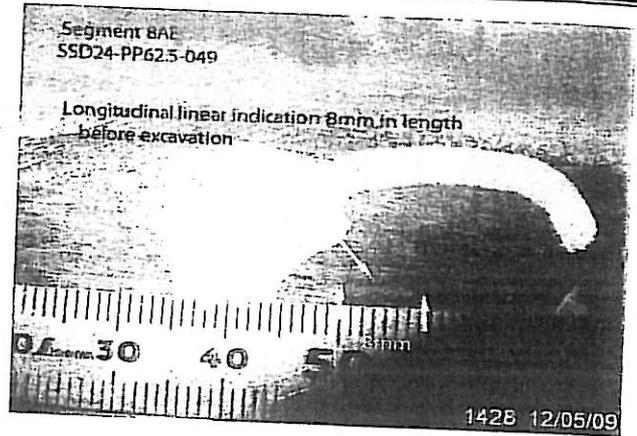
During Quality Assurance Magnetic Particle Testing (MT) review of welds located on Segment 8AE, this Quality Assurance Inspector (QA) discovered the following issues:

-Two (2) Longitudinal linear indications measuring approximately 8mm and 15mm in length. The welds are identified as:

1. SD24-PP62.5-049 @ Panel Point (PP)-062.5 (8 mm indication)
2. CSD4-PP62-109 @ Panel Point (PP)-062 (15 mm indication)

-The Notice of Witness Inspection Number (NWIT) is 004796. The indication is located inside the area that has been previously tested and accepted by ZPMC Quality Control (QC) personnel.

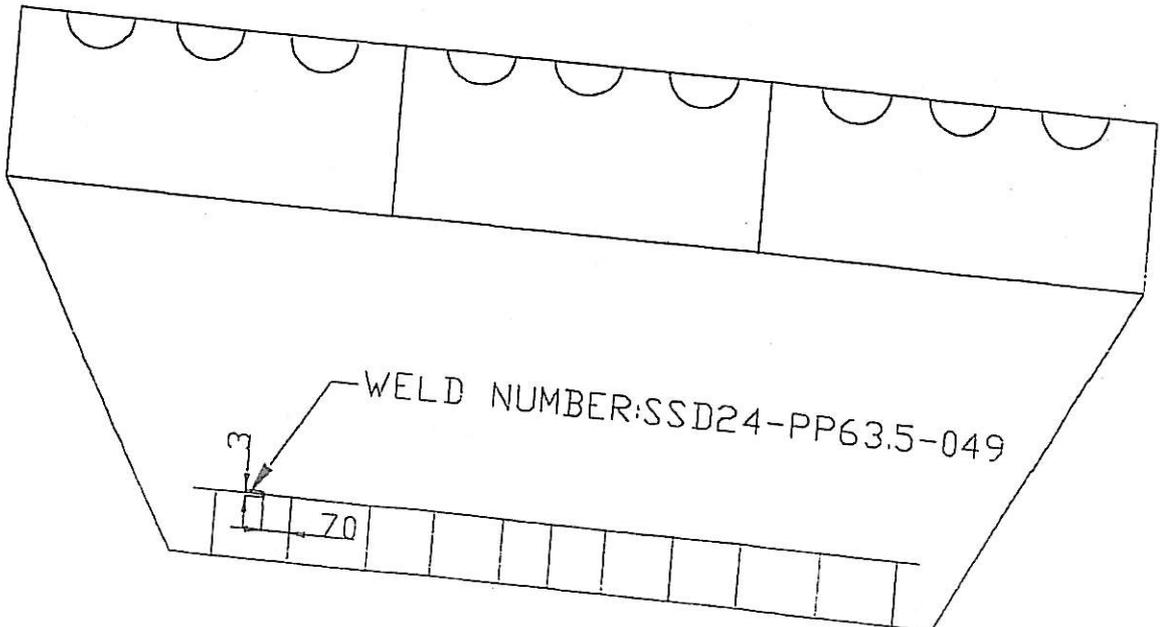
Draft of Welding Discontinuity:

One transverse crack was found by use of MT on SSD24-PP63.5-049.

1. 火焰加热时, 水汽没有完全的去掉或者这个区域预热不够;
1. Moisture wasn't completely removed during drying operation (preheating) or the area wasn't preheated sufficiently.

1. QC and a Lead CWI shall be present, direct and supervise all grinding and welding operations during this repair to ensure the repair is per the disposition requirements

2. QC and a Lead CWI shall have an approved copy of the CWR in hand prior to the repair.

4. Clean the excavation area of all loose debris including MT powder. Preheat to 65° C before removing cracks by grinding, repair area shall extend a minimum of 50mm beyond each end of single crack repairs.

5. If base metal is damaged by grinding, the damaged area shall be ground clean prior to performing weld repair. If gap > 5mm is found during or after grinding, comply with the notification on changing fillet weld to CJP which is submitted for Engineer's review and approval form.

6. Prepare excavation in accordance with the New Repair Procedure prior to welding.

7. Before this repair, Verify with VT and MT repair areas are defects free, and also MT shall be performed on the base metal laying abroad cracks to ensure that no cracks were propagated to the base metal. Separate CWR approval is needed if cracks are found in the base metal, and only after this new CWR's approval can continue the repair.

8. Clean excavation area of all loose debris including MT powder after excavation. Preheat and weld according to repair WPS, the preheat shall between 160° C-230° C.

9. Perform post weld heating according to repair WPS, the postheat shall between 230° C-315° C and for one hour minimum.

11. Grind the repaired area flush with base metal or the adjacent weld after post weld heating.

12. Wait 48 hours at least after the repair area has cooled to ambient temperature before performing NDT.

13. Perform MT inspection to all repair area according to Contract Drawings along with all additional NDT required by the applicable notes Special Provision Section 10-1.59 'Steel Structure', subsection 'inspection testing'. NDT include VT, MT and UT if it is a CJP weld.

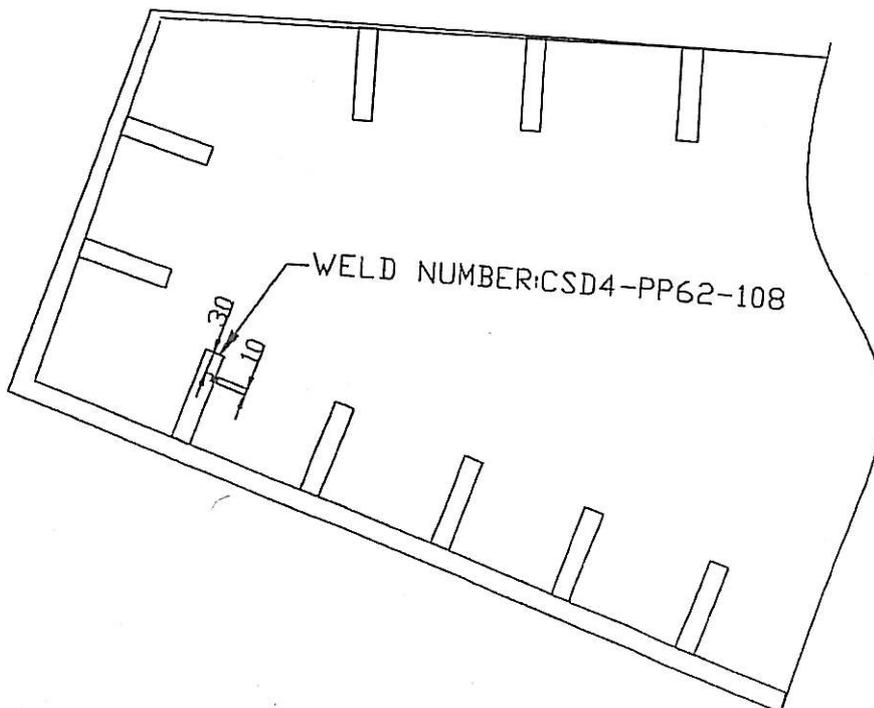
### Draft of Welding Discontinuity:

One longitudinal crack was found by use of MT on CSD4-PP62-108.

1. 火焰加热时, 水汽没有完全的去掉或者这个区域预热不够;
1. Moisture wasn't completely removed during drying operation (preheating) or the area wa sn't preheated sufficiently.

1. QC and a Lead CWI shall be present, direct and supervise all grinding and welding operations during this repair to ensure the repair is per the disposition requirements

2. QC and a Lead CWI shall have an approved copy of the CWR in hand prior to the repair.
3. Remove paint  $\geq 25\text{mm}$  in all direction of HAZ prior to MT.

4. Clean the excavation area of all loose debris including MT powder. Preheat to 65° C before removing cracks by grinding, repair area shall extend a minimum of 50mm beyond each end of single crack repairs.

5. If base metal is damaged by grinding, the damaged area shall be ground clean prior to performing weld repair. If gap  $> 5\text{mm}$  is found during or after grinding, comply with the notification on changing fillet weld to CJP which is submitted for Engineer's review and approval form.

6. Prepare excavation in accordance with the New Repair Procedure prior to welding.
7. Before this repair, Verify with VT and MT repair areas are defects free, and also MT shall be performed on the base metal laying abroad cracks to ensure that no cracks were propagated to the base metal. Separate CWR approval is needed if cracks are found in the base metal, and only after this new CWR's approval can continue the repair.

8. Clean excavation area of all loose debris including MT powder after excavation. Preheat and weld according to repair WPS, the preheat shall between 160° C-230° C

9. Perform post weld heating according to repair WPS, the postheat shall between 230° C-315° C and for one hour minimum.
10. Allow the weld to cool to ambient temperature gradually. Control cooling rate after PWHT to no more than 50° C per hour.

11. Grind the repaired area flush with base metal or the adjacent weld after post weld heating.
12. Wait 48 hours at least after the repair area has cooled to ambient temperature before performing NDT.

13. Perform MT inspection to all repair area according to Contract Drawings along with all additional NDT required by the applicable notes Special Provision Section 10-1.59 'Steel Structure', subsection 'inspection testing'. NDT include VT, MT and UT if it is a CJP weld.
