Contract #: 04-0120F4Cty: SF/ALA Rte: 80 PM: 13.2/13.9File #: 69.25B**QUALITY ASSURANCE -- NON-CONFORMANCE REPORT****Location:** Changxing Island, Shanghai, P.R. China**Report No:** NCR-000528**Prime Contractor:** American Bridge/Fluor Enterprises, a JV**Date:** 07-Dec-2009**Submitting Contractor:** Zhenhua Port Machinery Company, Ltd (ZPMC), Changxing Island**NCR #:** ZPMC-0501**Type of problem:**

# QUALITY ASSURANCE -- NON-CONFORMANCE REPORT

<b>To:</b>	AMERICAN BRIDGE/FLUOR, A JV 375 BURMA ROAD OAKLAND CA 95607	<b>Date:</b>	24-Dec-2009
<b>Dear:</b>	Mr. Charles Kanapicki	<b>Contract No:</b>	04-0120F4 04-SF-80-13.2 / 13.9
<b>Attention:</b>	Mr. Thomas Nilsson Project/Fabrication Manager	<b>Job Name:</b>	SAS Superstructure
<b>Subject:</b>	NCR No. ZPMC-0501	<b>Document No:</b>	05.03.06-000489

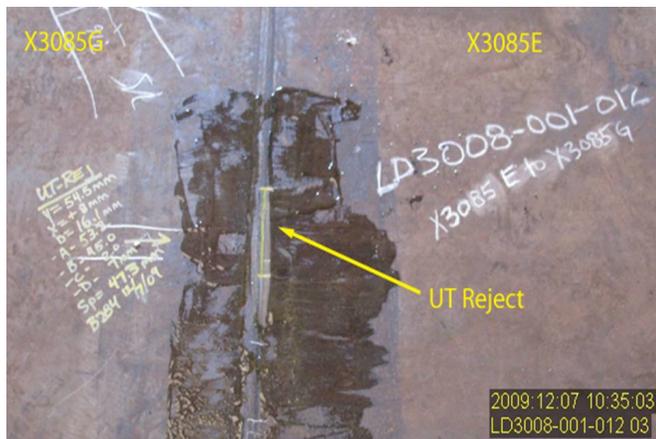
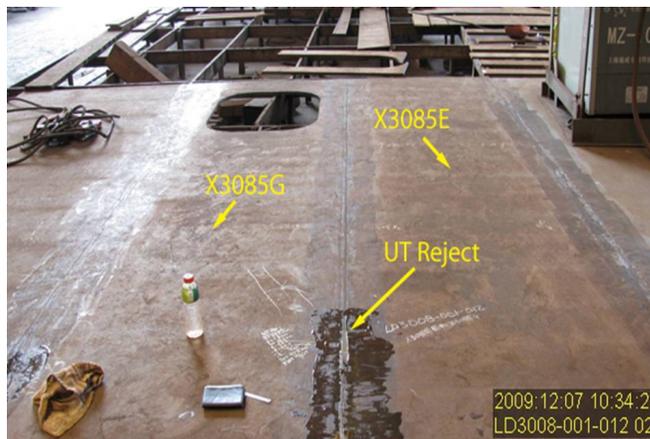
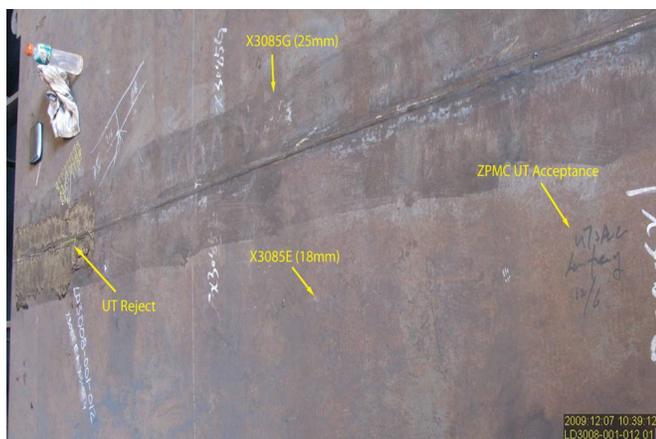
During the Quality Assurance Ultrasonic Testing (UT) review of welds located on Longitudinal Diaphragm LD3008-001, this Quality Assurance Inspector (QA) discovered the following issues:

- One (1) longitudinal indication measuring approximately 100mm in length, a depth of 16.2mm. The dB rating is a +7 and the material thickness is a transition from 18mm to 25mm. For additional information please see the UT report for this date.
- The weld is identified as: LD3008-001-012 for Lift 12.
- The Weld is a Complete Joint Penetration (CJP) butt weld joining the 18mm plate (X3085E), to the 25mm plate (X3085G).
- The member is located in Bay 3.
- The Notice of Witness Inspection Number (NWIT) is 004810. The indication is located inside the area that has been previously tested and accepted by ZPMC Quality Control (QC) personnel. As per the contract documents, ZPMC's QC personnel are required to perform one hundred (100%) percent UT inspection of this weld.

-AWS D1.5 Section 6.26.3.1; "Welds that are subject to UT in addition to visual inspection shall be acceptable if they meet the following requirements:...(1) Welds subject to tensile stress under any condition of loading shall conform to the requirements of Table 6.3...(2) Welds subject to compressive stress shall conform to the requirements of Table 6.4."

Submit a resolution for the identified non-conformance to the engineer for approval. Missed indications by ZPMC technicians is a chronic problem. Provide training with procedures to prevent future occurrences. A response for the resolution of this issue is expected within 7 days.

**Reference Resolution:** In the presence of the CT inspector, ZPMC ground the surface. The weld was re-UT'd immediately and found to be acceptable. ZPMC requests closure of this NCR.

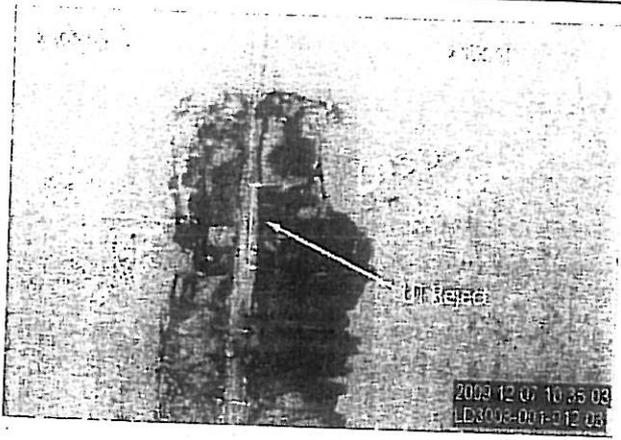
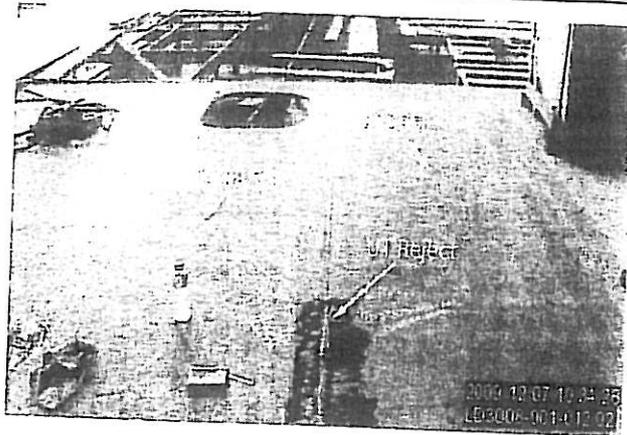
During the Quality Assurance Ultrasonic Testing (UT) review of welds located on Longitudinal Diaphragm LD3008-001, this Quality Assurance Inspector (QA) discovered the following issues:

- One (1) longitudinal indication measuring approximately 100mm in length, a depth of 16.2mm. The dB rating is a +7 and the material thickness is a transition from 18mm to 25mm. For additional information please see the UT report for this date.
- The weld is identified as: LD3008-001-012 for Lift 12.
- The Weld is a Complete Joint Penetration (CJP) butt weld joining the 18mm plate (X3085E), to the 25mm plate (X3085G).
- The member is located in Bay 3.
- The Notice of Witness Inspection Number (NWIT) is 004810. The indication is located inside the area that has been previously tested and accepted by ZPMC Quality Control (QC) personnel. As per the contract documents, ZPMC's QC personnel are required to perform one hundred (100%) percent UT inspection of this weld.

-AWS D1.5 Section 6.26.3.1; "Welds that are subject to UT in addition to visual inspection shall be acceptable if they meet the following requirements:...(1) Welds subject to tensile stress under any condition of loading shall conform to the requirements of Table 6.3...(2) Welds subject to compressive stress shall conform to the requirements of Table 6.4."

Remove indication by grinding.

Indication was removed by grinding. Magnetic Particle Testing was performed to verify the indication was removed completely.
