QUALITY ASSURANCE -- NON-CONFORMANCE REPORT

Report No: NCR-000530

NCR #: ZPMC-0503

Reference Description: I-Rib components for Segment 5AW were welded in a misaligned position

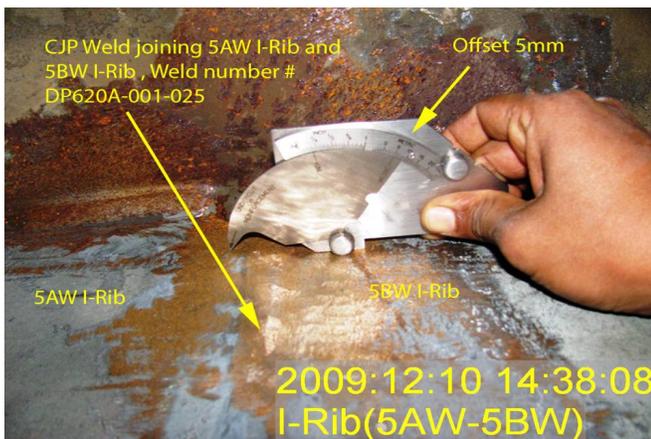
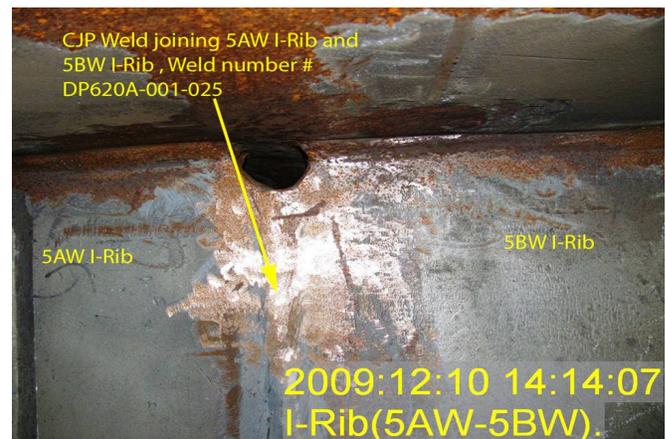
The Caltrans Quality Assurance (QA) Inspector observed an I-Rib weld between 5AW to 5BW Crossbeam side (W5) that was misaligned and welded. The out of tolerance offset measurement across the weld is 5mm and the maximum allowed per AWS D1.5 2002 is 3mm.

The weld is identified as: DP620A-001-025

The weld is a Complete Joint Penetration (CJP) butt weld.

The location of the weld is between 5AW I-Rib to 5BW I-Rib, Cross beam side at W5.

AWS D1.5 (02) Section 3.3.3; "Parts to be joined by groove welds shall be carefully aligned. Where the parts are effectively restrained against bending due to eccentricity in alignment, the offset from theoretical alignment shall not exceed 10 percent of the thickness of the thinner part joined, but in no case shall be more than 3 mm

This NCT was previously sent with a conflicting description on December 24,2009 and has now been corrected. Submit a repair procedure to the engineer for approval. A response for the resolution of this issue is expected within 7 days.

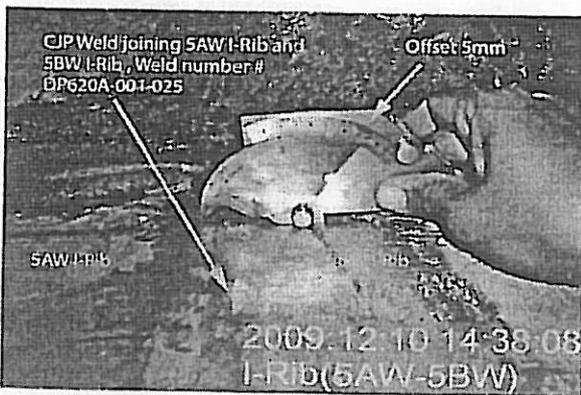
The Caltrans Quality Assurance (QA) Inspector observed an I-Rib weld between 5AW to 5BW Crossbeam side (W5) that was misaligned and welded. The out of tolerance offset measurement across the weld is 5mm and the maximum allowed per AWS D1.5 2002 is 3mm.

The weld is identified as: DP620A-001-025

The weld is a Complete Joint Penetration (CJP) butt weld.

The location of the weld is between 5AW I-Rib to 5BW I-Rib, Cross beam side at W5.

AWS D1.5 (02) Section 3.3.3; "Parts to be joined by groove welds shall be carefully aligned. Where the parts are effectively restrained against bending due to eccentricity in alignment, the offset from theoretical alignment shall not exceed 10 percent of the thickness of the thinner part joined, but in no case shall be more than 3 mm

Correct misalignment issue by bringing welded members into conformance with specifications listed in AWS D1.5 Section 3.3.3. for parts to be joined by groove welds.

Contractor supplied survey data showing that the misalignment was corrected and the members were brought within 3mm of each other. This issue was tracked by Voyage 2 Punchlist item no. 344 and was signed off 02-23-2010.

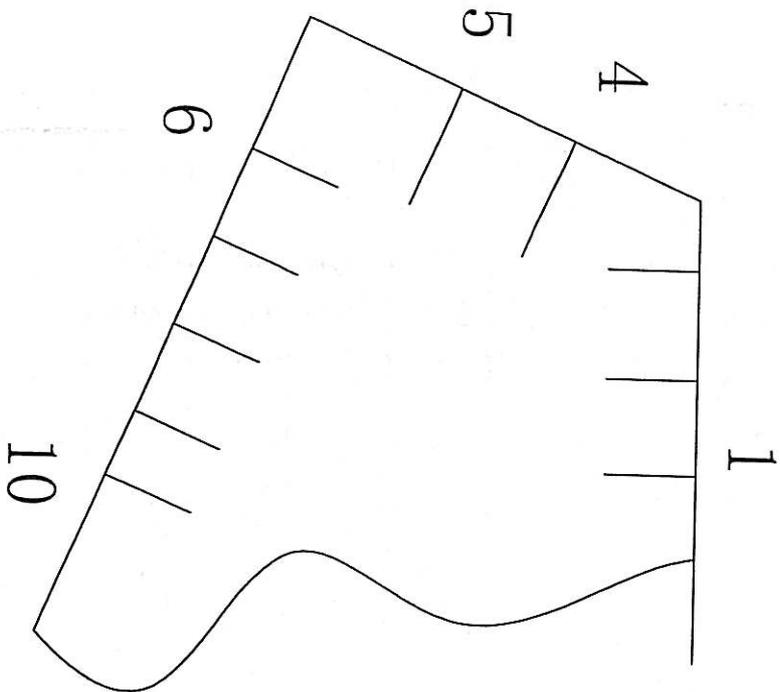
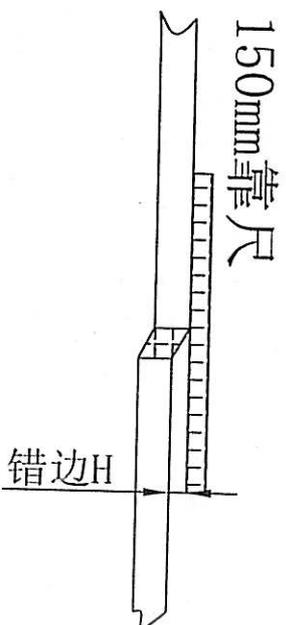
SURVEY DATA FOR CORNER ASSEMBLY

- After ZPMC's confirmation with CT the misalignment for this I-rib was measured to be 3mm what was acceptable.
- Punch List item 344 was closed basing on the measurement by CT.

编号	1	2	3	4	5
测量值H	3	1	2	3	2
编号	6	7	8	9	10
测量值H	2	2	1	2	3
