Contract #: 04-0120F4
 Cty: SF/ALA Rte: 80 PM: 13.2/13.9
 File #: 69.25B

QUALITY ASSURANCE -- NON-CONFORMANCE REPORT

Report No: NCR-000531

Reference Description: Segment 5CW Heat Straightening in wet conditions and not following the approved HSR

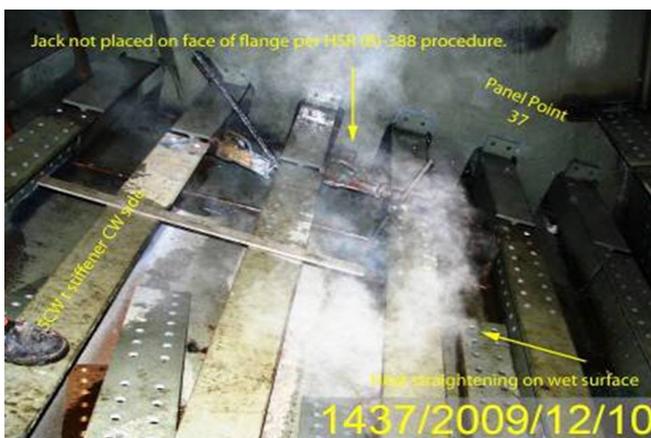
During a random visual inspection of Heat Straightening of Side Plate (SP147) T Stiffeners (RS37AD) located at panel point 37, the Quality Assurance (QA) Inspector discovered the following issues listed below:

- 1) ZPMC personnel deviated from the approved HSR(B)-338 Heat Straightening procedure by not utilizing the mechanical jacks the way it was detailed on the approved HSR. The jacks were placed from web to web between the T-Stiffeners, which are not allowed per this approved HSR.
- 2) Heat Straightening was performed on interior weld surfaces while rain water was flowing freely over the heated surface.

The T Stiffeners were located at 5CW to 6AW PP37 Counter Weight side, 3rd, 4th and 5th T Stiffeners (RS37AD) from the Bottom Plate.

AWS D1.5 2002 Section 3.1.3; Welding shall not be done when the ambient temperature is lower than -20 degree C, when surfaces are wet or exposed to rain, snow, or high wind velocities, nor when the welders are exposed to inclement conditions.

Submit a repair plan to the engineer for approval that includes a determination of weld condition (due to quenching by rain water). A response for the resolution of this issue is expected within 7 days.

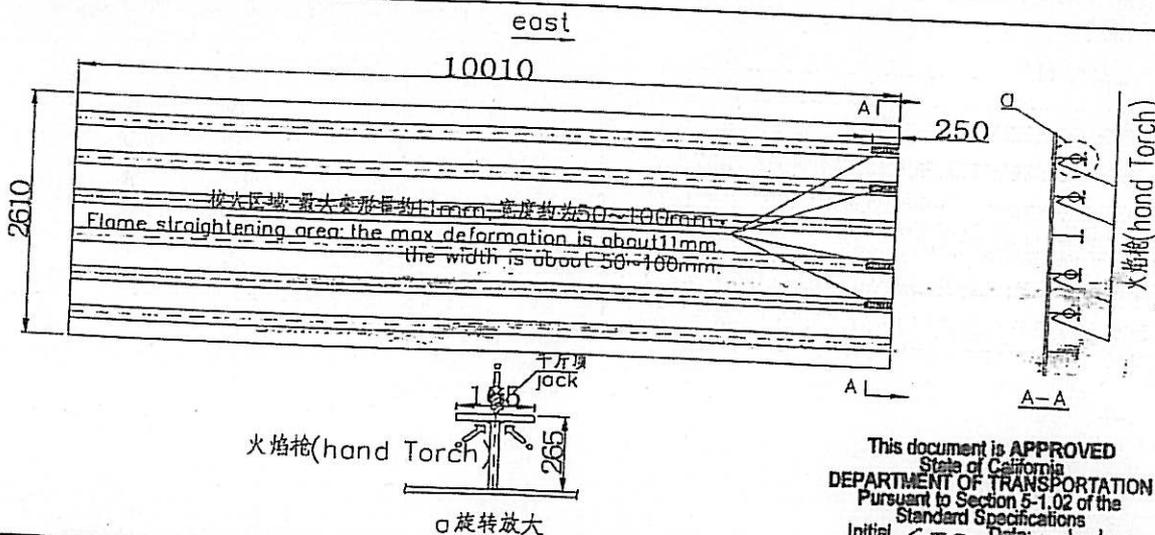
简图 Sketch

Welding distortion 焊接变形

缺陷去除方(Defect Removal Method): Using hand torch and additional force (Jack) as well 使用火焰枪以及外力(千斤顶)进行校火

Jacking shall not be used to plastically deform the edge plate. The jack shall only be used as a fixture. After finishing the heat straightening operation, VT, MT and UT shall be performed on the entire length of the weld between the SPCM floor beam and edge plate stiffener. 不能使用千斤顶进行塑性变形, 千斤顶只能用作固定装置, 校火后需按照图纸上的要求对SPCM隔板与翼缘板之间焊缝进行VT, MT和UT检测。

Control current, voltage and weld speed according to relevant WPS. If necessary anti-deformation or hold down device can be added. 依据相应的WPS的要求控制电流, 电压和焊接速度, 如有必要, 可使用反变形设施进行校正。
