**DEPARTMENT OF TRANSPORTATION**  
 DIVISION OF ENGINEERING SERVICES  
 Office of Structural Materials  
 Quality Assurance and Source Inspection

## QUALITY ASSURANCE -- NON-CONFORMANCE REPORT

**Report No:** NCR-000532

**Reference Description:** Missed UT Indication by QC, Segment 11BW

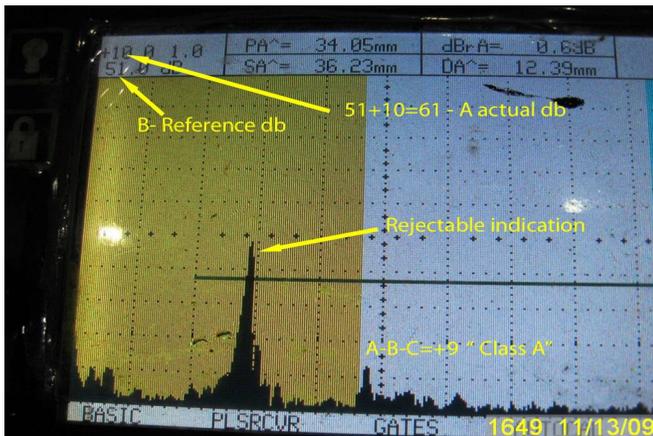
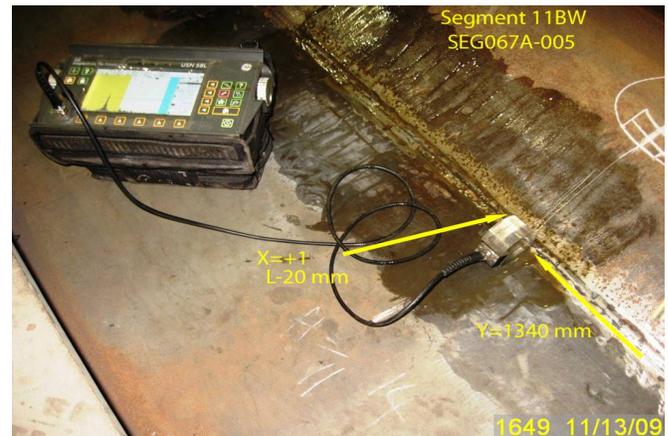
During random Ultrasonic Testing (UT) verification of the Bottom plate to Side plate weld identified as SEG067A-005 in OBG segment 11BW, Caltrans Quality Assurance (QA) Inspector discovered a total of (1) one, rejectable longitudinal indication that measured 20mm in length.

This weld has been previously tested and accepted by ZPMC Quality Control (UT) Technicians.

Submit a repair procedure to the engineer for approval. Provide additional training and or equipment to the UT technician. A response for the resolution of this issue is expected within 7 days.

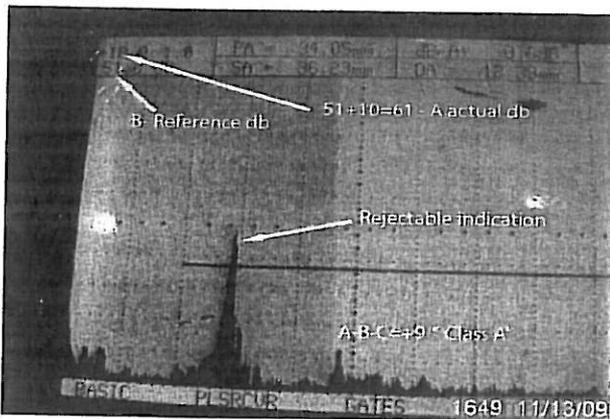
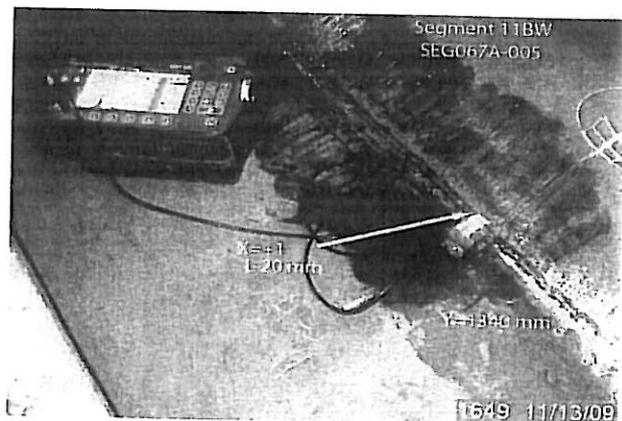
During random Ultrasonic Testing (UT) verification of the Bottom plate to Side plate weld identified as SEG067A-005 in OBG segment 11BW, Caltrans Quality Assurance (QA) Inspector discovered a total of (1) one, rejectable longitudinal indication that measured 20mm in length.

This weld has been previously tested and accepted by ZPMC Quality Control (UT) Technicians.

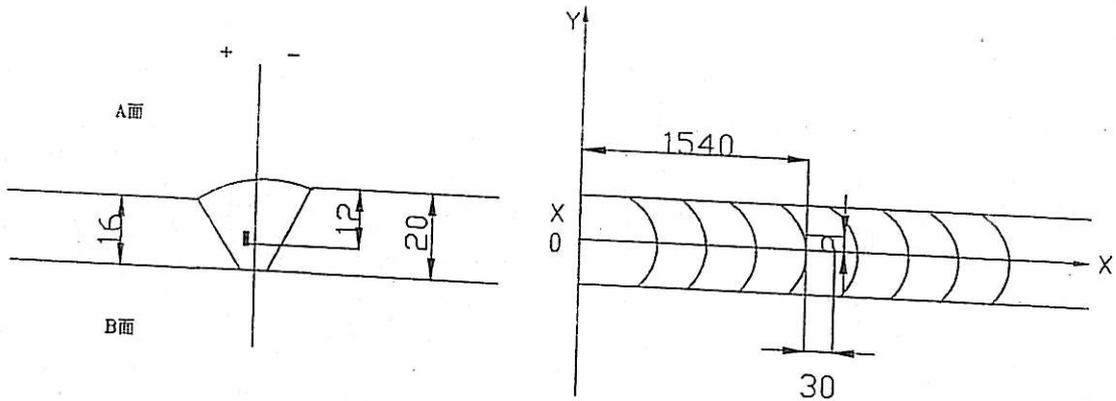
WELD NUMBER: SEG067A-005

Rejected indication found by ultrasonic inspection is less than the maximum allowance aggregate length.

1. Did not clear the weld pass completely in time.

1. Gouge or grind from nearer side from metal edge ( $D \leq 0.65T$ , "D" is depth of defects, "T" is thickness of metal) to remove all defects;
2. Follow repair WPS for joint preparation, preheat, and weld deposit;
3. Verify with VT no defects remain in the weld joint prior to welding;
4. Grind the repaired area flush with base metal or the adjacent weld;
5. Check the welds according to the working drawings.
