Contract #: 04-0120F4Cty: SF/ALA Rte: 80 PM: 13.2/13.9File #: 69.25B**QUALITY ASSURANCE -- NON-CONFORMANCE REPORT****Location:** Changxing Island, Shanghai, P.R. China**Report No:** NCR-000534**Prime Contractor:** American Bridge/Fluor Enterprises, a JV**Date:** 10-Dec-2009**Submitting Contractor:** Zhenhua Port Machinery Company, Ltd (ZPMC), Changxing Island**NCR #:** ZPMC-0507**Type of problem:**

Reference Description: ZPMC performed base metal repairs without the Engineer's approval for Segment 7DW

Dear: Mr. Charles Kanapicki
Job Name: SAS Superstructure

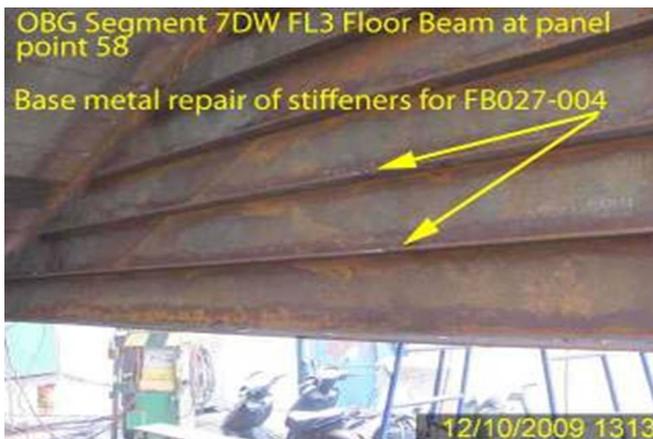
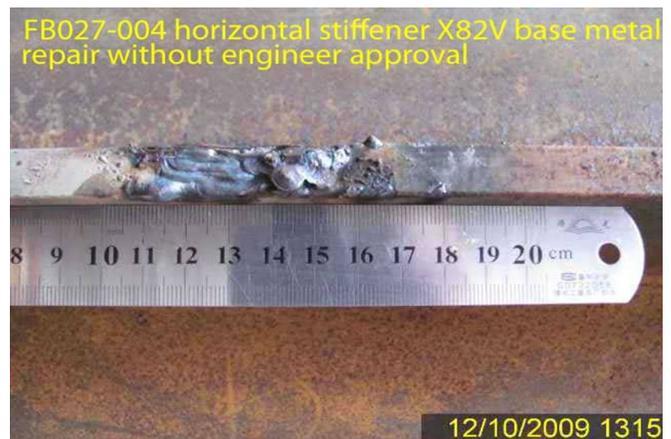
During a random visual inspection at OBG Segment 7DW of Floor Beam FL3 stiffeners, the Quality Assurance (QA) Inspector observed ZPMC performing un-approved base metal repairs on two (2) horizontal stiffeners located at FL3 Floor Beam PP58. Additional information about the non-conforming base metal repairs are listed below.

- 1) The Floor Beam is identified as: FB027-004
- 2) The 2 horizontal stiffeners are identified as: X82T and X82V
- 3) The welds were identified as: FB027-001,038/039 and FB027-001,040/041
- 4) ZPMC performed base metal repairs without the prior approval of the Engineer.

Submit a repair plan to the engineer for approval. A response for the resolution of this issue is expected within 7 days.

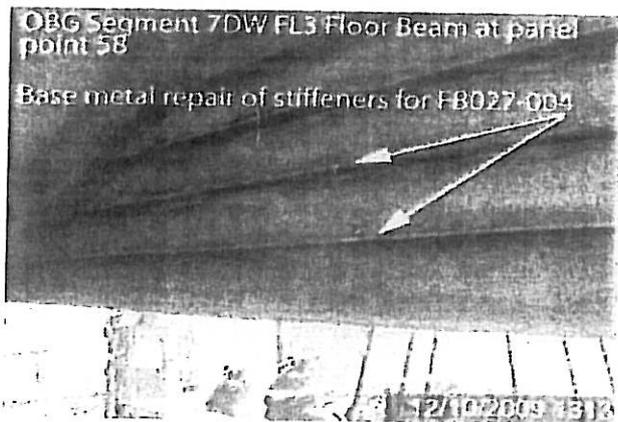
During a random visual inspection at OBG Segment 7DW of Floor Beam FL3 stiffeners, the Quality Assurance (QA) Inspector observed ZPMC performing un-approved base metal repairs on two (2) horizontal stiffeners located at FL3 Floor Beam PP58. Additional information about the non-conforming base metal repairs are listed below.

- 1) The Floor Beam is identified as: FB027-004
- 2) The 2 horizontal stiffeners are identified as: X82T and X82V
- 3) The welds were identified as: FB027-001,038/039 and FB027-001,040/041
- 4) ZPMC performed base metal repairs without the prior approval of the Engineer.

Reference Resolution: ZPMC is providing NDT to show that the repair performed is acceptable.

This proposed resolution is acceptable. The documentation received is sufficient and the Department concurs that Non-Conformance ZPMC-0507 is closed.

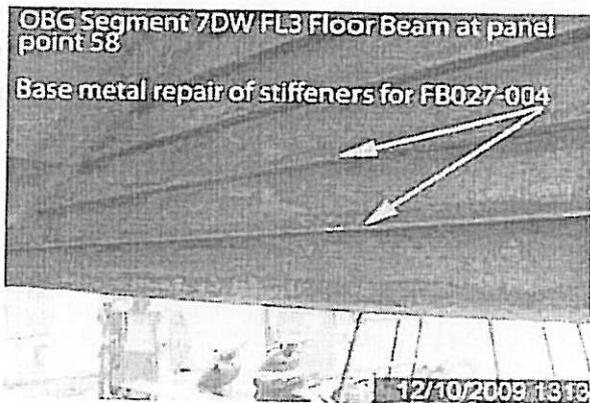
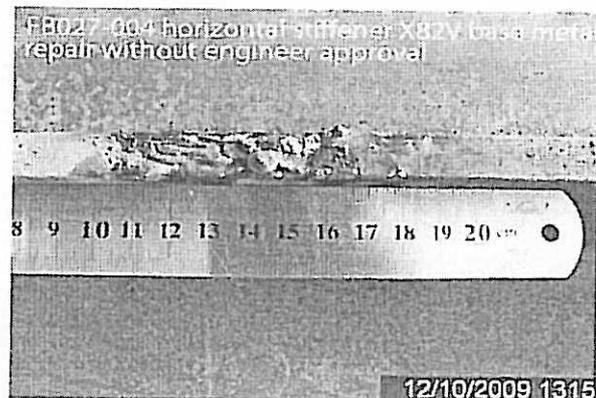
During a random visual inspection at OBG Segment 7DW of Floor Beam FL3 stiffeners, the Quality Assurance (QA) Inspector observed ZPMC performing un-approved base metal repairs on two (2) horizontal stiffeners located at FL3 Floor Beam PP58. Additional information about the non-conforming base metal repairs are listed below.

- 1) The Floor Beam is identified as: FB027-004
- 2) The 2 horizontal stiffeners are identified as: X82T and X82V
- 3) The welds were identified as: FB027-001,038/039 and FB027-001,040/041
- 4) ZPMC performed base metal repairs without the prior approval of the Engineer.

Submit a repair plan to the engineer for approval. A response for the resolution of this issue is expected within 7 days.
