Contract #: 04-0120F4
 Cty: SF/ALA Rte: 80 PM: 13.2/13.9
 File #: 69.25B

QUALITY ASSURANCE -- NON-CONFORMANCE REPORT

Report No: NCR-000536

Reference Description: Excessive Root Opening at the Floor Beam Flange to the Top Flange of the Longitudinal Diaphragm for Segment 6BW

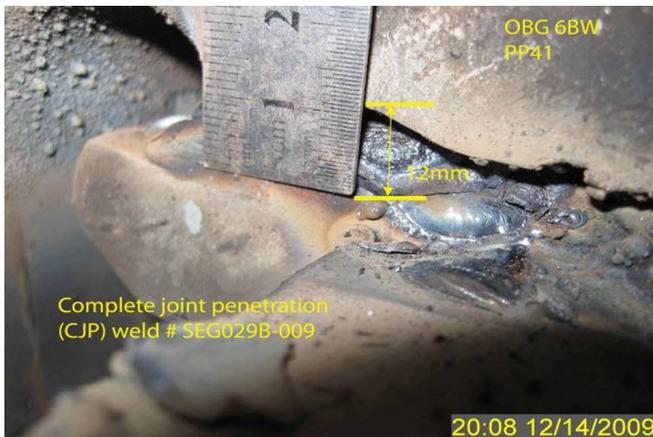
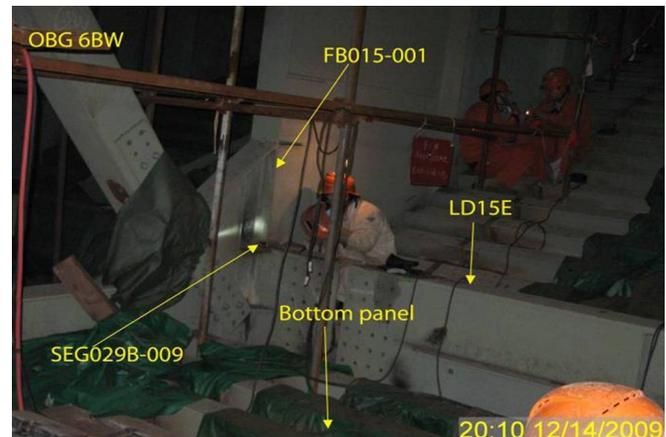
During a random in-process visual inspection of OBG segment 6BW, the Caltrans Quality Assurance (QA) Inspector observed an excessive root joint opening (12mm) of a complete joint penetration (CJP) weld between the Floor Beam (FB) Flange and Top Flange of the Longitudinal Diaphragm (LD) located at PP41 and W4. Additional information identifying this non-conformance is listed below.

- 1) The approved welding procedure specification (WPS) is identified as: WPS-B-T-2232-TC-U4B-F.
- 2) The affected weld is identified as: SEG029B-009
- 3) This weld is a Complete Joint Penetration (CJP)
- 4) The Floor Beam Flange is identified as: FB015-001
- 5) The Top Flange of the Longitudinal Diaphragm is identified as: LD15E
- 6) The maximum allowable root opening per this approved WPS is 5mm.

Approved WPS; WPS-B-T-2232-Tc-U4b-F states that the root opening is 3mm (+2mm max).

AWS D1.5-2002 Section 3.3.2.1; The root opening between parts shall not exceed 5mm [3/16 in.] except in cases involving rolled shapes or plates 75mm [3 in.] or greater in thickness if, after straightening and in assembly, the root opening cannot be closed sufficiently to meet this tolerance. In such cases, a maximum root opening of 8mm [5/16 in.] may be used with a backing weld or suitable backing and the final weld meets the requirements for weld size.

Submit a repair plan to the engineer for approval. A response for the resolution of this issue is expected within 7 days.

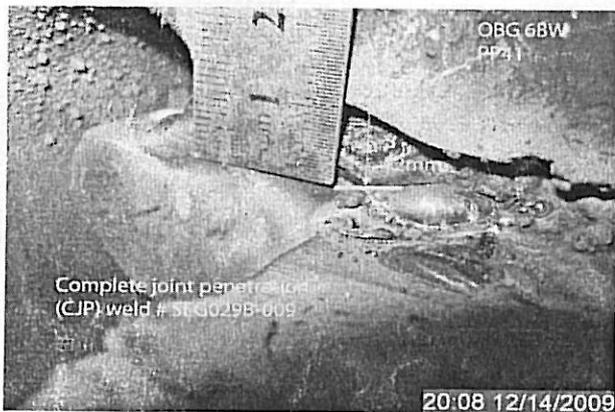
During a random in-process visual inspection of OBG segment 6BW, the Caltrans Quality Assurance (QA) Inspector observed an excessive root joint opening (12mm) of a complete joint penetration (CJP) weld between the Floor Beam (FB) Flange and Top Flange of the Longitudinal Diaphragm (LD) located at PP41 and W4. Additional information identifying this non-conformance is listed below.

- 1) The approved welding procedure specification (WPS) is identified as: WPS-B-T-2232-TC-U4B-F.
- 2) The affected weld is identified as: SEG029B-009
- 3) This weld is a Complete Joint Penetration (CJP)
- 4) The Floor Beam Flange is identified as: FB015-001
- 5) The Top Flange of the Longitudinal Diaphragm is identified as: LD15E
- 6) The maximum allowable root opening per this approved WPS is 5mm.

Approved WPS; WPS-B-T-2232-Tc-U4b-F states that the root opening is 3mm (+2mm max).

AWS D1.5-2002 Section 3.3.2.1; The root opening between parts shall not exceed 5mm [3/16 in.] except in cases involving rolled shapes or plates 75mm [3 in.] or greater in thickness if, after straightening and in assembly, the root opening cannot be closed sufficiently to meet this tolerance. In such cases, a maximum root opening of 8mm [5/16 in.] may be used with a backing weld or suitable backing and the final weld meets the requirements for weld size.

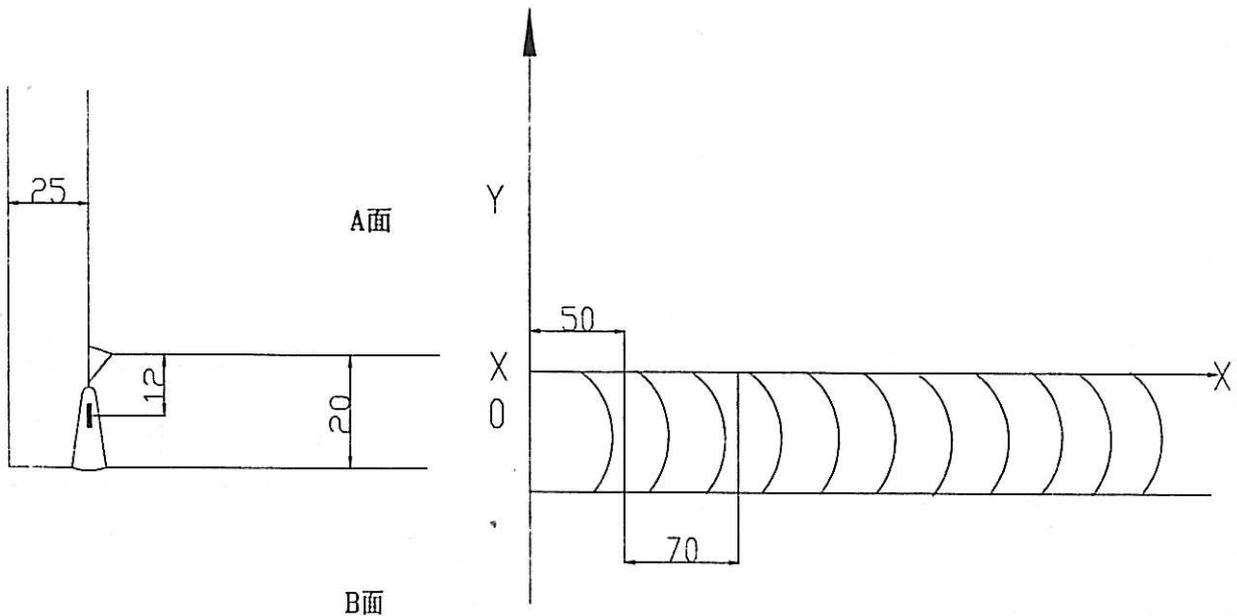
WELD NUMBER: **SEG029B-009**

Rejected indication found by ultrasonic inspection is less than the maximum allowance aggregate length.

- 1、焊道未及时处理干净。
1. Did not clear the weld pass completely in time.

1. 从缺陷距离端面较近一侧 ($D \leq 0.65T$, D 为缺陷深度, T 为板厚) 采用碳刨或打磨的方法去除焊缝缺陷;
 2. 参照返修焊接工艺规程 (WPS) 准备正确的接头型式, 预热和焊接;
 3. 焊前对修补区域进行VT检测保证缺陷完全被消除;
 4. 将修补区域打磨到与母材或邻近焊缝平齐;
 5. 对焊缝进行UT检测, 检测范围为返修区域以及其两端各延长50mm.
-
1. Gouge or grind from nearer side from metal edge ($D \leq 0.65T$, "D" is depth of defects, "T" is thickness of metal) to remove all defects;
 2. Follow repair WPS for joint preparation, preheat, and weld deposit;
 3. Verify with VT no defects remain in the weld joint prior to welding;
 4. Grind the repaired area flush with base metal or the adjacent weld;
 5. Perform UT inspection to the weld along with 50mm on each end of the repair area;

1. Improve monitoring of welding and interpass cleaning.
