**DEPARTMENT OF TRANSPORTATION**

Contract #: 04-0120F4Cty: SF/ALA Rte: 80 PM: 13.2/13.9File #: 69.25B**QUALITY ASSURANCE -- NON-CONFORMANCE REPORT****Location:** Changxing Island, Shanghai, P.R. China**Report No:** NCR-000537**Prime Contractor:** American Bridge/Fluor Enterprises, a JV**Date:** 17-Dec-2009**Submitting Contractor:** Zhenhua Port Machinery Company, Ltd (ZPMC), Changxing Island**NCR #:** ZPMC-0510**Type of problem:**

**Reference Description:** Base Metal Repair without Engineer's Approval, Side Panel SP205A, Crossbeam CB8**Description of Non-Conformance:**

**Reference Description:** Base Metal Repair without Engineer's Approval, Side Panel SP205A, Crossbeam CB8

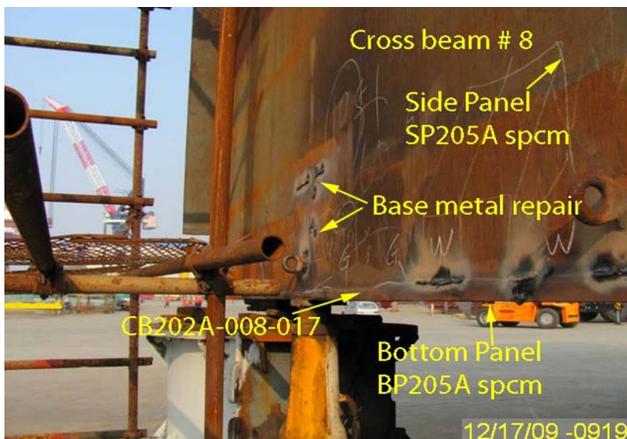
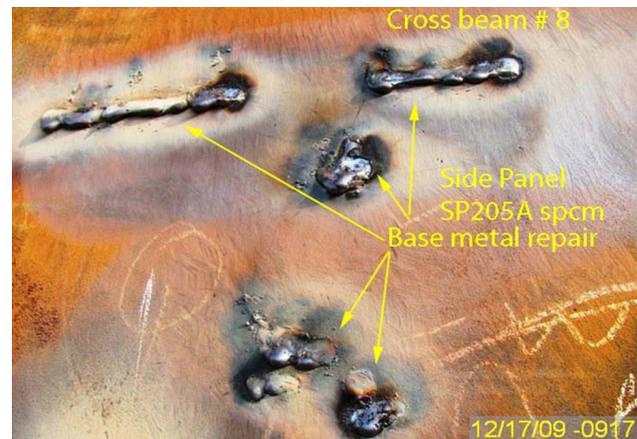
During a random visual inspection of the Orthotropic Box Girder (OBG) Crossbeam CB8, the Caltrans Quality Assurance (QA) Inspector observed ZPMC personnel performing un-approved Seismic Performance Critical Member (SPCM) base metal repairs on the Side Panel (SP) of Crossbeam CB8 without the Engineer's approval.

- The BP was identified as: BP205A
- The SP was identified as: SP205A
- The weld number between the SP and BP is identified as: CB202A-008-017
- The material utilized is A709 Grade 345 SPCM.
- The welding process used was SMAW.

The NCR shows that the base metal repairs were performed prior to the NCR being written in November 2009 while CWR was approved long after this in March of 2010. Additionally, the MT report for the excavation is dated the same as the MT report for after welding. This conflicts with the SPCM material requirements of AWS D1.5 Section 12.16.4, which requires welds to cool for a period of 24 hours prior to inspection.

Submit a repair procedure to the engineer for approval. A response for the resolution of this issue is expected within 7 days.

ZPMC is providing the NDT records what show these base metal repair are now acceptable. The repair procedure please look at B-CWR 1236. Based on this, ZPMC is requesting closure of these NCRs.

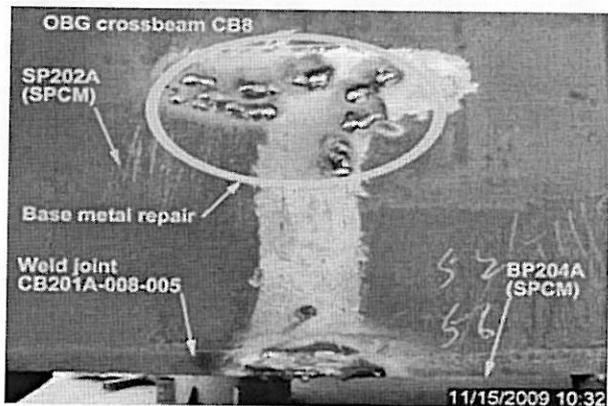
This Quality Assurance (QA) inspector observed ZPMC personnel performing base metal weld repairs on material designated as SPCM on the approved shop drawings without prior Engineer's approval. The areas being repaired were damaged while removing temporary lifting lug welds at the corners of this crossbeam. The component is identified as Orthotropic Box Girder (OBG) crossbeam CB8. The Seismic Performance Critical Member (SPCM) panels affected are identified as side panel SP202A and bottom panel BP204A.

1. AWS D1.5 2002 section 3.3.7.3 "Tack welds not incorporated into the final weld shall be removed in such a manner that the base metal is not nicked or undercut. Repair of base metal accidentally removed shall be approved by the Engineer prior to making the repair.
2. AWS D1.5 2002 section 3.7.4 "Prior approval of the Engineer shall be obtained for repairs to base metal..."

Submit a repair plan to the engineer for approval.

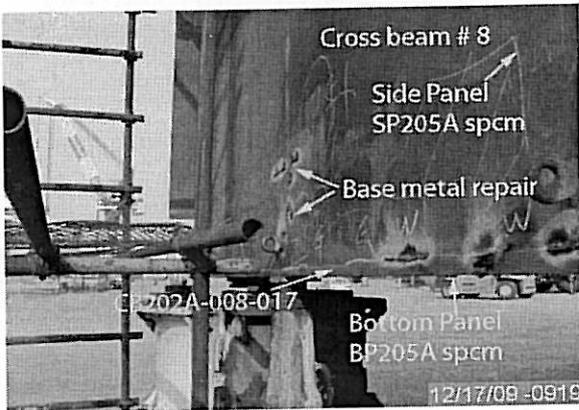
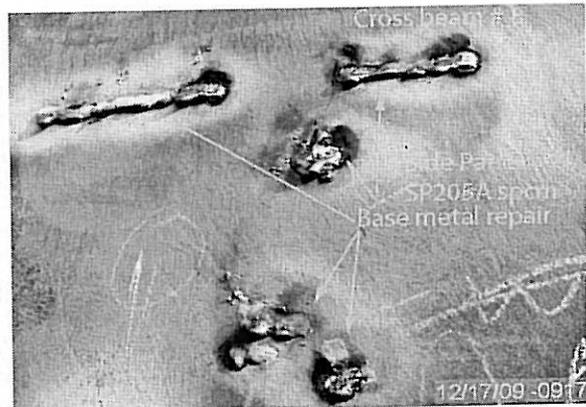
During a random visual inspection of the Orthotropic Box Girder (OBG) Crossbeam CB8, the Caltrans Quality Assurance (QA) Inspector observed ZPMC personnel performing un-approved Seismic Performance Critical Member (SPCM) base metal repairs on the Side Panel (SP) of Crossbeam CB8 without the Engineer's approval.

- The BP was identified as: BP205A
- The SP was identified as: SP205A
- The weld number between the SP and BP is identified as: CB202A-008-017
- The material utilized is A709 Grade 345 SPCM.
- The welding process used was SMAW.

Submit a repair procedure to the engineer for approval. A response for the resolution of this issue is expected within 7 days.

ZPMC is providing NDT records which show that the testing was performed after the required waiting period and the results are acceptable. Based on this ZPMC requests closure of this NCR.

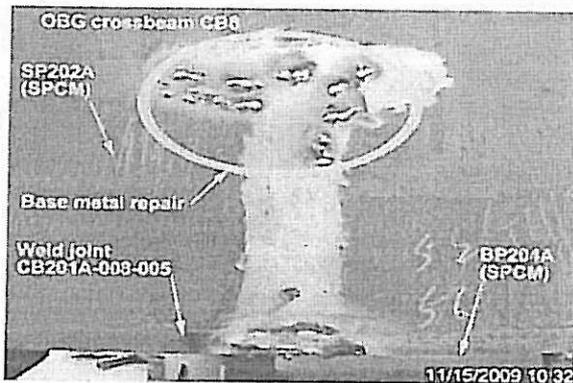
This Quality Assurance (QA) inspector observed ZPMC personnel performing base metal weld repairs on material designated as SPCM on the approved shop drawings without prior Engineer's approval. The areas being repaired were damaged while removing temporary lifting lug welds at the corners of this crossbeam. The component is identified as Orthotropic Box Girder (OBG) crossbeam CB8. The Seismic Performance Critical Member (SPCM) panels affected are identified as side panel SP202A and bottom panel BP204A.

1. AWS D1.5 2002 section 3.3.7.3 "Tack welds not incorporated into the final weld shall be removed in such a manner that the base metal is not nicked or undercut. Repair of base metal accidentally removed shall be approved by the Engineer prior to making the repair.

2. AWS D1.5 2002 section 3.7.4 "Prior approval of the Engineer shall be obtained for repairs to base metal..."

Submit a repair plan to the engineer for approval.

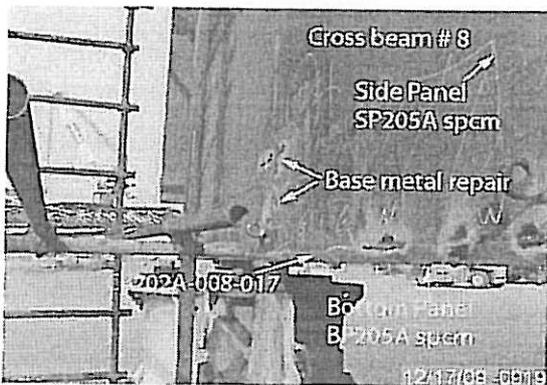
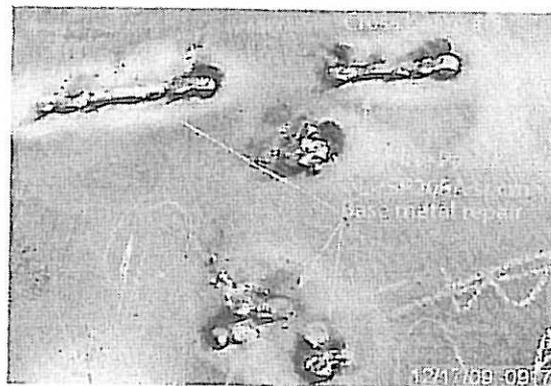
During a random visual inspection of the Orthotropic Box Girder (OBG) Crossbeam CB8, the Caltrans Quality Assurance (QA) Inspector observed ZPMC personnel performing un-approved Seismic Performance Critical Member (SPCM) base metal repairs on the Side Panel (SP) of Crossbeam CB8 without the Engineer's approval.

- The BP was identified as: BP205A
- The SP was identified as: SP205A
- The weld number between the SP and BP is identified as: CB202A-008-017
- The material utilized is A709 Grade 345 SPCM.
- The welding process used was SMAW.

Submit a repair procedure to the engineer for approval. A response for the resolution of this issue is expected within 7 days.

Contractor submitted NDT report verifying the repairs are in conformance with Contract weld quality requirements.
