DEPARTMENT OF TRANSPORTATION

Contract #: 04-0120F4Cty: SF/ALA Rte: 80 PM: 13.2/13.9File #: 69.25B**QUALITY ASSURANCE -- NON-CONFORMANCE REPORT****Location:** Changxing Island, Shanghai, P.R. China**Report No:** NCR-000538**Prime Contractor:** American Bridge/Fluor Enterprises, a JV**Date:** 16-Dec-2009**Submitting Contractor:** Zhenhua Port Machinery Company, Ltd (ZPMC), Changxing Island**NCR #:** ZPMC-0511**Type of problem:**

Reference Description: Base Metal Repairs without Engineer's Approval, Segment 7CW**Description of Non-Conformance:**

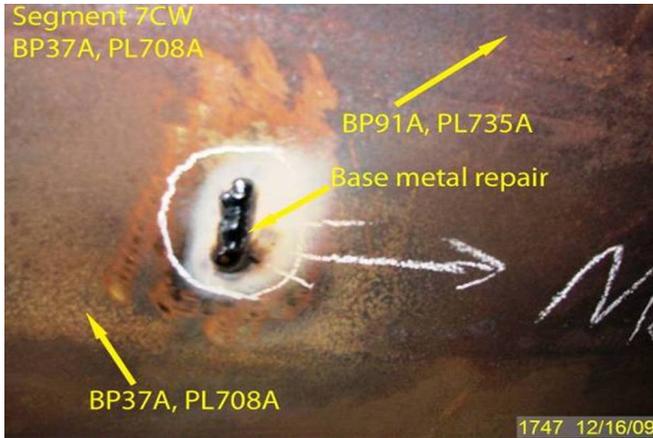
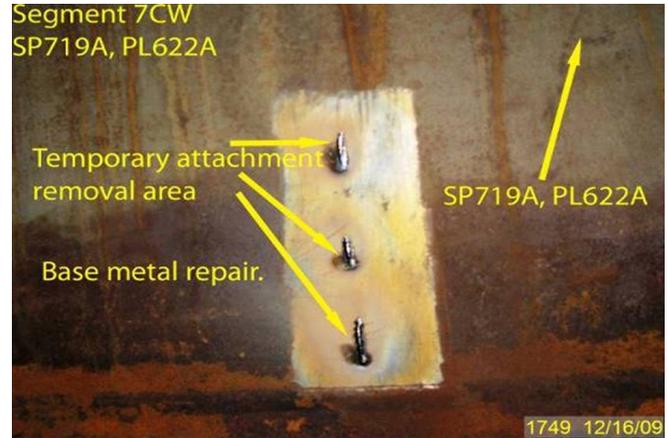
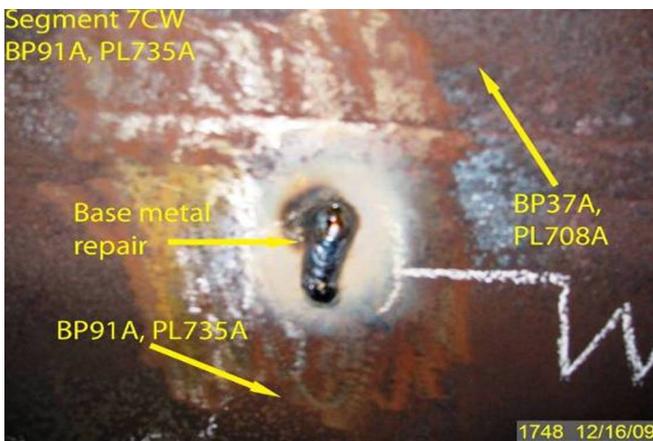
During the Quality Assurance random in-process visual inspection of Segment 7CW, this Quality Assurance Inspector (QA) discovered the following issue:

-Base metal repairs being performed in way of temporary attachment removal areas on the bottom and side plates without the prior approval of the engineer.

The plate identifications under repair are identified as:

- SP126A, Plate number-PL250A
- SP153A, Plate Number-PL533A
- SP719A, Plate Number-PL622A
- SP481A, Plate Number-PL621A
- SP440A, Plate Number-PL1279A
- BP91A, Plate Number-PL735A
- BP37A, Plate Number-PL708A
- BP145A, Plate Number-PL789A
- The material is A709 Grade 345 non SPCM

Submit a repair procedure to the engineer for approval. A response for the resolution of this issue is expected within 7 days.
