Contract #: 04-0120F4Cty: SF/ALA Rte: 80 PM: 13.2/13.9File #: 69.25B**QUALITY ASSURANCE -- NON-CONFORMANCE REPORT****Location:** Changxing Island, Shanghai, P.R. China**Report No:** NCR-000541**Prime Contractor:** American Bridge/Fluor Enterprises, a JV**Date:** 18-Dec-2009**Submitting Contractor:** Zhenhua Port Machinery Company, Ltd (ZPMC), Changxing Island**NCR #:** ZPMC-0514**Type of problem:**

**Reference Description:** Missed UT Indication by QC, Segment 8BW**Description of Non-Conformance:**

**Job Name:** SAS Superstructure

## Welding Repair Report

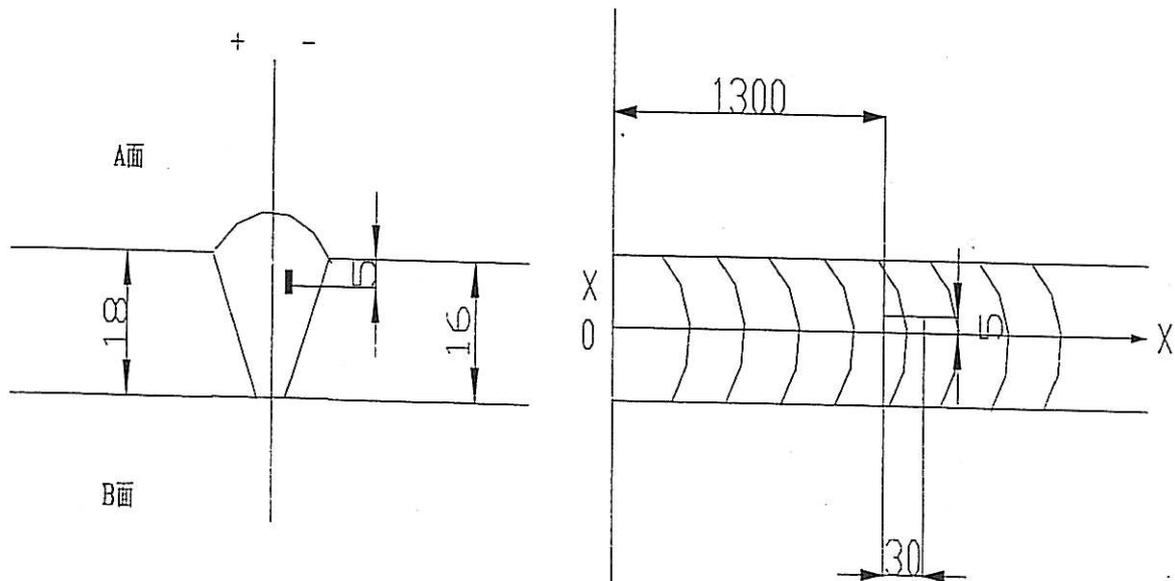
WELD NUMBER: SEG045A-001

Rejected indication found by ultrasonic inspection is less than the maximum allowance aggregate length.

(UT探伤发现的缺陷总长度小于最大允许长度。) SEG045A-001

1、焊道未及时处理干净。

1. Did not clear the weld pass completely in time.

1. 从缺陷距离端面较近一侧 ( $D \leq 0.65T$ , D为缺陷深度, T为板厚) 采用碳刨或打磨的方法去除焊缝缺陷;
  2. 参照返修焊接工艺规程 (WPS) 准备正确的接头型式, 预热和焊接;
  3. 焊前对修补区域进行VT检测保证缺陷完全被清除;
  4. 将修补区域打磨到与母材或邻近焊缝平齐;
  5. 根据批准的车间图纸检查焊缝.
- 
1. Gouge or grind from nearer side from metal edge ( $D \leq 0.65T$ , "D" is depth of defects, "T" is thickness of metal) to remove all defects;
  2. Follow repair WPS for joint preparation, preheat, and weld deposit;
  3. Verify with VT no defects remain in the weld joint prior to welding;
  4. Grind the repaired area flush with base metal or the adjacent weld;
  5. Check the welds according to the working drawings.
