Contract #: 04-0120F4
 Cty: SF/ALA Rte: 80 PM: 13.2/13.9
 File #: 69.25B

QUALITY ASSURANCE -- NON-CONFORMANCE REPORT

Report No: NCR-000546

Reference Description: Side Panel Flatness, Segments 6BE/6CE

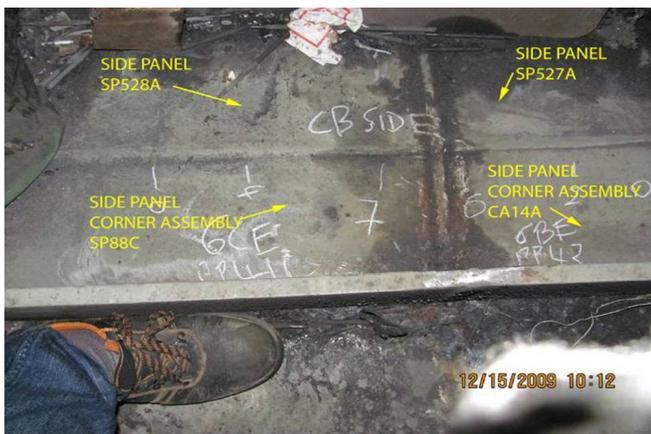
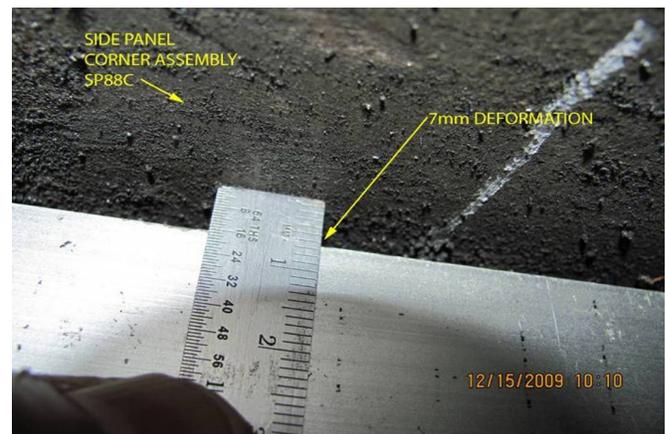
During a random visual survey inspection for flatness of Corner Assembly (CA) to Side Panels (SP) of the Transverse Splice for segment 6BE to segment 6CE between PP43 and PP44, the Caltrans Quality Assurance (QA) Inspector verified out of flatness measurements at the intersections of CA to SP welds. The maximum out of flatness measurement was 7mm, utilizing a 600mm straight edge and the maximum allowable tolerance is 5mm. Additional information identifying this non-conformance is listed below.

- 1) Side Panel 6BE plate is identified as: SP527A
- 2) Side Panel 6CE plate is identified as: SP528A
- 3) Corner Assembly 6BE plate is identified as: CA14A
- 4) Corner Assembly 6CE plate is identified as: SP88C
- 5) Transverse weld splice for 6BE to 6CE is identified as: OBE6C-002
- 6) Horizontal weld splices are identified as: SEG030A-010 and SEG032B-025

Standard Specifications July, 1999: Section 55-3.17 WELDING; "The flat side of all butt welded joints shall not deviate from flatness by more than 5 mm in a length of 600 mm centered over the weld joint."

Submit a repair procedure to correct flatness to within the specified tolerance to the engineer for approval. A response for the resolution of this issue is expected within 7 days.

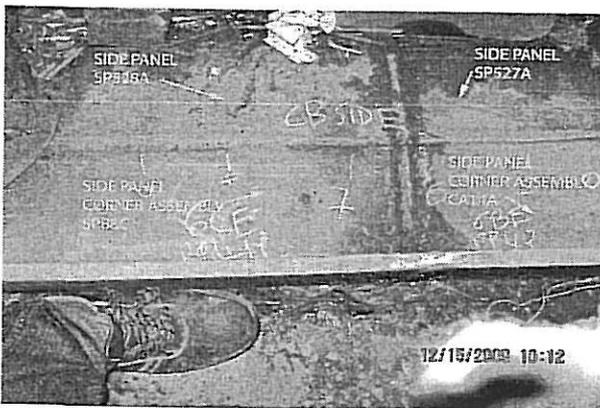
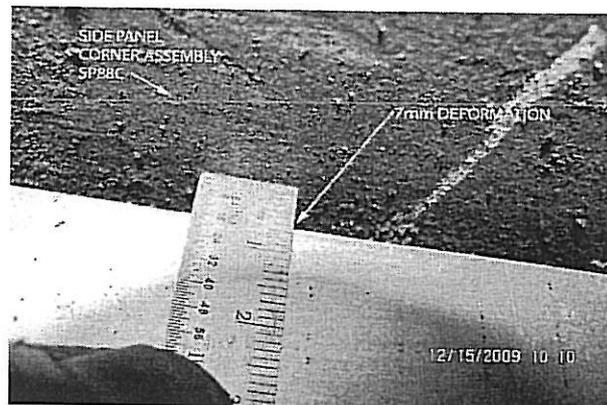
During a random visual survey inspection for flatness of Corner Assembly (CA) to Side Panels (SP) of the Transverse Splice for segment 6BE to segment 6CE between PP43 and PP44, the Caltrans Quality Assurance (QA) Inspector verified out of flatness measurements at the intersections of CA to SP welds. The maximum out of flatness measurement was 7mm, utilizing a 600mm straight edge and the maximum allowable tolerance is 5mm. Additional information identifying this non-conformance is listed below.

- 1) Side Panel 6BE plate is identified as: SP527A
- 2) Side Panel 6CE plate is identified as: SP528A
- 3) Corner Assembly 6BE plate is identified as: CA14A
- 4) Corner Assembly 6CE plate is identified as: SP88C
- 5) Transverse weld splice for 6BE to 6CE is identified as: OBE6C-002
- 6) Horizontal weld splices are identified as: SEG030A-010 and SEG032B-025

Standard Specifications July, 1999: Section 55-3.17 WELDING; "The flat side of all butt welded joints shall not deviate from flatness by more than 5 mm in a length of 600 mm centered over the weld joint."

Submit a repair procedure to correct flatness to within the specified tolerance to the engineer for approval. A response for the resolution of this issue is expected within 7 days.

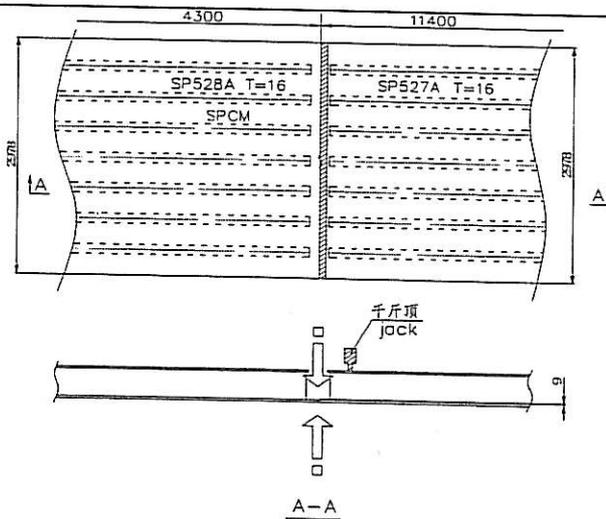
简图 Sketch

Welding distortion 焊接变形

注: 最大变形量约 9mm, 校火宽度50~100mm.

NOTE: the max deformation is about 9mm, heat straightening the width is 50~100mm.

Flame Straightening by oxygen acetylene

Control current, voltage and weld speed according to relevant WPS. If necessary anti-deformation or hold down device can be added.

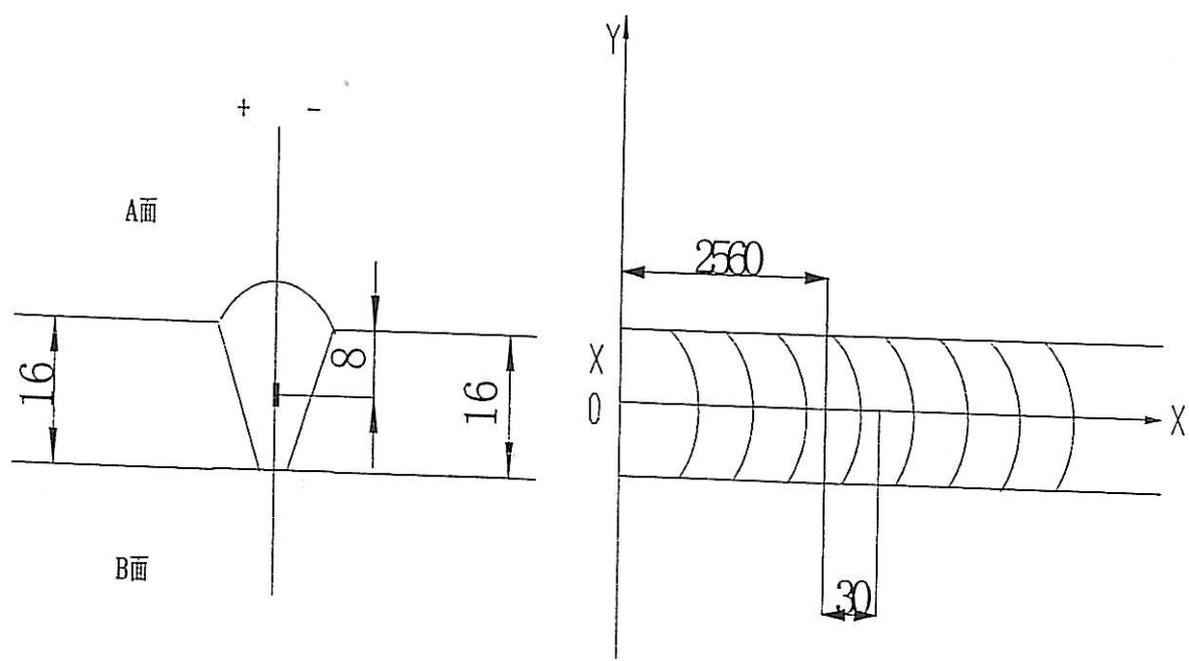
WELD NUMBER: SEG030A-010

Rejected indication found by ultrasonic inspection is less than the maximum allowance aggregate length.
(UT探伤发现的缺陷总长度小于最大允许长度。) SEG030A-010

- 1、焊道未及时处理干净。
1. Did not clear the weld pass completely in time.

1. Gouge or grind from nearer side from metal edge ($D \leq 0.65T$, "D" is depth of defects, "T" is thickness of metal) to remove all defects;
2. Follow repair WPS for joint preparation, preheat, and weld deposit;
3. Verify with VT no defects remain in the weld joint prior to welding;
4. Grind the repaired area flush with base metal or the adjacent weld;
5. Check the welds according to the working drawings.

1. Improve monitoring of welding and interpass cleaning.
