## QUALITY ASSURANCE -- NON-CONFORMANCE REPORT

**Report No:** NCR-000553

**Component:** 8BW Floor Beam FL2-2 to Bottom Panel

**Reference Description:** Segment 8BW, Linear Indication discovered with the MT after the contractor's NDT testing and acceptance

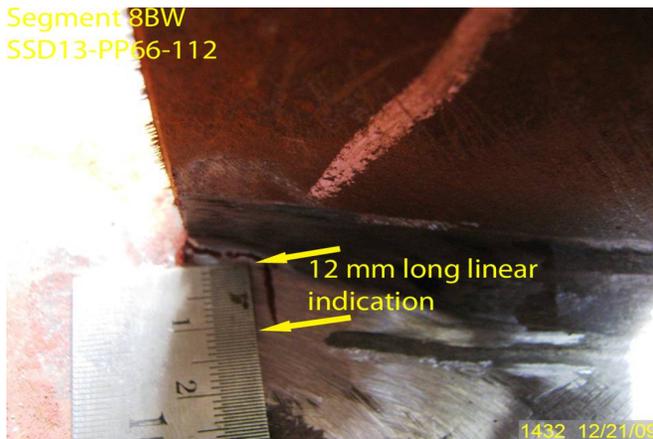
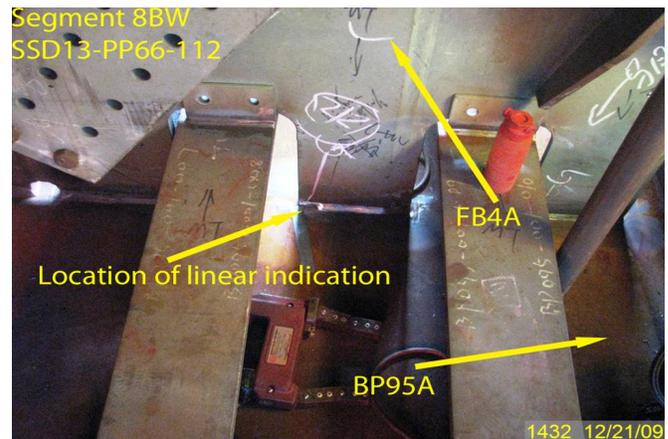
-One (1) Transverse linear indication that measured to be a total of 15mm in length, in the fillet weld joining the FL2-2 floor beam (FB004-027) to bottom panel (BP95A-001) at panel point 66. The weld is designated as SSD13-PP66-112.

The Notice of Witness Inspection Number (NWIT) is 004905. The indication is located inside the area that has been previously tested and accepted by ZPMC Quality Control (QC) personnel.

Submit a repair procedure for approval of the engineer. Provide training to the ZPMC MT technician that missed this indication and provide documentation of such training to the engineer. A response for the resolution of this issue is expected within 7 days.

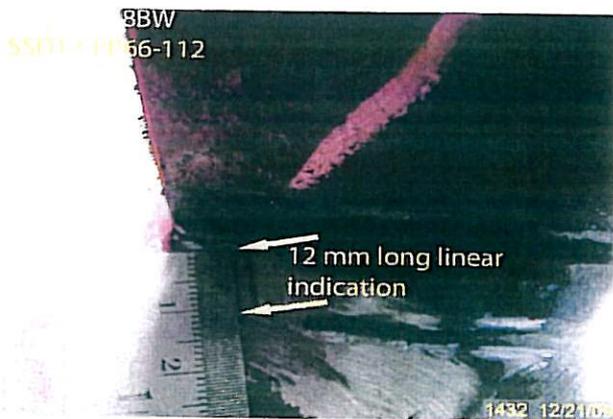
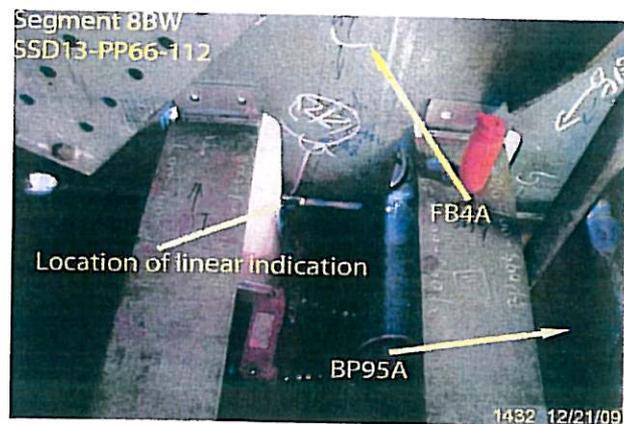
-One (1) Transverse linear indication that measured to be a total of 15mm in length, in the fillet weld joining the FL2-2 floor beam (FB004-027) to bottom panel (BP95A-001) at panel point 66. The weld is designated as SSD13-PP66-112.

The Notice of Witness Inspection Number (NWIT) is 004905. The indication is located inside the area that has been previously tested and accepted by ZPMC Quality Control (QC) personnel.

Submit a repair procedure for approval of the engineer. Provide training to the ZPMC MT technician that missed this indication and provide documentation of such training to the engineer. A response for the resolution of this issue is expected within 7 days.

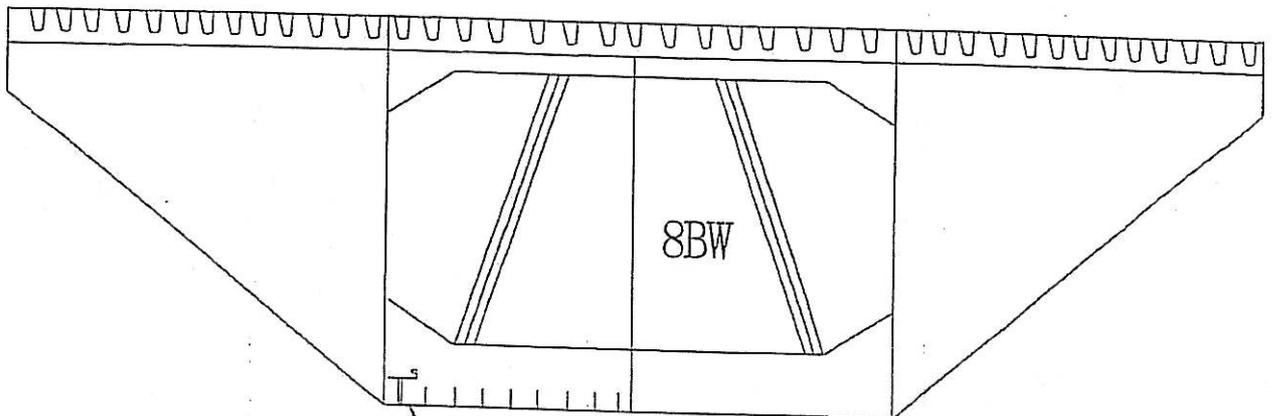
WELD NUMBER: SSD13-PP066-112

One longitudinal crack was found by use of MT on SSD13-PP066-112.

1. 火焰加热时, 水汽没有完全的去掉或者这个区域预热不够;
1. Moisture wasn't completely removed during drying operation (preheating) or the area wasn't preheated sufficiently.

1. QC and a Lead CWI shall be present, direct and supervise all grinding and welding operations during this repair to ensure the repair is per the disposition requirements

2. QC and a Lead CWI shall have an approved copy of the CWR in hand prior to the repair.
3. Remove paint  $\geq 25$ mm in all direction of HAZ prior to MT.

4. Clean the excavation area of all loose debris including MT powder. Preheat to 65° C before removing cracks by grinding, repair area shall extend a minimum of 50mm beyond each end of single crack repairs.

5. If base metal is damaged by grinding, the damaged area shall be ground clean prior to performing weld repair. If gap  $> 5$ mm is found during or after grinding, comply with the notification on changing fillet weld to CJP which is submitted for Engineer's review and approval form.

6. Prepare excavation in accordance with the New Repair Procedure prior to welding.
7. Before this repair, Verify with VT and MT repair areas are defects free, and also MT shall be performed on the base metal laying abroad cracks to ensure that no cracks were propagated to the base metal. Separate CWR approval is needed if cracks are found in the base metal, and only after this new CWR's approval can continue the repair.

8. Clean excavation area of all loose debris including MT powder after excavation. Preheat and weld according to repair WPS, the preheat shall between 160° C-230° C.

9. Perform post weld heating according to repair WPS, the postheat shall between 230° C-315° C and for one hour minimum.
10. Allow the weld to cool to ambient temperature gradually. Control cooling rate after PWHT to no more than 50° C per hour.

11. Grind the repaired area flush with base metal or the adjacent weld after post weld heating.
12. Wait 48 hours at least after the repair area has cooled to ambient temperature before performing NDT.

13. Perform MT inspection to all repair area according to Contract Drawings along with all additional NDT required by the applicable notes Special Provision Section 10-1.59 'Steel Structure', subsection 'inspection testing'. NDT include VT, MT and UT if it is a CJP weld.
