Contract #: 04-0120F4
 Cty: SF/ALA Rte: 80 PM: 13.2/13.9
 File #: 69.25B

QUALITY ASSURANCE -- NON-CONFORMANCE REPORT

Report No: NCR-000555

Reference Description: Segment 8AW, 2 Longitudinal Linear indication discovered with the MT method after the contractor's NDT acceptance

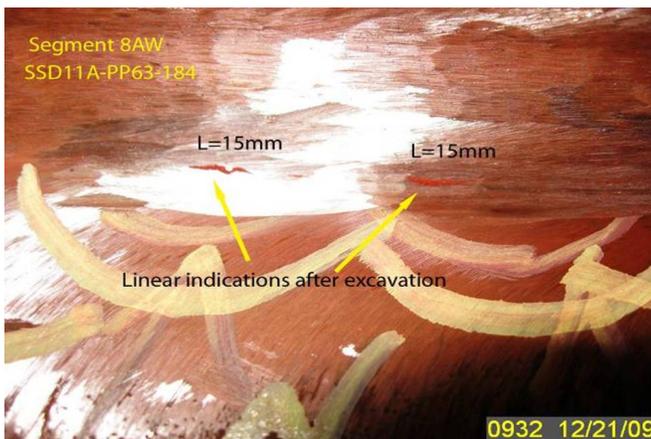
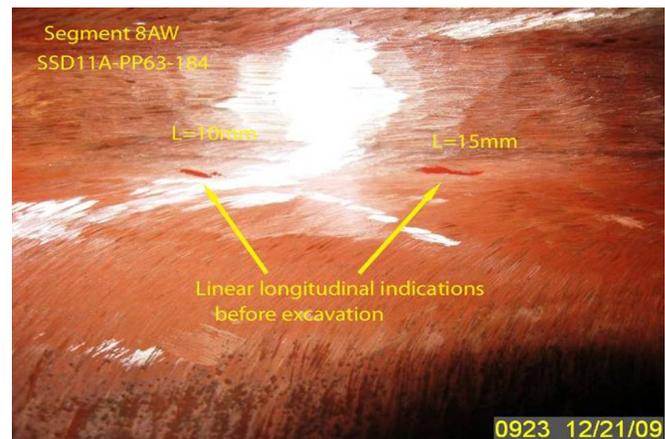
-Two (2) Longitudinal linear indications that measured from 10mm to 15mm in length, in the fillet weld joining the side panel access hole stiffener (X28D) to the side panel (SP723B) at panel point 63. The weld is designated as SSD11A-PP63-183.

The Notice of Witness Inspection Number (NWIT) is 004868. The indication is located inside the area that has been previously tested and accepted by ZPMC Quality Control (QC) personnel.

Submit a repair procedure to the engineer for approval. Missed MT indications by ZPMC technicians is a chronic problem. Provide additional training to the ZPMC technician that missed these two indications and provide evidence of such training to the engineer. A response for the resolution of this issue is expected within 7 days.

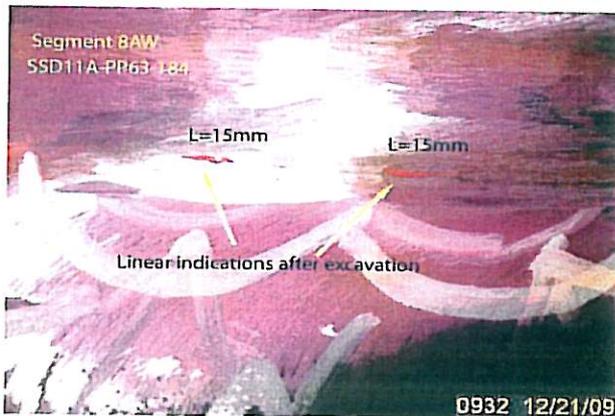
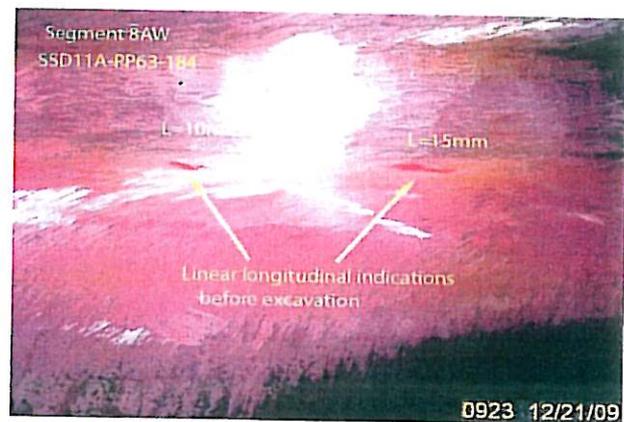
-Two (2) Longitudinal linear indications that measured from 10mm to 15mm in length, in the fillet weld joining the side panel access hole stiffener (X28D) to the side panel (SP723B) at panel point 63. The weld is designated as SSD11A-PP63-183.

The Notice of Witness Inspection Number (NWIT) is 004868. The indication is located inside the area that has been previously tested and accepted by ZPMC Quality Control (QC) personnel.

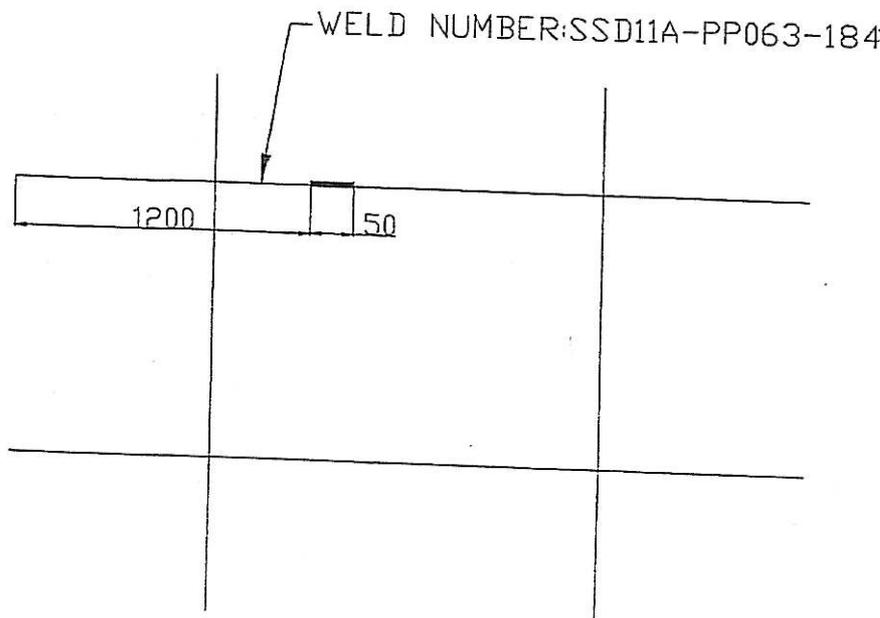
Draft of Welding Discontinuity:

One longitudinal crack was found by use of MT on SSD11A-PP063-184.

1. 火焰加热时, 水汽没有完全的去掉或者这个区域预热不够;
1. Moisture wasn't completely removed during drying operation (preheating) or the area wasn't preheated sufficiently.

1. QC and a Lead CWI shall be present, direct and supervise all grinding and welding operations during this repair to ensure the repair is per the disposition requirements

2. QC and a Lead CWI shall have an approved copy of the CWR in hand prior to the repair.
3. Remove paint ≥ 25 mm in all direction of HAZ prior to MT.
4. Clean the excavation area of all loose debris including MT powder. Preheat to 65° C before removing cracks by grinding, repair area shall extend a minimum of 50mm beyond each end of single crack repairs.

5. If base metal is damaged by grinding, the damaged area shall be ground clean prior to performing weld repair. If gap > 5 mm is found during or after grinding, comply with the notification on changing fillet weld to CJP which is submitted for Engineer's review and approval form.

6. Prepare excavation in accordance with the New Repair Procedure prior to welding.
7. Before this repair, Verify with VT and MT repair areas are defects free, and also MT shall be performed on the base metal laying abroad cracks to ensure that no cracks were propagated to the base metal. Separate CWR approval is needed if cracks are found in the base metal, and only after this new CWR's approval can continue the repair.

8. Clean excavation area of all loose debris including MT powder after excavation. Preheat and weld according to repair WPS, the preheat shall between 160° C-230° C.

9. Perform post weld heating according to repair WPS, the postheat shall between 230° C-315° C and for one hour minimum.
10. Allow the weld to cool to ambient temperature gradually. Control cooling rate after PWHT to no more than 50° C per hour.

11. Grind the repaired area flush with base metal or the adjacent weld after post weld heating.
12. Wait 48 hours at least after the repair area has cooled to ambient temperature before performing NDT.

13. Perform MT inspection to all repair area according to Contract Drawings along with all additional NDT required by the applicable notes Special Provision Section 10-1.59 'Steel Structure', subsection 'inspection testing'. NDT include VT, MT and UT if it is a CJP weld.
