Contract #: 04-0120F4
 Cty: SF/ALA Rte: 80 PM: 13.2/13.9
 File #: 69.25B

QUALITY ASSURANCE -- NON-CONFORMANCE REPORT

Report No: NCR-000557

Reference Description: Base Metal Repairs without Engineer's Approval, L6W

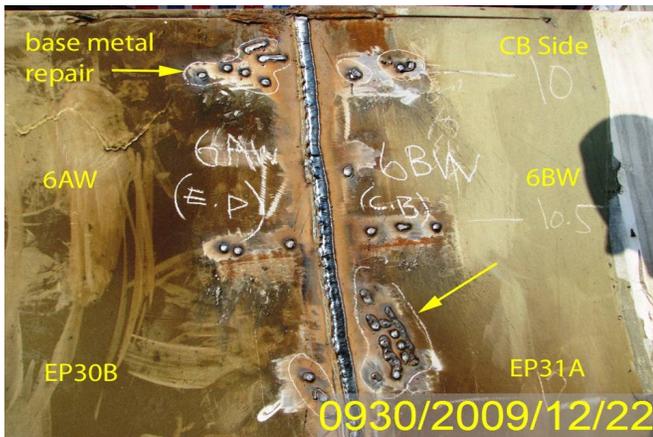
During a random in-process visual inspection at Segments 6AW+6BW, weld joint number #OBW6-005, Edge Plate (EP) (cross beam side), temporary attachment removal areas, this Caltrans Quality Assurance (QA) Inspector observed base metal repairs on EP's without prior approval of the Engineer.

- 1) The Edge Plates were identified as: EP31A and EP30B
- 2) The un-approved base metal repairs were located between PP40 and PP41 on the Cross Beam side.
- 3) These base metal repairs were caused by removal of temporary attachments.
- 4) ZPMC performed base metal repairs without the prior approval of the Engineer.
- 5) EP 30B is SPCM material and falls under Section 12 of the AWS D1.5, 2002 code.

For subsequent base metal repairs, notify the engineer prior to starting the work and provide weld test data to the engineer. A response for the resolution of this issue is expected within 7 days.

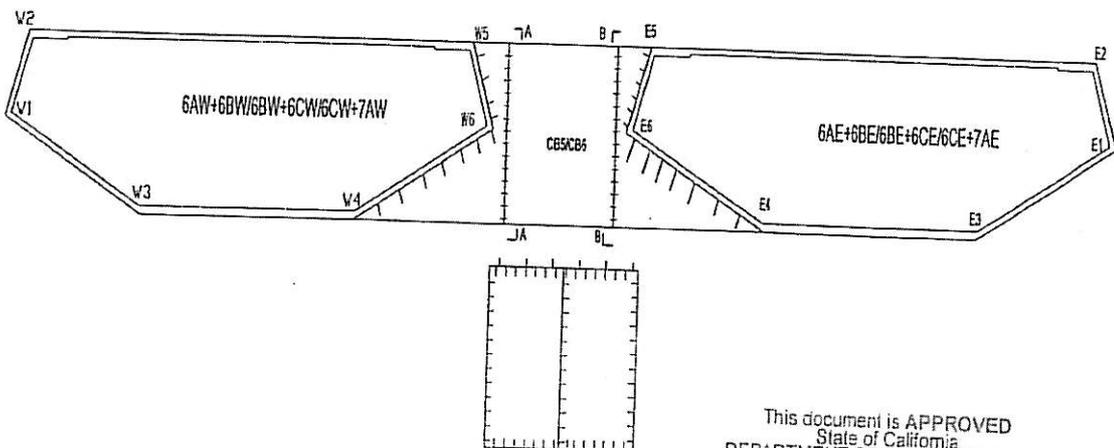
焊缝返修位置示意图:

经检查发现西线 6AW+6BW/6BW+6CW/6CW+7AW 和东线 6AE+6BE/6BE+6CE/6CE+7AE 吊装段联系梁侧斜底板及腹板以及 CB5 及 CB6 顶板、底板、腹板、隔板马板去除后母材需修补。具体位置见下图所示:

After inspection west linear 6AW+6BW/6BW+6CW/6CW+7AW and east line 6AE+6BE/6BE+6CE/6CE+7AE lifting side plate and edge plate face strut plate, CB5 and CB6 deck plate, side plate, edge plate, floor beam attachment temporary, the base metal needed to repair

Worker operator error caused base metal gouged.

2. Grind the repair area to a smooth finish according to the approved repair WPS.
 3. Prepare the joint according to the approved WPS.
 4. Notify QA verbally prior to NDT. Perform 100%MT and 100%VT of the repair area.

5. Remove all defects by grinding to ensure all defects are completely removed if defects still exist, and repeat "step 4" to assure complete removal of all defects if necessary.

6. Clean the repair area of all loose debris including MT powder.
 7. Preheat and weld according to the approved WPS.
 8. Grind the weld flush after welding.

9. Notify QA verbally prior NDT. Perform 100%MT and 100%VT of the repair area.
