**DEPARTMENT OF TRANSPORTATION**

Contract #: 04-0120F4Cty: SF/ALA Rte: 80 PM: 13.2/13.9File #: 69.25B**QUALITY ASSURANCE -- NON-CONFORMANCE REPORT****Location:** Changxing Island, Shanghai, P.R. China**Report No:** NCR-000558**Prime Contractor:** American Bridge/Fluor Enterprises, a JV**Date:** 22-Dec-2009**Submitting Contractor:** Zhenhua Port Machinery Company, Ltd (ZPMC), Changxing Island**NCR #:** ZPMC-0531**Type of problem:**

**Reference Description:** Side Panel Flatness, L5E**Description of Non-Conformance:**

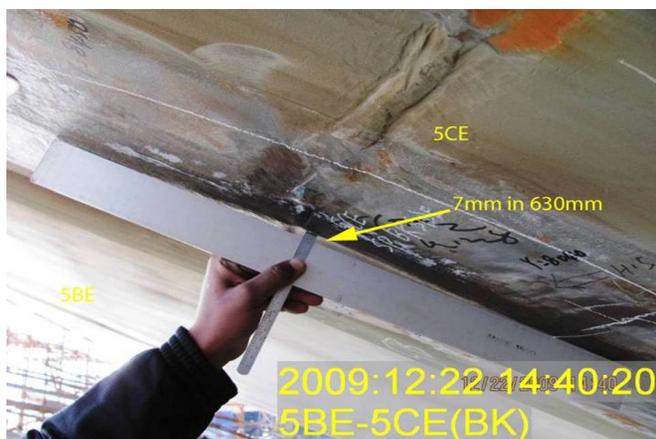
### 1) 5BE SP (SP305A) to SP (SP424A) - Bike path side

Surface flatness surveys were taken on the exterior Side Panel (SP) surface of weld splice SEG024A-031, Bike path side of 5BE between PP34 to PP35. The out of flatness measurements were taken across the Side Panel in the transverse direction between the longitudinal weld splice. These measurements were out of flatness 7mm in 630mm, which exceeds the maximum 5mm out of flatness requirement per State letter 05.03.01.004667.

- Out of flatness 7mm in 630mm.
- The longitudinal weld splice is identified as: SEG024A-031.
- The Transverse weld splice for 5BE to 5CE is identified as: OBE5A-009 & OBE5A-010.
- The SP to SP plate numbers are: SP305A to SP424A.
- The location was at the Bike path side of Segment 5BE.
- Between PP34 to PP35

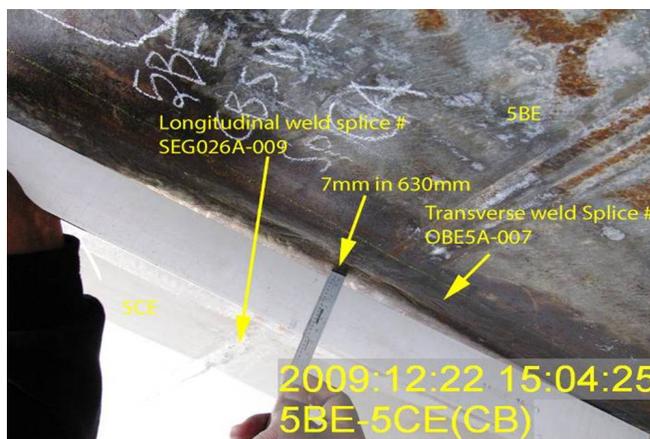
### 2) 5CE SP (SP524A) to SP (SP422A) - Cross beam Side

Surface flatness surveys were taken on the exterior Side Panel (SP) surface of weld splice SEG026A-009, Cross beam side of 5CE between PP34 to PP35. The out of flatness measurements were taken across the Side Panel in the transverse direction between the longitudinal weld splice. These measurements were out of flatness 7mm in 630mm, which exceeds the maximum 5mm out of flatness requirement per State letter 05.03.01.004667.

- Out of flatness 7mm in 630mm
- The longitudinal weld splice is identified as: SEG026A-009.
- The Transverse weld splice for 5BE to 5CE is identified as: OBE5A-007 & OBE5A-006.
- The SP to SP plate numbers are: SP524A to SP422A
- The location was at the Cross Beam side of Segment 5CE.
- Between PP34 to PP35

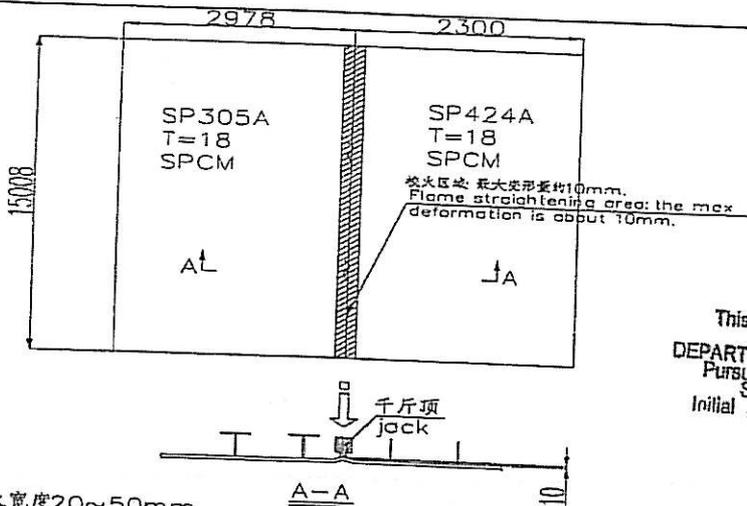
### 简图 Sketch

Cause原因 Welding distortion 焊接变形

Type of Defect缺陷类型 Welding distortion 焊接变形

最高温度(Maximum temperature): &lt;600°C

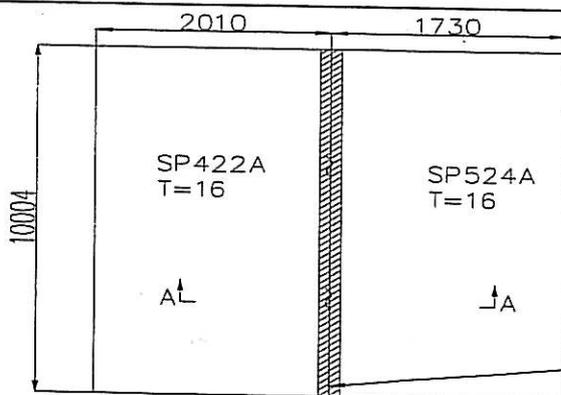
### 简图 Sketch

校火区域: 最大变形量约10mm.  
Flame straightening area; the max deformation is about 10mm.

最高温度(Maximum temperature): &lt;650°C
