Contract #: 04-0120F4Cty: SF/ALA Rte: 80 PM: 13.2/13.9File #: 69.25B**QUALITY ASSURANCE -- NON-CONFORMANCE REPORT****Location:** Changxing Island, Shanghai, P.R. China**Report No:** NCR-000560**Prime Contractor:** American Bridge/Fluor Enterprises, a JV**Date:** 23-Dec-2009**Submitting Contractor:** Zhenhua Port Machinery Company, Ltd (ZPMC), Changxing Island**NCR #:** ZPMC-0533**Type of problem:**

**Reference Description:** Skin flatness allowable tolerance not met at Side Panels on Lift 5W**Description of Non-Conformance:**

**Job Name:** SAS Superstructure

**Subject:** NCR No. ZPMC-0533

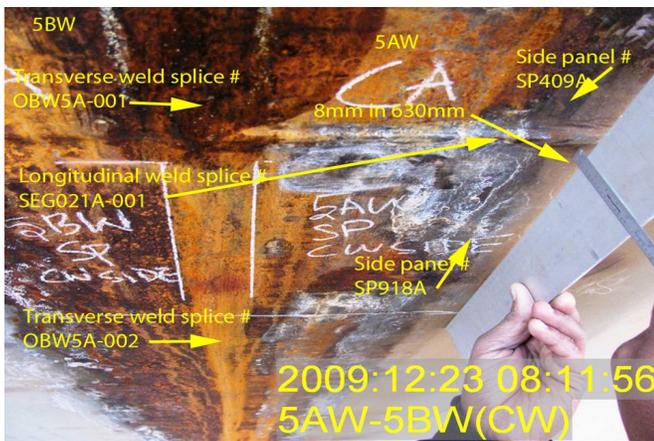
5AW SP (SP918A) to SP (SP409A) - CW Side

Surface flatness surveys were taken on the exterior Side Panel (SP) surface of longitudinal weld joint identified as SEG021A-001, counterweight side of 5AW between PP31 to PP32. The measurements were taken transverse to the direction of the side panel longitudinal weld joint. This area exceeded the maximum 5mm deviation from flat specified in State letter 05.03.01.004667.

-Deviation from flat is 8mm in 630mm

-The longitudinal weld splice is identified as: SEG021A-001.

-The transverse weld splice is identified as: OBE5A-002 &amp; OBE5A-001.

-The SP plate numbers are: SP918A to SP409A.

-The location is on the counterweight side of segment 5AW between PP31 to PP32.

Provide a repair procedure to the engineer for approval. A response for the resolution of this issue is expected within 7 days.

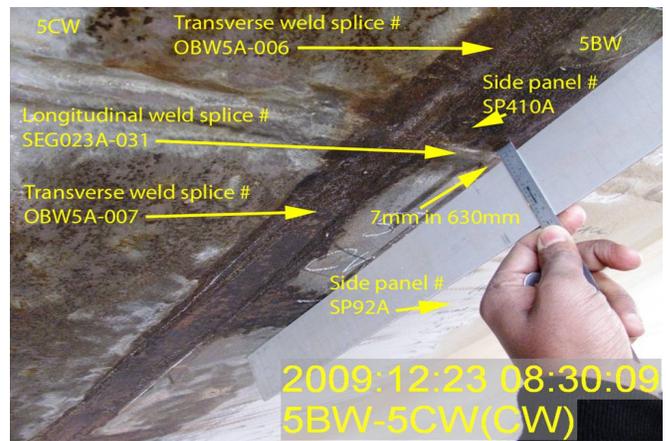
5BW SP (SP92A) to SP (SP410A) - CW Side

Surface flatness surveys were taken on the exterior Side Panel (SP) surface of longitudinal weld joint identified as SEG023A-031, counterweight side of 5BW between PP34 to PP35. The measurements were taken transverse to the direction of the side panel longitudinal weld joint. This area exceeded the maximum 5mm deviation from flat specified in State letter 05.03.01.004667.

-Deviation from flat is 7mm in 630mm.

-The longitudinal weld splice is identified as: SEG023A-031.

-The transverse weld splice for 5BW to 5CW is identified as: OBW5A-007 &amp; OBW5A-006.

-The SP plate numbers are: SP92A to SP410A.

-The location is on the counterweight side of segment 5BW between PP34 to PP35.

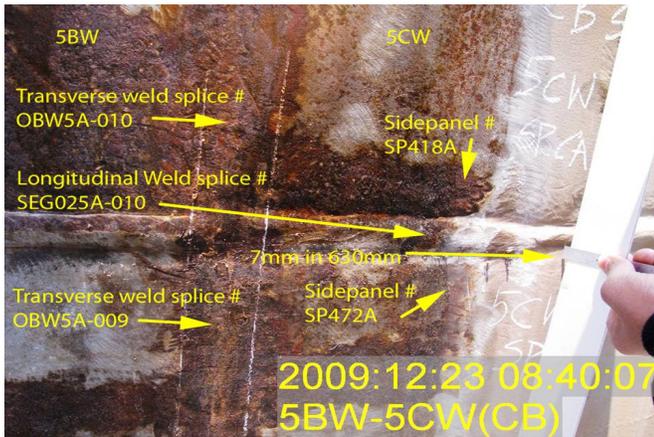
5CW SP (SP472A) to SP (SP418A) - CB Side

Surface flatness surveys were taken on the exterior Side Panel (SP) surface of longitudinal weld joint identified as SEG025A-010, cross beam side of 5CW between PP34 to PP35. The measurements were taken transverse to the direction of the side panel longitudinal weld joint. This area exceeded the maximum 5mm deviation from flat specified in State letter 05.03.01.004667.

-Deviation from flat is 7mm in 630mm

-The longitudinal weld splice is identified as: SEG025A-010.

-The transverse weld splice for 5BE to 5CE is identified as: OBW5A-009 & OBW5A-010

-The SP plate numbers are: SP472A to SP418A

-The location is on the cross beam side of segment 5CW between PP34 to PP35.

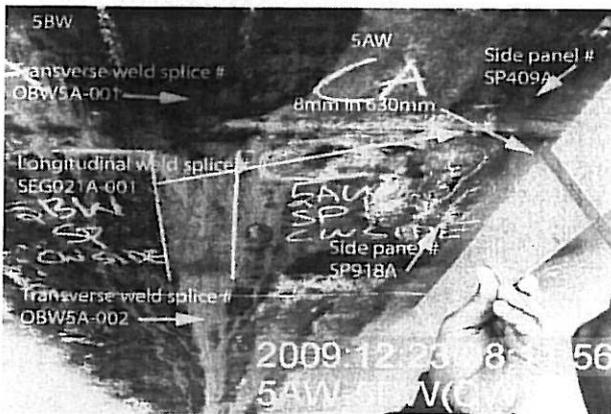
5AW SP (SP918A) to SP (SP409A) - CW Side

Surface flatness surveys were taken on the exterior Side Panel (SP) surface of longitudinal weld joint identified as SEG021A-001, counterweight side of 5AW between PP31 to PP32. The measurements were taken transverse to the direction of the side panel longitudinal weld joint. This area exceeded the maximum 5mm deviation from flat specified in State letter 05.03.01.004667.

-Deviation from flat is 8mm in 630mm

-The longitudinal weld splice is identified as: SEG021A-001.-The transverse weld splice is identified as: OBE5A-002 & OBE5A-001.

-The SP plate numbers are: SP918A to SP409A.

-The location is on the counterweight side of segment 5AW between PP31 to PP32.

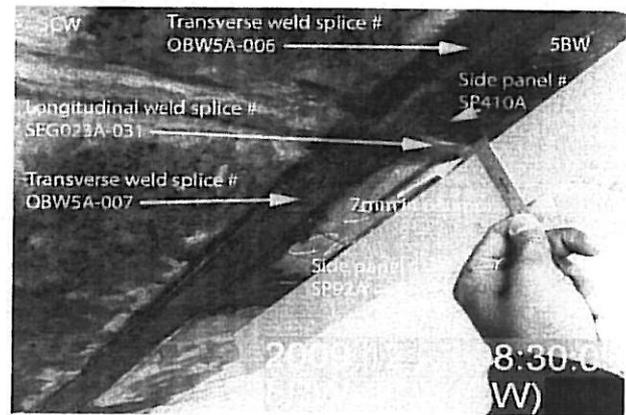
5BW SP (SP92A) to SP (SP410A) - CW Side

Surface flatness surveys were taken on the exterior Side Panel (SP) surface of longitudinal weld joint identified as SEG023A-031, counterweight side of 5BW between PP34 to PP35. The measurements were taken transverse to the direction of the side panel longitudinal weld joint. This area exceeded the maximum 5mm deviation from flat specified in State letter 05.03.01.004667.

-Deviation from flat is 7mm in 630mm.

-The longitudinal weld splice is identified as: SEG023A-031.-The transverse weld splice for 5BW to 5CW is identified as: OBW5A-007 & OBW5A-006.

-The SP plate numbers are: SP92A to SP410A.

-The location is on the counterweight side of segment 5BW between PP34 to PP35.

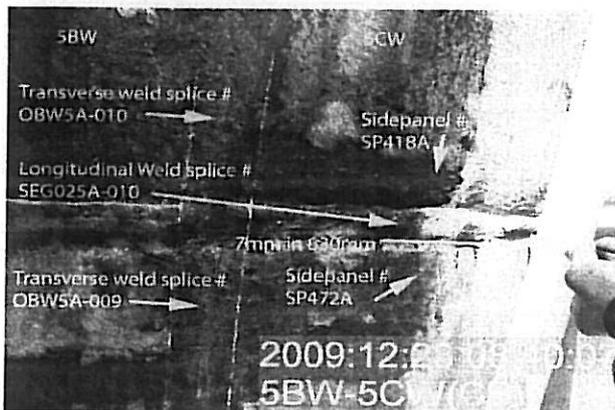
5CW SP (SP472A) to SP (SP418A) - CB Side

-The SP plate numbers are: SP472A to SP418A

-The location is on the cross beam side of segment 5CW between PP34 to PP35.

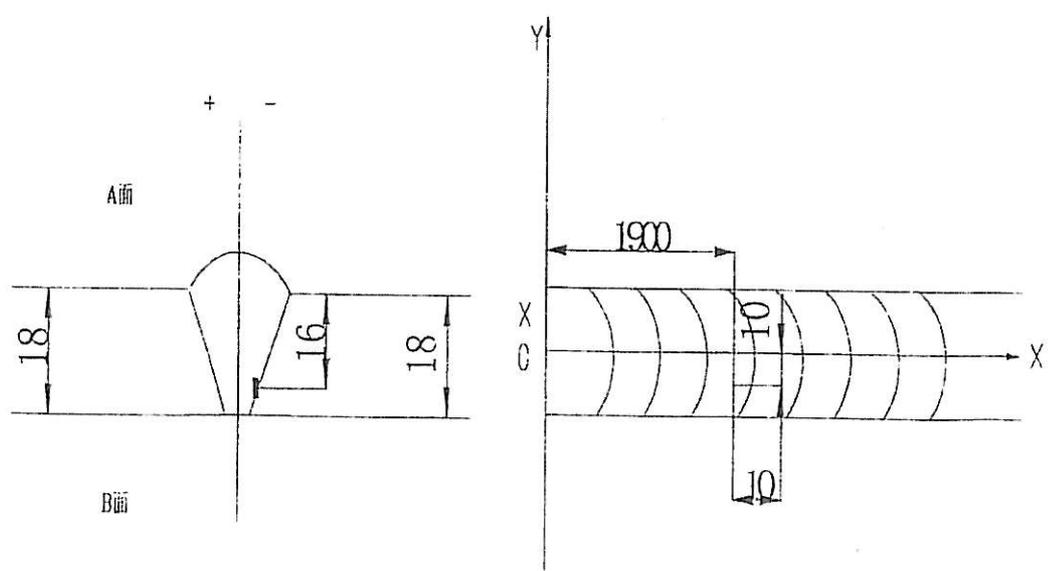
WELD NUMBER: SEG021A-001

Rejected indication found by ultrasonic inspection is less than the maximum allowance aggregate length.

(UT探伤发现的缺陷总长度小于最大允许长度。) SEG021A-001

1. Gouge or grind from nearer side from metal edge ( $D \leq 0.65T$ , "D" is depth of defects, "T" is thickness of metal) to remove all defects;
2. Follow repair WPS for joint preparation, preheat, and weld deposit;
3. Verify with VT no defects remain in the weld joint prior to welding;
4. Grind the repaired area flush with base metal or the adjacent weld;
5. Check the welds according to the working drawings.

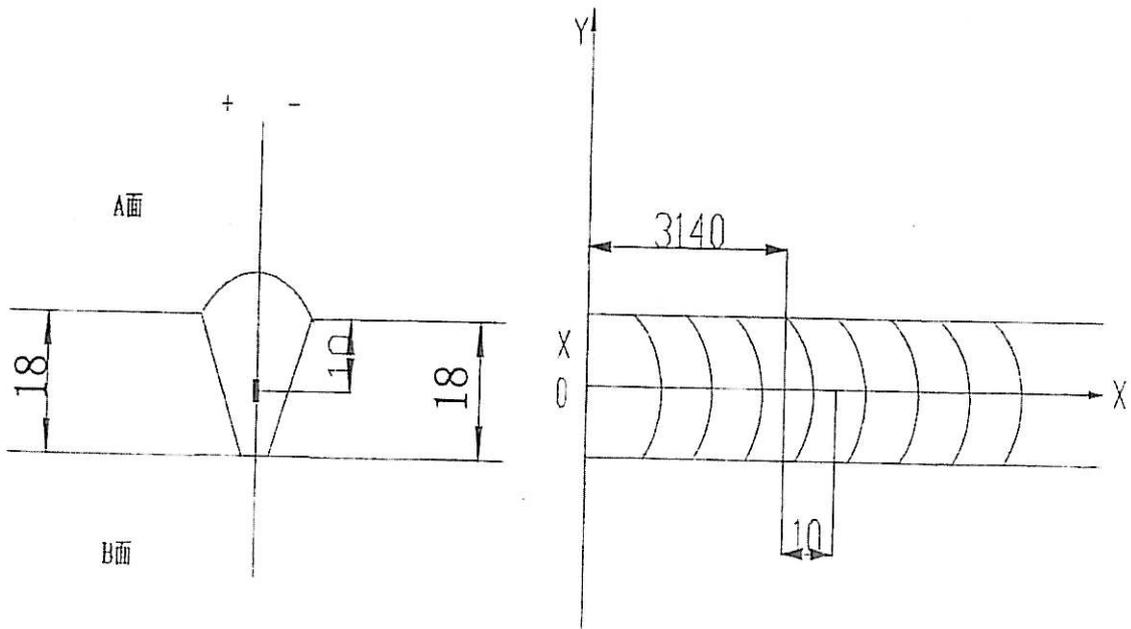
WELD NUMBER: SEG021A-031

Rejected indication found by ultrasonic inspection is less than the maximum allowance aggregate length.

(UT探伤发现的缺陷总长度小于最大允许长度。) SEG023A-031

1. 从缺陷距离端面较近一侧 ( $D \leq 0.65T$ , D为缺陷深度, T为板厚) 采用碳刨或打磨的方法去除焊缝缺陷;
  2. 参照返修焊接工艺规程 (WPS) 准备正确的接头型式, 预热和焊接;
  3. 焊前对修补区域进行VT检测保证缺陷完全被消除;
  4. 将修补区域打磨到与母材或邻近焊缝平齐;
  5. 根据批准的车间图纸检查焊缝.
- 
1. Gouge or grind from nearer side from metal edge ( $D \leq 0.65T$ , "D" is depth of defects, "T" is thickness of metal) to remove all defects;
  2. Follow repair WPS for joint preparation, preheat, and weld deposit;
  3. Verify with VT no defects remain in the weld joint prior to welding;
  4. Grind the repaired area flush with base metal or the adjacent weld;
  5. Check the welds according to the working drawings.

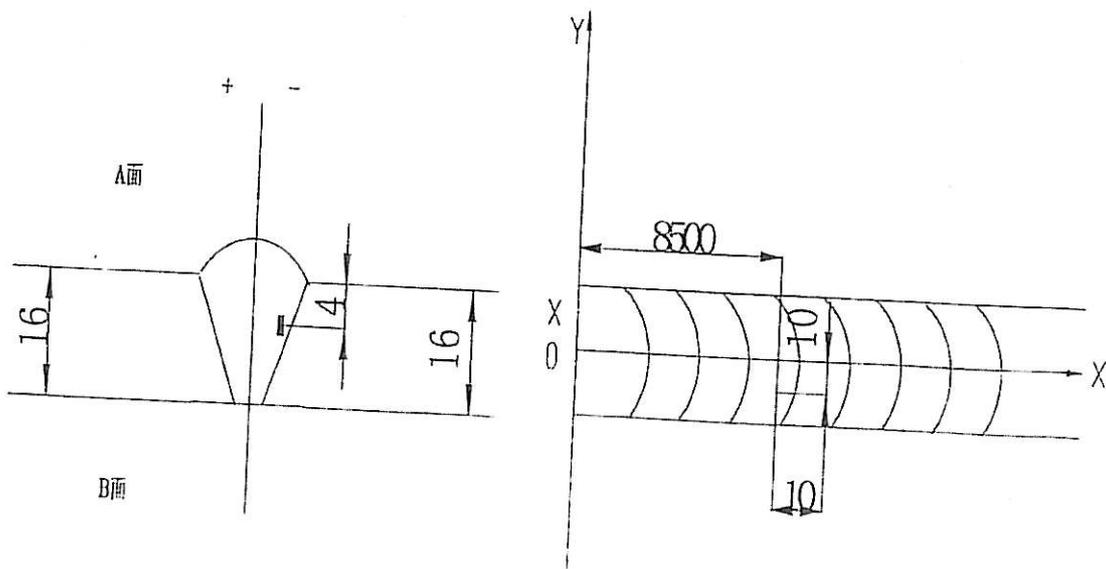
WELD NUMBER: SEG025A-010

Rejected indication found by ultrasonic inspection is less than the maximum allowance aggregate length.

(UT探伤发现的缺陷总长度小于最大允许长度。) SEG025A-010

1. 从缺陷距离端面较近一侧 ( $D \leq 0.65T$ , D为缺陷深度, T为板厚) 采用破刨或打磨的方法去除焊缝缺陷;
  2. 参照返修焊接工艺规程 (WPS) 准备正确的接头型式, 预热和焊接;
  3. 焊前对修补区域进行VT检测保证缺陷完全被消除;
  4. 将修补区域打磨到与母材或邻近焊缝平齐;
  5. 根据批准的车间图纸检查焊缝.
- 
1. Gouge or grind from nearer side from metal edge ( $D \leq 0.65T$ , "D" is depth of defects, "T" is thickness of metal) to remove all defects;
  2. Follow repair WPS for joint preparation, preheat, and weld deposit;
  3. Verify with VT no defects remain in the weld joint prior to welding;
  4. Grind the repaired area flush with base metal or the adjacent weld;
  5. Check the welds according to the working drawings.
