Contract #: 04-0120F4Cty: SF/ALA Rte: 80 PM: 13.2/13.9File #: 69.25B**QUALITY ASSURANCE -- NON-CONFORMANCE REPORT****Location:** Changxing Island, Shanghai, P.R. China**Report No:** NCR-000561**Prime Contractor:** American Bridge/Fluor Enterprises, a JV**Date:** 21-Dec-2009**Submitting Contractor:** Zhenhua Port Machinery Company, Ltd (ZPMC), Changxing Island**NCR #:** ZPMC-0534**Type of problem:****Welding****Concrete****Other****Welding****Curing****Procedural****Bridge No:** 34-0006**Joint fit-up****Coating****Other****Component:** Side Panel at Segment 9AW**Procedural****Procedural****Description:**

**Reference Description:** ZPMC performed base metal repairs at Segment 9AW without the Engineer's approval

**Job Name:** SAS Superstructure

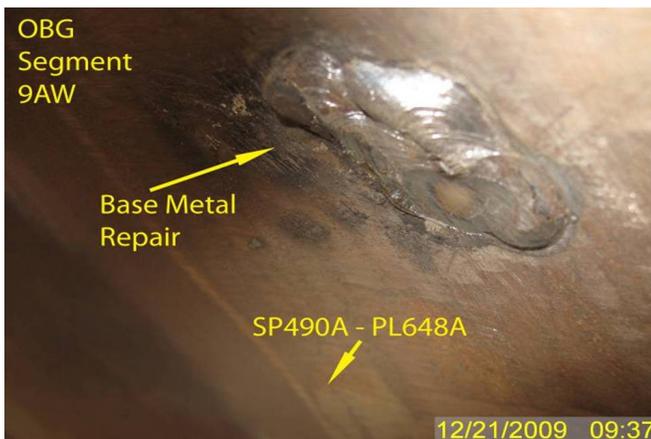
During the Quality Assurance (QA) random in-process visual inspection of Segment 9AW, this QA inspector discovered the following issue:

-Base metal repairs being performed in way of temporary attachment removal areas on the side plate without the prior approval of the engineer.

-SP490A, Plate number-PL648A

-The material is A709 Grade 345 non SPCM:

-OBG Segment 9AW is located in the segment yard north of Bay 17.

On subsequent base metal repairs, notify the engineer prior to the start of the work. Provide weld test information to the engineer. A response for the resolution of this issue is expected within 7 days.

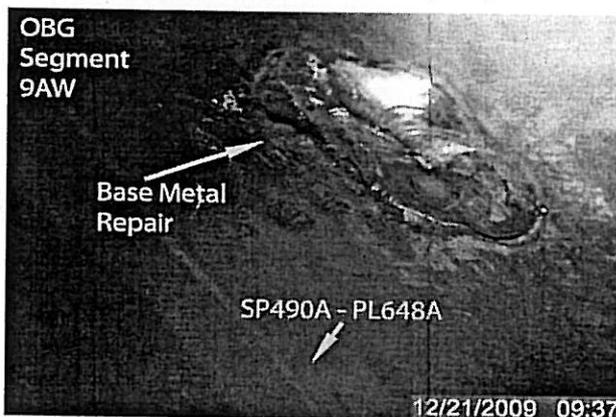
During the Quality Assurance (QA) random in-process visual inspection of Segment 9AW, this QA inspector discovered the following issue:

-Base metal repairs being performed in way of temporary attachment removal areas on the side plate without the prior approval of the engineer.

-SP490A, Plate number-PL648A

-The material is A709 Grade 345 non SPCM:

-OBG Segment 9AW is located in the segment yard north of Bay 17.

On subsequent base metal repairs, notify the engineer prior to the start of the work. Provide weld test information to the engineer. A response for the resolution of this issue is expected within 7 days.
