Contract #: 04-0120F4Cty: SF/ALA Rte: 80 PM: 13.2/13.9File #: 69.25B**QUALITY ASSURANCE -- NON-CONFORMANCE REPORT****Location:** Changxing Island, Shanghai, P.R. China**Report No:** NCR-000564**Prime Contractor:** American Bridge/Fluor Enterprises, a JV**Date:** 16-Dec-2009**Submitting Contractor:** Zhenhua Port Machinery Company, Ltd (ZPMC), Changxing Island**NCR #:** ZPMC-0537**Type of problem:****Welding****Concrete****Other****Welding****Curing****Procedural****Bridge No:** 34-0006**Joint fit-up****Coating****Other****Component:** OBG Segment 10AW FL3**Procedural****Procedural****Description:****Reference Description:** Fabrication not according to the approved shop drawings in Segment 10AW**Description of Non-Conformance:**

QUALITY ASSURANCE -- NON-CONFORMANCE REPORT

Reference Description: Fabrication not according to the approved shop drawings in Segment 10AW

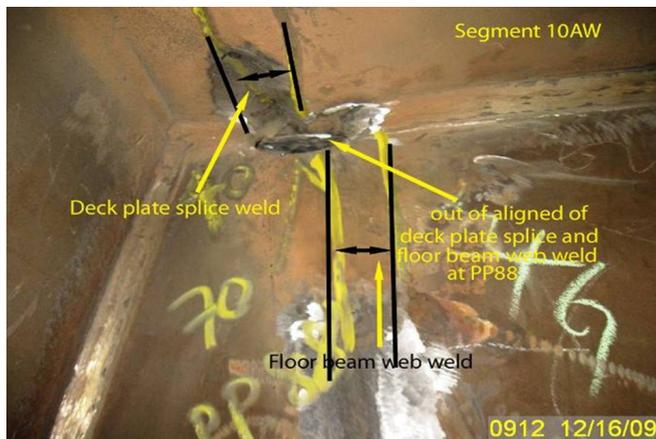
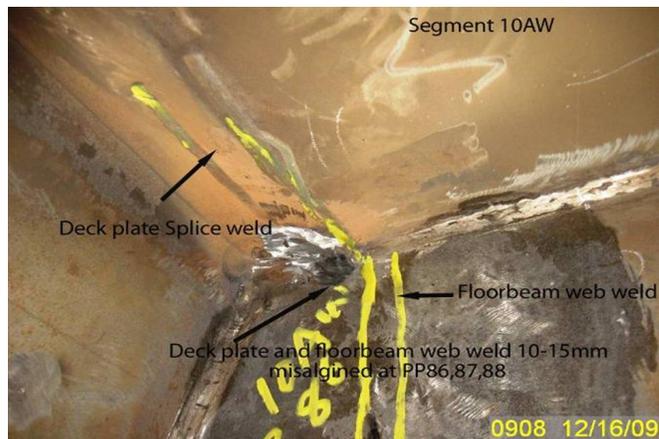
The complete joint penetration (CJP) weld joining the Deck panel diaphragm to the FL3 floor beam at panel points 86, 87 and 88 was found to be misaligned approximately 10 to 15mm with the weld access hole for the deck panel splice. The issue was explained by ZPMC QC Mr. Li Ming yang to be due to excessive cutting at fit up. Additional information identifying the weld and component location is listed below. The fabrication at these locations are not conforming to the approved shop drawings.

- Deck plate splice weld is identified as: SEG059*-010.
- The FL3 floor beam (FB19) to deck panel diaphragm weld at panel point 86 is designated as SSD10A-PP86-004.
- The FL3 floor beam (FB23) to deck panel diaphragm weld at panel point 87 is designated as SSD10A-PP87-004.
- The FL3 floor beam (FB27) to deck panel diaphragm weld at panel point 88 is designated as SSD10A-PP88-005.
- The OBG Segment 10AW is located inside the fabrication Bay 14.

Approved Drawing for segment Assembly 10AW; "SEGSD1 – Detail 1AA". Shows that the weld access hole, deck panel splice weld and floor beam to diaphragm splice weld should align.

The concern is the method used to terminate the weld between the misaligned deck plate splices. Indicate to the engineer how the termination was done. A response for the resolution of this issue is expected within 7 days.

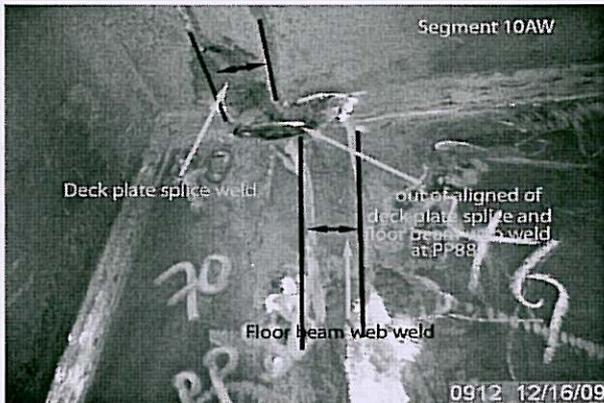
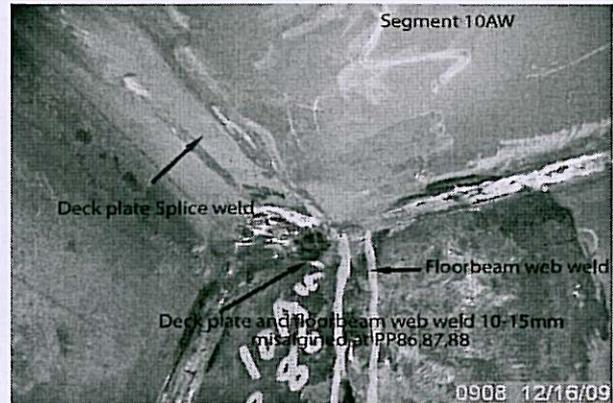
The complete joint penetration (CJP) weld joining the Deck panel diaphragm to the FL3 floor beam at panel points 86, 87 and 88 was found to be misaligned approximately 10 to 15mm with the weld access hole for the deck panel splice. The issue was explained by ZPMC QC Mr. Li Ming yang to be due to excessive cutting at fit up. Additional information identifying the weld and component location is listed below. The fabrication at these locations are not conforming to the approved shop drawings.

- Deck plate splice weld is identified as: SEG059*-010.
- The FL3 floor beam (FB19) to deck panel diaphragm weld at panel point 86 is designated as SSD10A-PP86-004.
- The FL3 floor beam (FB23) to deck panel diaphragm weld at panel point 87 is designated as SSD10A-PP87-004.
- The FL3 floor beam (FB27) to deck panel diaphragm weld at panel point 88 is designated as SSD10A-PP88-005.
- The OBG Segment 10AW is located inside the fabrication Bay 14.

Approved Drawing for segment Assembly 10AW; "SEGSD1 – Detail 1AA". Shows that the weld access hole, deck panel splice weld and floor beam to diaphragm splice weld should align.

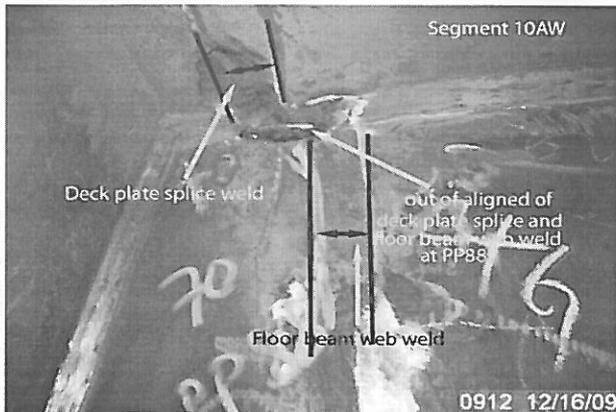
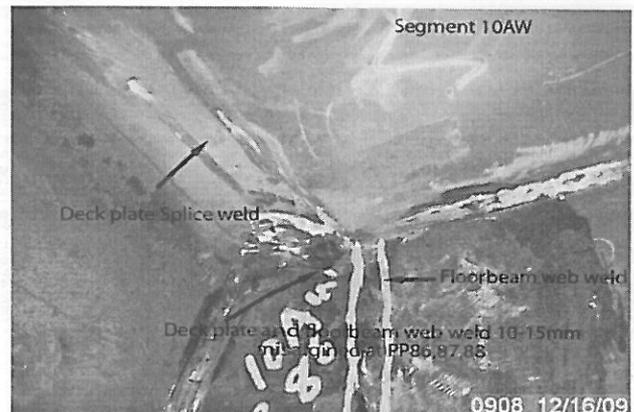
The complete joint penetration (CJP) weld joining the Deck panel diaphragm to the FL3 floor beam at panel points 86, 87 and 88 was found to be misaligned approximately 10 to 15mm with the weld access hole for the deck panel splice. The issue was explained by ZPMC QC Mr. Li Ming yang to be due to excessive cutting at fit up. Additional information identifying the weld and component location is listed below. The fabrication at these locations are not conforming to the approved shop drawings.

- Deck plate splice weld is identified as: SEG059*-010.
- The FL3 floor beam (FB19) to deck panel diaphragm weld at panel point 86 is designated as SSD10A-PP86-004.
- The FL3 floor beam (FB23) to deck panel diaphragm weld at panel point 87 is designated as SSD10A-PP87-004.
- The FL3 floor beam (FB27) to deck panel diaphragm weld at panel point 88 is designated as SSD10A-PP88-005.
- The OBG Segment 10AW is located inside the fabrication Bay 14.

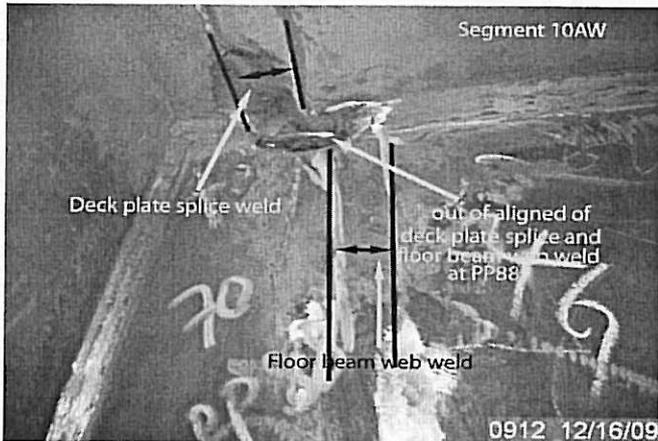
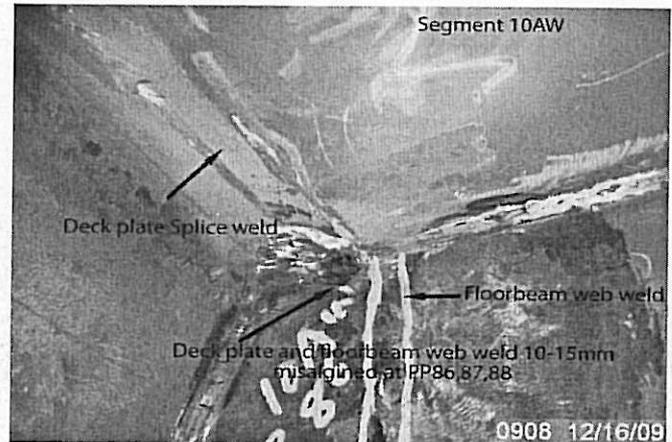
The complete joint penetration (CJP) weld joining the Deck panel diaphragm to the FL3 floor beam at panel points 86, 87 and 88 was found to be misaligned approximately 10 to 15mm with the weld access hole for the deck panel splice. The issue was explained by ZPMC QC Mr. Li Ming yang to be due to excessive cutting at fit up. Additional information identifying the weld and component location is listed below. The fabrication at these locations are not conforming to the approved shop drawings.
