Contract #: 04-0120F4Cty: SF/ALA Rte: 80 PM: 13.2/13.9File #: 69.25B**QUALITY ASSURANCE -- NON-CONFORMANCE REPORT****Location:** Changxing Island, Shanghai, P.R. China**Report No:** NCR-000570**Prime Contractor:** American Bridge/Fluor Enterprises, a JV**Date:** 29-Dec-2009**Submitting Contractor:** Zhenhua Port Machinery Company, Ltd (ZPMC), Changxing Island**NCR #:** ZPMC-0543**Type of problem:**

Reference Description: Missed UT indications by QC on Segment 8CW Side to Edge Plate Joint**Description of Non-Conformance:**

To:	AMERICAN BRIDGE/FLUOR, A JV 375 BURMA ROAD OAKLAND CA 95607	Date:	30-Dec-2009
Dear:	Mr. Charles Kanapicki	Contract No:	04-0120F4 04-SF-80-13.2 / 13.9
Attention:	Mr. Thomas Nilsson Project/Fabrication Manager	Job Name:	SAS Superstructure
Subject:	NCR No. ZPMC-0543	Document No:	05.03.06-000533

**REGARDING: NCR-000539(ZPMC-0512) NCR-000567(ZPMC-0540)
NCR-000570(ZPMC-0543) NCR-000571(ZPMC-0544)**

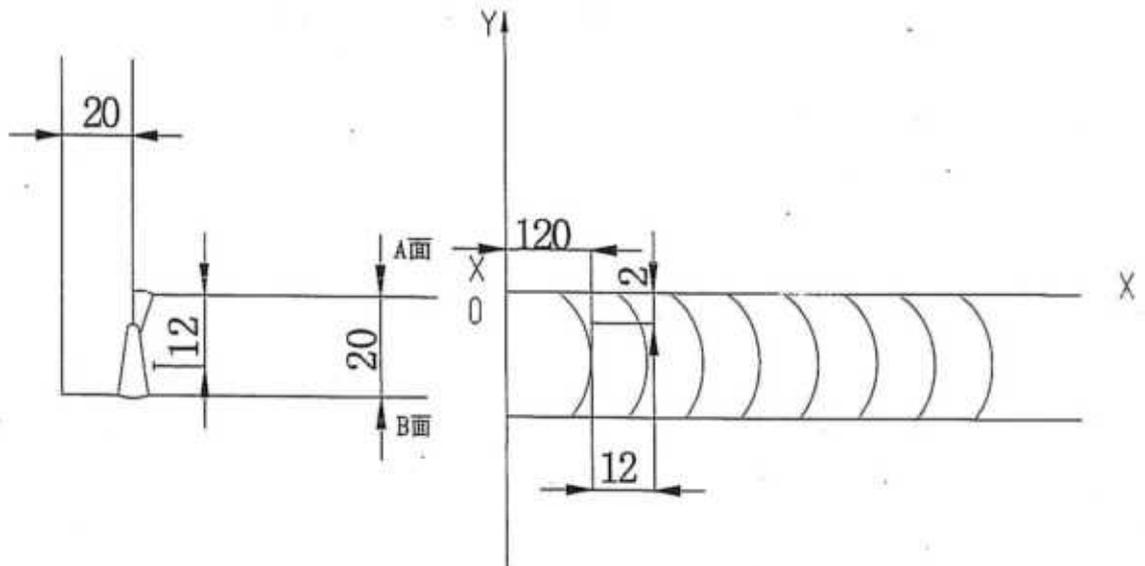
WELD NUMBER: SSD13A-PP065-128

Rejected indication found by ultrasonic inspection is less than the maximum allowance aggregate length.

(UT探伤发现的缺陷总长度小于最大允许长度。) SSD13A-PP065-128

WELD IDENTIFICATION 焊缝部件编号	INDICATION NO. 指示号	PROBE ANGLE 探测角度	FROM FACE 检测面	LEG (次数)	DECIBELS分贝				DISCONTINUITY 不连续性					Discontinuity Evaluation 缺陷估计	Remark 备注
					Indication Level	Reference Level	Attenuation Factor	Indication Rating	LOCATION OF DISCONTINUITY 不连续位置(mm)						
									a	b	c	d	Length 长度		
SSD13A-PP065-128	1	70	A	1	42	32	1	+9	12	36	12	-2	120	REJ.	100%
BLANK

1. Gouge or grind from nearer side from metal edge ($D \leq 0.65T$, "D" is depth of defects, "T" is thickness of metal) to remove all defects;

2. Follow repair WPS for joint preparation, preheat, and weld deposit;

3. Verify with VT no defects remain in the weld joint prior to welding;

4. Grind the repaired area flush with base metal or the adjacent weld;

5. Perform UT inspection to the weld along with 50mm on each end of the repair area;

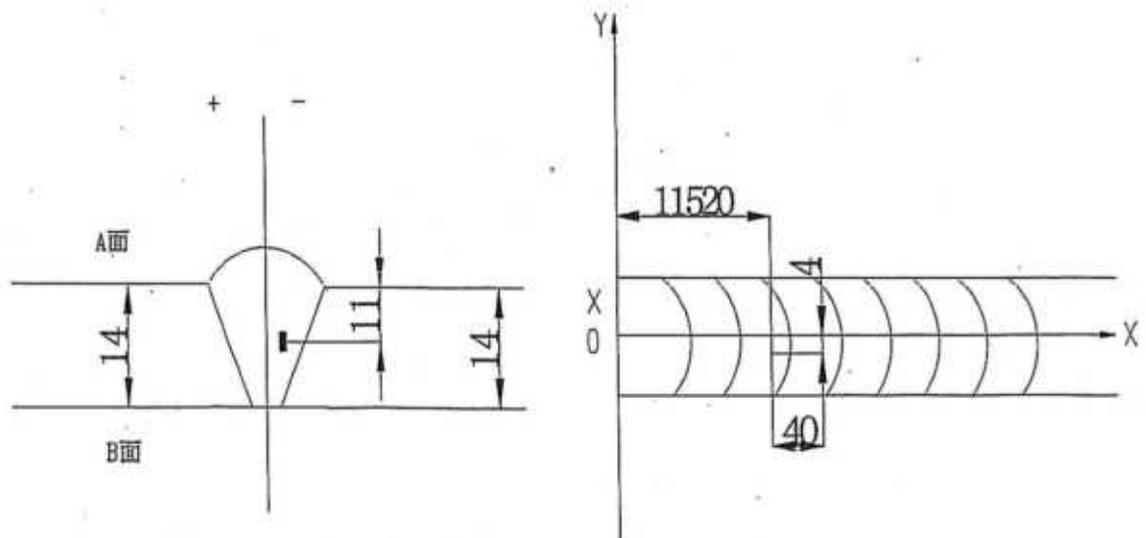
WELD NUMBER: SEG048*-005

Rejected indication found by ultrasonic inspection is less than the maximum allowance aggregate length.

(UT探伤发现的缺陷总长度小于最大允许长度。) SEG048*-005

WELD IDENTIFICATION 焊缝部件编号	INDICATION NO. 指示号	PROBE ANGLE 探测角度	FROM FACE 检测面	LEG (次数)	DECIBELS分贝				DISCONTINUITY 不连续性					Discontinuity Evaluation 缺陷估计	Remark 备注
					Indication Level	Reference Level	Attenuation Factor	Indication Rating	LOCATION OF DISCONTINUITY 不连续位置(mm)						
									a	b	c	d	Length 长度		
SEG048*-005	1	70	A	1	39	32	1	+6	40	32	11	-4	11520	REJ.	100%

1. Gouge or grind from nearer side from metal edge ($D \leq 0.65T$, "D" is depth of defects, "T" is thickness of metal) to remove all defects;

2. Follow repair WPS for joint preparation, preheat, and weld deposit;

3. Verify with VT no defects remain in the weld joint prior to welding;

4. Grind the repaired area flush with base metal or the adjacent weld;

5. Perform UT inspection to the weld along with 50mm on each end of the repair area;

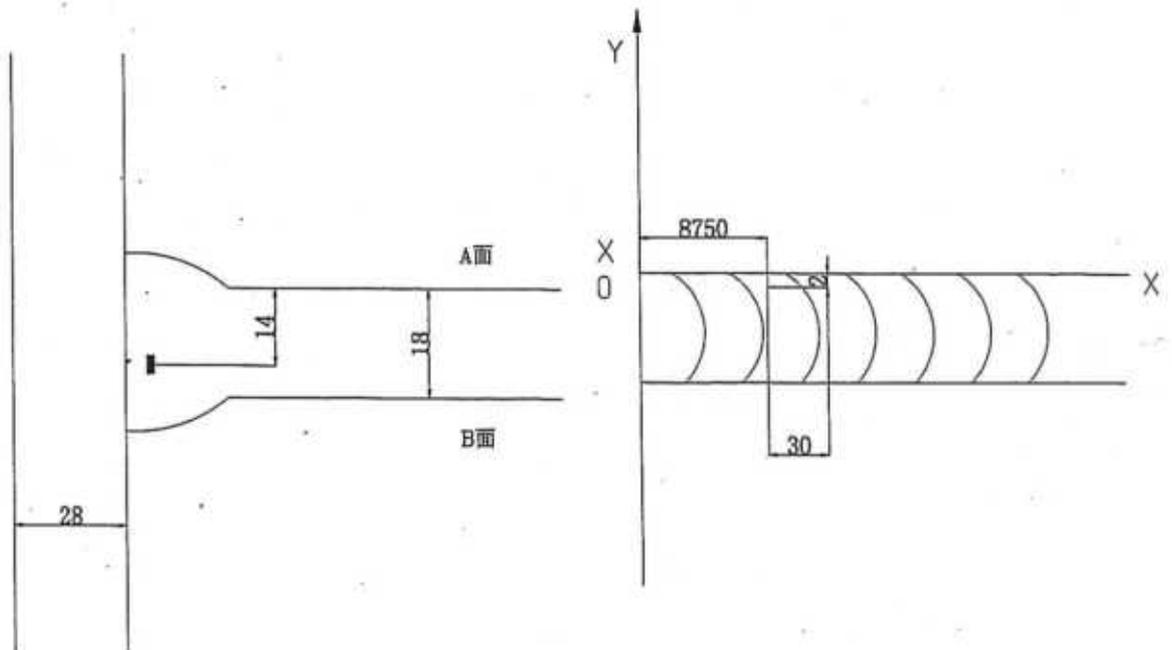
WELD NUMBER: CA053-003

Rejected indication found by ultrasonic inspection is less than the maximum allowance aggregate length.

(UT探伤发现的缺陷总长度小于最大允许长度。) CA053-003

WELD IDENTIFICATION 焊缝部件编号	INDICATION NO. 指示号	PROBE ANGLE 探测角度	FROM FACE 检测面	LEG (次数)	DECIBELS 分贝				DISCONTINUITY 不连续性					Discontinuity Evaluation 缺陷估计	Remark 备注
					Indication Level	Reference Level	Attenuation Factor	Indication Rating	LOCATION OF DISCONTINUITY 不连续位置(mm)						
									a	b	c	d	Length 长度		
CA053-003	1	70	A	1	41	32	2	+7	30	42	14	-2	8750	REJ.	100%
BLANK

1. 从缺陷距高端面较近一侧 ($D \leq 0.65T$, D为缺陷深度, T为板厚) 采用碳刨或打磨的方法去除焊缝缺陷;
 2. 参照返修焊接工艺规程 (WPS) 准备正确的接头型式, 预热和焊接;
 3. 焊前对修补区域进行VT检测保证缺陷完全被消除;
 4. 将修补区域打磨到与母材或邻近焊缝平齐;
 5. 对焊缝进行UT检测, 检测范围为返修区域以及其两端各延长50mm.
-
1. Gouge or grind from nearer side from metal edge ($D \leq 0.65T$, "D" is depth of defects, "T" is thickness of metal) to remove all defects;
 2. Follow repair WPS for joint preparation, preheat, and weld deposit;
 3. Verify with VT no defects remain in the weld joint prior to welding;
 4. Grind the repaired area flush with base metal or the adjacent weld;
 5. Perform UT inspection to the weld along with 50mm on each end of the repair area;

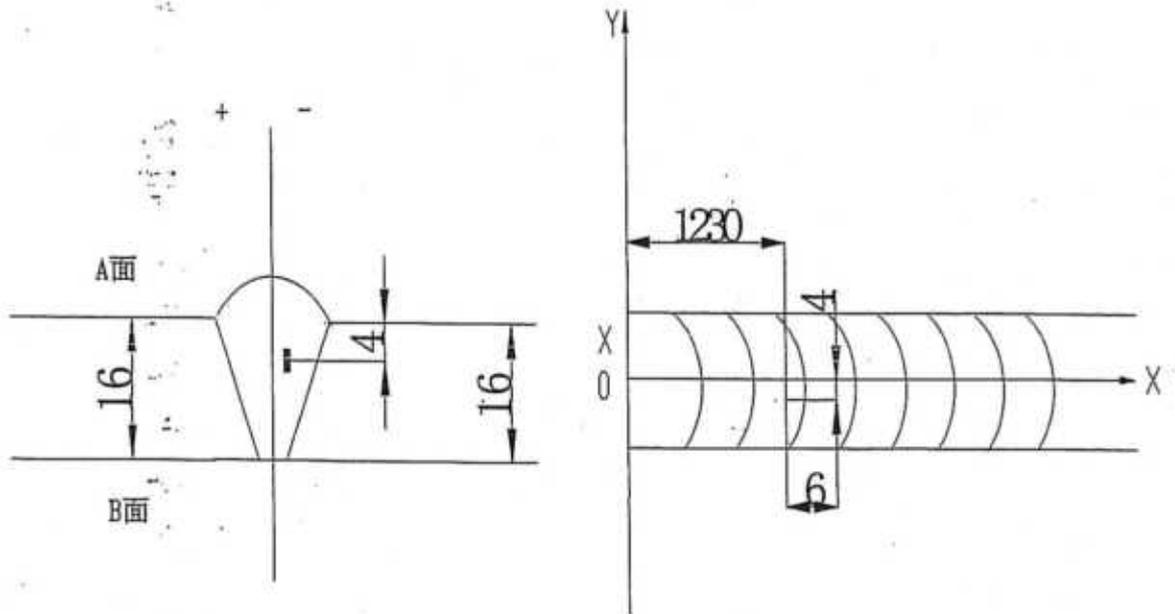
WELD NUMBER: SEG047B-012

Rejected indication found by ultrasonic inspection is less than the maximum allowance aggregate length.

(UT探伤发现的缺陷总长度小于最大允许长度。) SEG047B-012

1. Gouge or grind from nearer side from metal edge ($D \leq 0.65T$, "D" is depth of defects, "T" is thickness of metal) to remove all defects;

2. Follow repair WPS for joint preparation, preheat, and weld deposit;

3. Verify with VT no defects remain in the weld joint prior to welding;

4. Grind the repaired area flush with base metal or the adjacent weld;

5. Perform UT inspection to the weld along with 50mm on each end of the repair area;

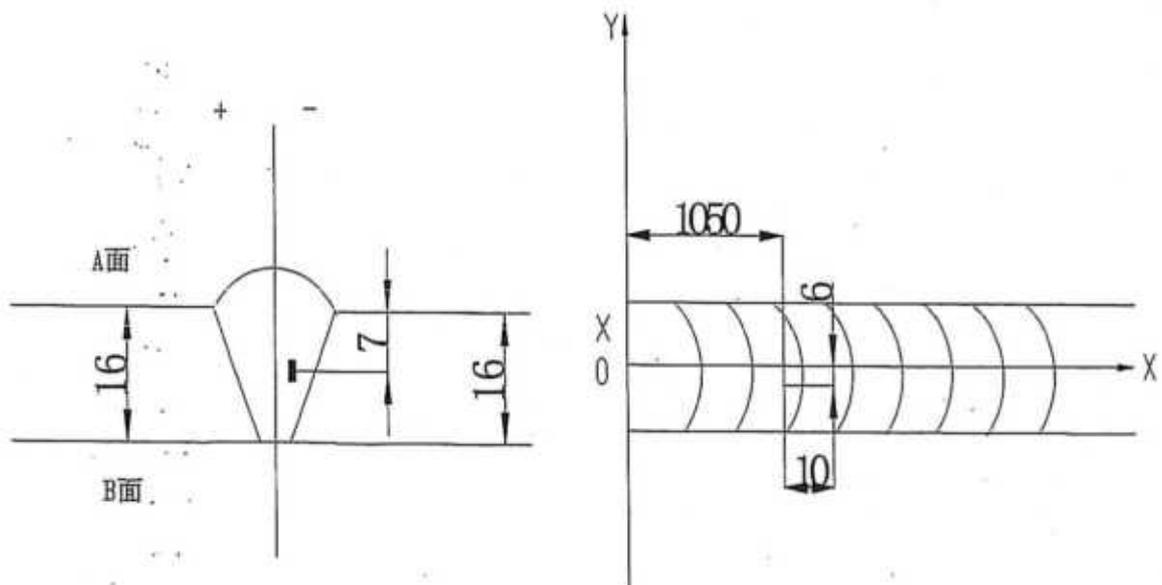
WELD NUMBER: SEG047B-013

Rejected indication found by ultrasonic inspection is less than the maximum allowance aggregate length.

(UT探伤发现的缺陷总长度小于最大允许长度。) SEG047B-013

1. Gouge or grind from nearer side from metal edge ($D \leq 0.65T$, "D" is depth of defects, "T" is thickness of metal) to remove all defects;

2. Follow repair WPS for joint preparation, preheat, and weld deposit;

3. Verify with VT no defects remain in the weld joint prior to welding;

4. Grind the repaired area flush with base metal or the adjacent weld;

5. Perform UT inspection to the weld along with 50mm on each end of the repair area;
