QUALITY ASSURANCE -- NON-CONFORMANCE REPORT

Location: Changxing Island, Shanghai, P.R. China**Report No:** NCR-000571**Prime Contractor:** American Bridge/Fluor Enterprises, a JV**Date:** 30-Dec-2009**Submitting Contractor:** Zhenhua Port Machinery Company, Ltd (ZPMC), Changxing Island**NCR #:** ZPMC-0544**Type of problem:**

Reference Description: Missed UT indications by QC on Side Plate of Segment 8CW**Description of Non-Conformance:**

Job Name: SAS Superstructure

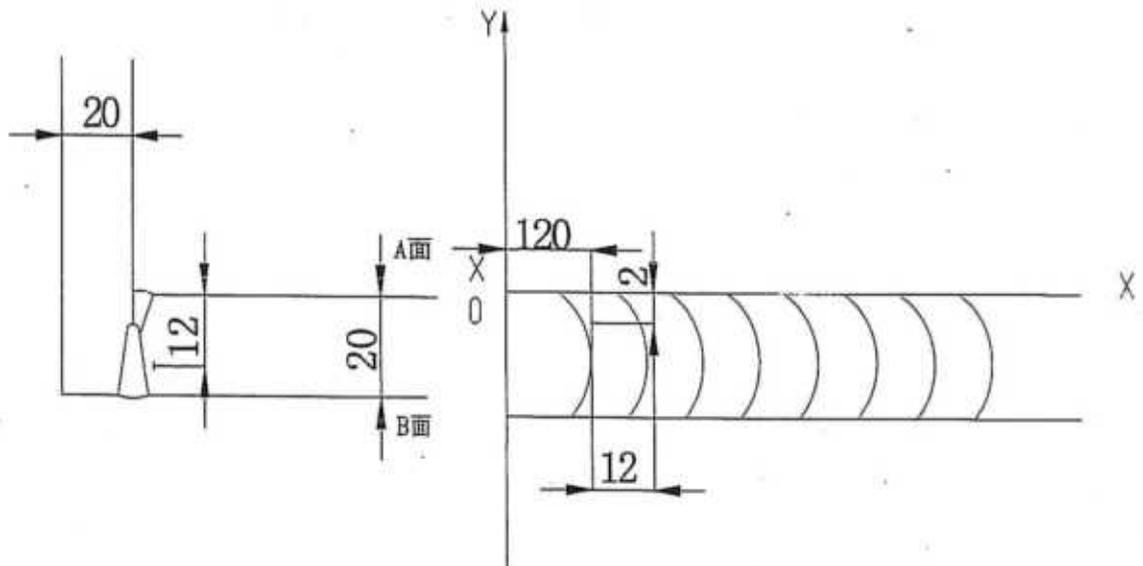
WELD NUMBER: SSD13A-PP065-128

- The non-conforming UT class "A" indication measured approximately 12mm in length.
- The weld is identified as: SSD13A-PP65-128 at PP65.
- The weld is a Complete Joint Penetration (CJP) Tee Joint.
- The OBG Segment 8BW is located at outside the Paint Shop.
- The Notice of Witness Inspection Number (NWIT) is 004500.
- TL-6027 UT report was written by QA inspector B205 on this date.

Rejected indication found by ultrasonic inspection is less than the maximum allowance aggregate length.

(UT探伤发现的缺陷总长度小于最大允许长度。) SSD13A-PP065-128

1. Gouge or grind from nearer side from metal edge ($D \leq 0.65T$, "D" is depth of defects, "T" is thickness of metal) to remove all defects;

2. Follow repair WPS for joint preparation, preheat, and weld deposit;

3. Verify with VT no defects remain in the weld joint prior to welding;

4. Grind the repaired area flush with base metal or the adjacent weld;

5. Perform UT inspection to the weld along with 50mm on each end of the repair area;

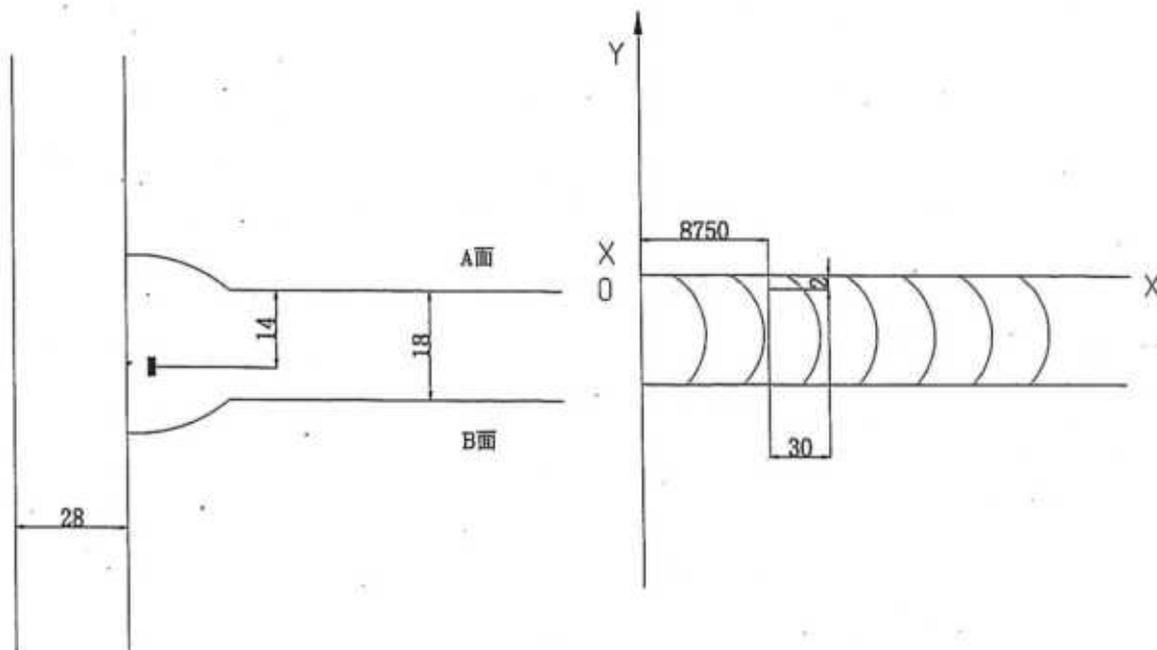
WELD NUMBER: CA053-003

Rejected indication found by ultrasonic inspection is less than the maximum allowance aggregate length.

(UT探伤发现的缺陷总长度小于最大允许长度。) CA053-003

1. 从缺陷距离端面较近一侧 ($D \leq 0.65T$, D为缺陷深度, T为板厚) 采用碳刨或打磨的方法去除焊缝缺陷;
 2. 参照返修焊接工艺规程 (WPS) 准备正确的接头型式, 预热和焊接;
 3. 焊前对修补区域进行VT检测保证缺陷完全被消除;
 4. 将修补区域打磨到与母材或邻近焊缝平齐;
 5. 对焊缝进行UT检测, 检测范围为返修区域以及其两端各延长50mm.
-
1. Gouge or grind from nearer side from metal edge ($D \leq 0.65T$, "D" is depth of defects, "T" is thickness of metal) to remove all defects;
 2. Follow repair WPS for joint preparation, preheat, and weld deposit;
 3. Verify with VT no defects remain in the weld joint prior to welding;
 4. Grind the repaired area flush with base metal or the adjacent weld;
 5. Perform UT inspection to the weld along with 50mm on each end of the repair area;

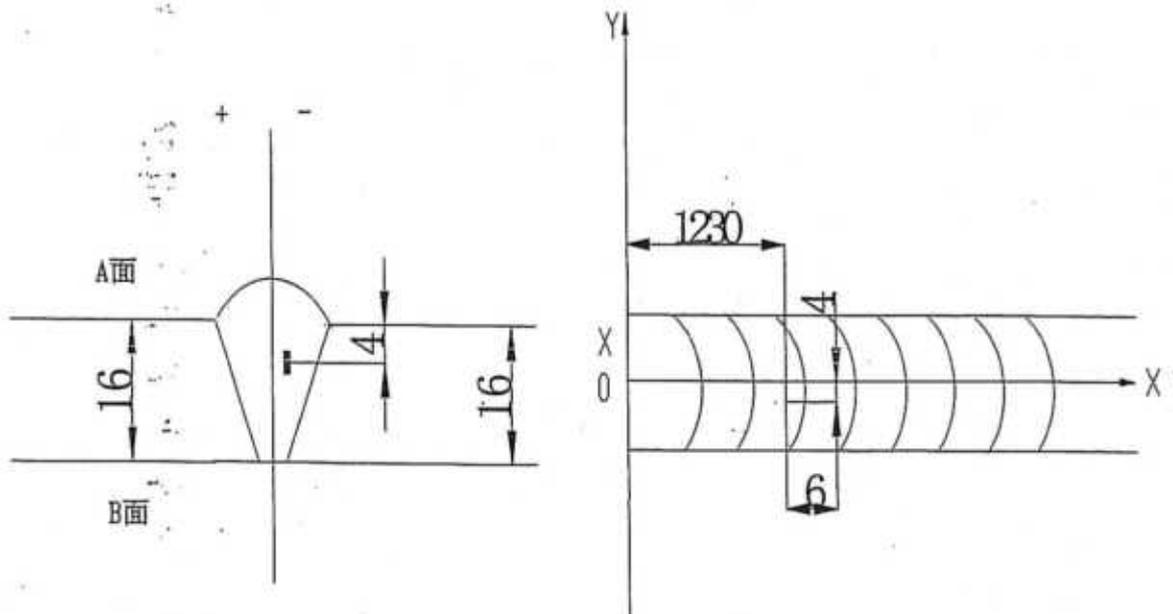
WELD NUMBER: SEG047B-012

-Two (2) class "A" longitudinal linear indications measuring approximately 6mm and 10mm in length. Indication #1 is located in weld identified as SEG047B-012.

-The indication dBs rating is a +10.

-Material thickness is 16mm.

-The depth of the indication is approximately 4mm.

-The weld is a Complete Joint Penetration (CJP) butt joint joining Side Plate SP767A (SPCM) to SP727A (SPCM).

Rejected indication found by ultrasonic inspection is less than the maximum allowance aggregate length.

(UT探伤发现的缺陷总长度小于最大允许长度。) SEG047B-012

1. Gouge or grind from nearer side from metal edge ($D \leq 0.65T$, "D" is depth of defects, "T" is thickness of metal) to remove all defects;

2. Follow repair WPS for joint preparation, preheat, and weld deposit;

3. Verify with VT no defects remain in the weld joint prior to welding;

4. Grind the repaired area flush with base metal or the adjacent weld;

5. Perform UT inspection to the weld along with 50mm on each end of the repair area;
