Contract #: 04-0120F4  
 Cty: SF/ALA Rte: 80 PM: 13.2/13.9  
 File #: 69.25B

## QUALITY ASSURANCE -- NON-CONFORMANCE REPORT

**Report No:** NCR-000576

**Reference Description:** Weld Repair without Engineer's Approval (CWR) and without WPS, Weld OBE5-004, Segments 5AE/5BE

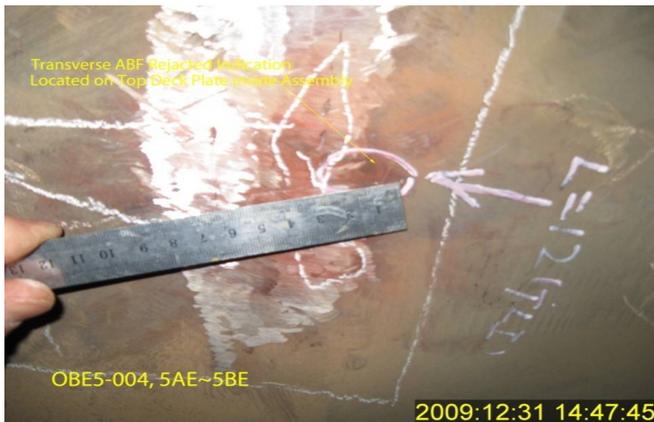
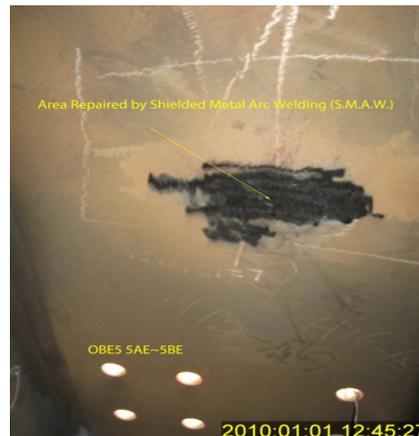
During the Quality Assurance in-process visual inspection of lift 5 East, the QA inspector (QA) discovered the following issues:

- Weld repair was performed without the Engineer's approval.
- No approved welding procedure specification (WPS) was onsite during the welding repair process.
- This weld is identified as: OBE5-004
- Y location is 710mm measured from the Counter Weight side on the interior of the Deck Plate at Panel Point (PP32).
- This is a second time weld repair performed on a Transverse Indication.
- ZPMC discovered this indication utilizing the Magnetic Particle (MT) method.
- Lift 5 East is located in the OGB Trial Assembly Area.

Special Provisions Section 8-3; The Engineer shall be notified in writing when welding problems, deficiencies, base metal repairs, or any other type of repairs not submitted in the WQCP are discovered and also of the proposal repair procedures to correct them.

AWS D1.5-2002 Section 3.7.4; Prior approval of the Engineer shall be obtained for repairs to base metal, repairs of major or delayed cracks.

AWS D1.5-2002 Section 6.3.1; The inspector shall make certain that all WPS's are qualified in conformance with Section 5 of this code The inspector shall make certain that each welding operation is covered by a written WPS and that such WPS's are available to the welders and inspectors for reference.

Submit a repair procedure to the engineer for approval. Notify the engineer prior to starting the repair work. A response for the resolution of this issue is expected within 7 days.

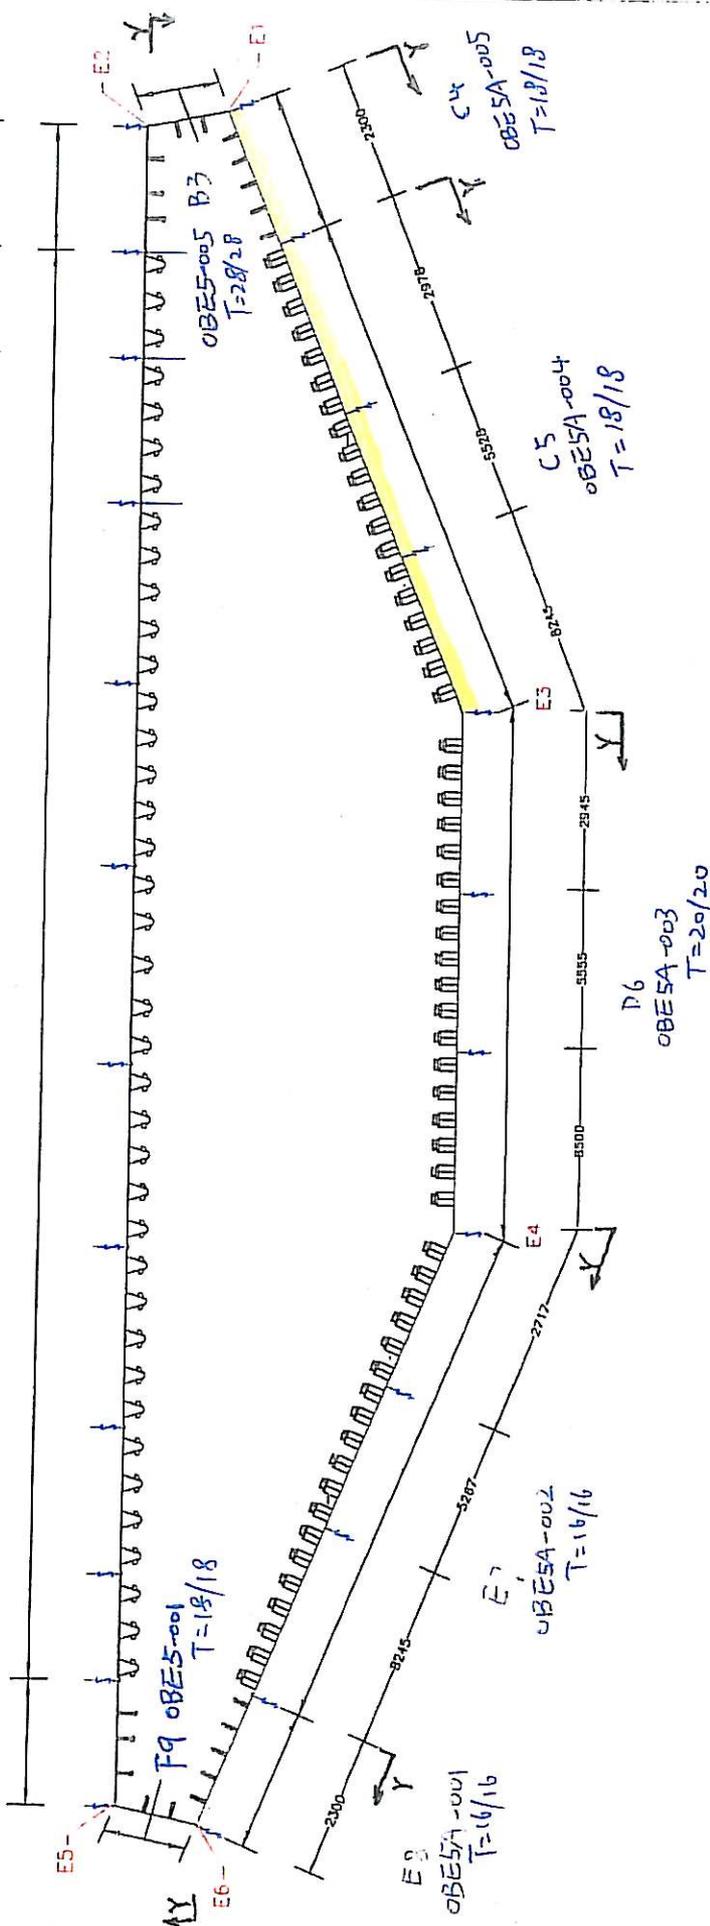
A2 T=20/20  
0BE5-004

Weld No.	Indication No.	Scan Face	Dimensions (mm)				Indication Rating "J"	Evaluation	Inspector	Inspection Date
			"Y" from O Axis	"X"	Length "L"	Depth "D"				
OBES-002 (A10)		outside	/	/	/	/	ACC.	S016, S014	09.12.9	
OBES-003 (A1)			/	/	/	/	↓	S013, S002		
OBES-004 (A2)	1	↓	710	10	30	16.8	+6	LLI, REJ.	S002	
	2	↓	820	10	30	16.1	+8	↓	↓
