Contract #: 04-0120F4  
 Cty: SF/ALA Rte: 80 PM: 13.2/13.9  
 File #: 69.25B

**QUALITY ASSURANCE -- NON-CONFORMANCE REPORT**

**Location:** Changxing Island, Shanghai, P.R. China **Report No:** NCR-000578  
**Prime Contractor:** American Bridge/Fluor Enterprises, a JV **Date:** 01-Jan-2010  
**Submitting Contractor:** Zhenhua Port Machinery Company, Ltd (ZPMC), Changxing Island **NCR #:** ZPMC-0551

**Reference Description:** The performed heat straightening in 6CW closed rib was deviated from the approved HSR procedure

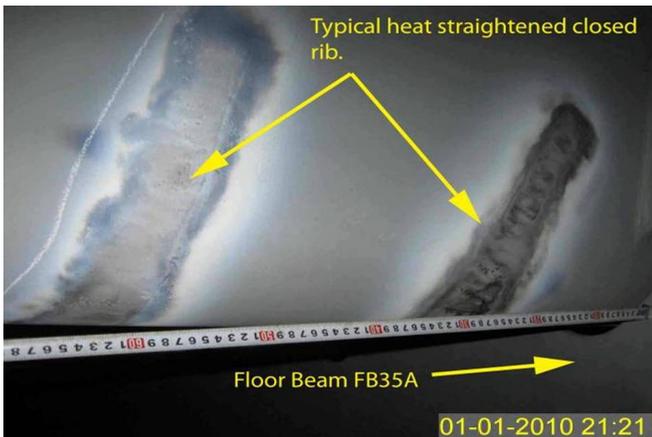
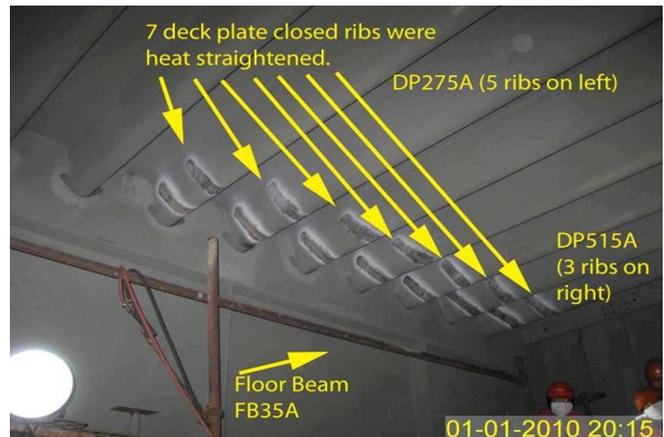
During the Quality Assurance in-process inspection of Closed Ribs being Heat Straightened at OBG segment 6CW, this Quality Assurance Inspector (QA) discovered the following issues:

- Deck Plates (DP) identified as: DP515A and DP275A are located inside segment 6CW.
- Heat Straightening (HS) was performed at two locations on each rib, one at approximately 160mm and the second at 620mm as measured from Floor Beam FB35A located at PP44 (as measured toward PP43).
- A total of seven (7) Closed Ribs were heat straightened. This is a deviation from the approved HSR document of heating the 3 closed ribs at the specified locations.
- Three (3) Closed Ribs were HS on DP515A and four (4) on DP275A.
- ZPMC QC or CWI were not present during the time of the HS process.
- Orthotropic Box Girder (OBG) segment 6CW is located in the Trial Assembly area.

Submit a revised HSR that shows what was actually done.

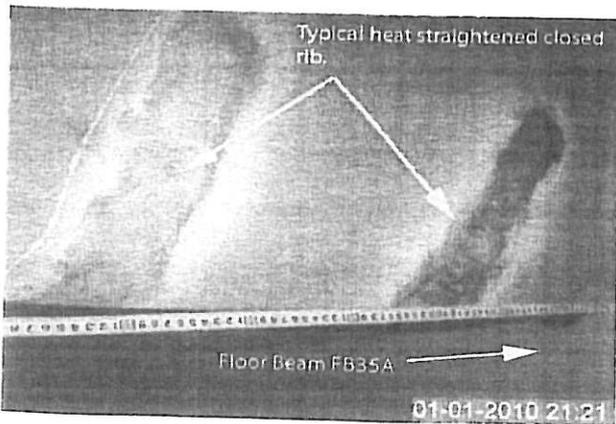
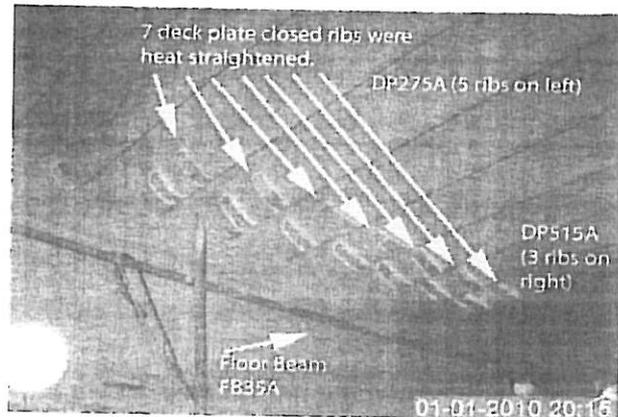
During the Quality Assurance in-process inspection of Closed Ribs being Heat Straightened at OBG segment 6CW, this Quality Assurance Inspector (QA) discovered the following issues:

- Deck Plates (DP) identified as: DP515A and DP275A are located inside segment 6CW.
- Heat Straightening (HS) was performed at two locations on each rib, one at approximately 160mm and the second at 620mm as measured from Floor Beam FB35A located at PP44 (as measured toward PP43).
- A total of seven (7) Closed Ribs were heat straightened. This is a deviation from the approved HSR document of heating the 3 closed ribs at the specified locations.
- Three (3) Closed Ribs were HS on DP515A and four (4) on DP275A.
- ZPMC QC or CWI were not present during the time of the HS process.
- Orthotropic Box Girder (OBG) segment 6CW is located in the Trial Assembly area.

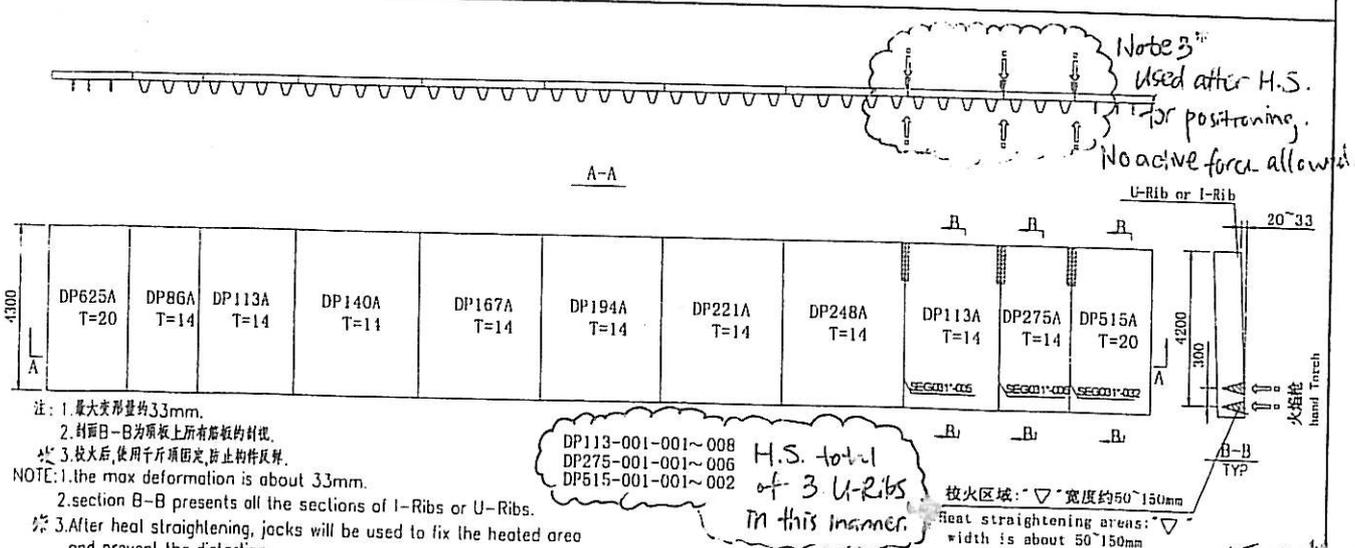
### 简图/Sketch

Cause/原因	Welding distortion 焊接变形
Type of Defect/缺陷类型	Welding distortion 焊接变形
Inspection Method/检查方法	Visual 目检

注: 1. 最大变形量约33mm.  
2. 剖面B-B为原板上所有肋板的剖视.  
3. 校火后,使用千斤顶固定,防止构件反弹.  
NOTE: 1. the max deformation is about 33mm.  
2. section B-B presents all the sections of I-Ribs or U-Ribs.  
3. After heat straightening, jacks will be used to fix the heated area and prevent the distortion.

DP113-001-001~008  
DP275-001-001~006  
DP515-001-001~002  
H.S. total of 3 U-Ribs in this manner.

校火区域: ▽ 宽度约50\*150mm  
Heat straightening areas: ▽ width is about 50\*150mm

缺陷去除方法(Defect Removal Method):  
Using hand torch and Jack, Jack shall be used in a manner such that all forces are applied passively.  
使用火焰枪以及千斤顶进行校火,千斤顶只能起到固定作用不能产生塑性变形。

后续NDE(Post-Removal NDE):  
Jacking shall not be used to plastically deform the flange. The Jack shall only be used as a fixture After finishing heat straightening, the weld of the heat area shall perform NDT according to the approved shop drawing. 不能使用千斤顶进行塑性变形,千斤顶只能用作固定装置,校火后需按照图纸上的要求对热影响区域进行NDT检测。

纠正措施(Corrective Action(s)):  
Increase the flange anti-deformation allowance during the course of fit-up and Control the welding parameters according to associated WPS. 在装配的过程中增加反变形量,根据相关WPS控制焊接参数。

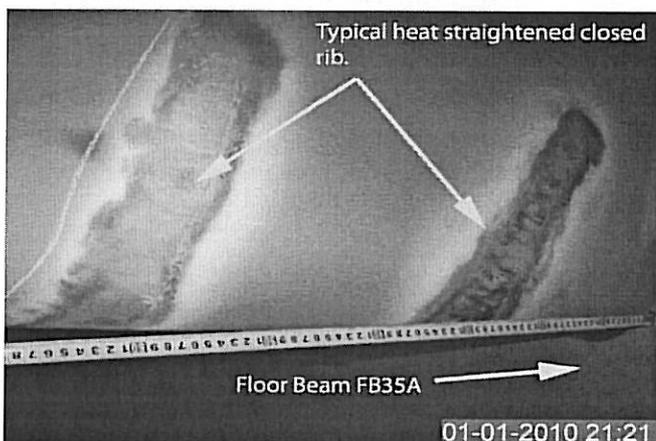
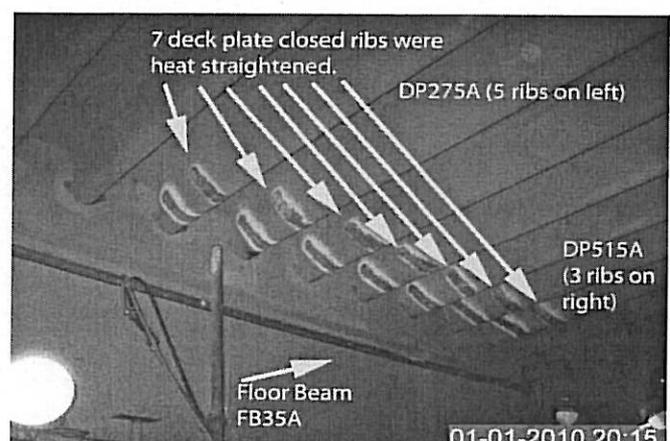
During the Quality Assurance in-process inspection of Closed Ribs being Heat Straightened at OBG segment 6CW, this Quality Assurance Inspector (QA) discovered the following issues:

- Deck Plates (DP) identified as: DP515A and DP275A are located inside segment 6CW.
- Heat Straightening (HS) was performed at two locations on each rib, one at approximately 160mm and the second at 620mm as measured from Floor Beam FB35A located at PP44 (as measured toward PP43).
- A total of seven (7) Closed Ribs were heat straightened. This is a deviation from the approved HSR document of heating the 3 closed ribs at the specified locations.
- Three (3) Closed Ribs were HS on DP515A and four (4) on DP275A.
- ZPMC QC or CWI were not present during the time of the HS process.
- Orthotropic Box Girder (OBG) segment 6CW is located in the Trial Assembly area.

Submit an amended HS plan for the additional 4 closed ribs. Ensure QC is present during the operation. A response for the resolution of this issue is expected within 7 days.

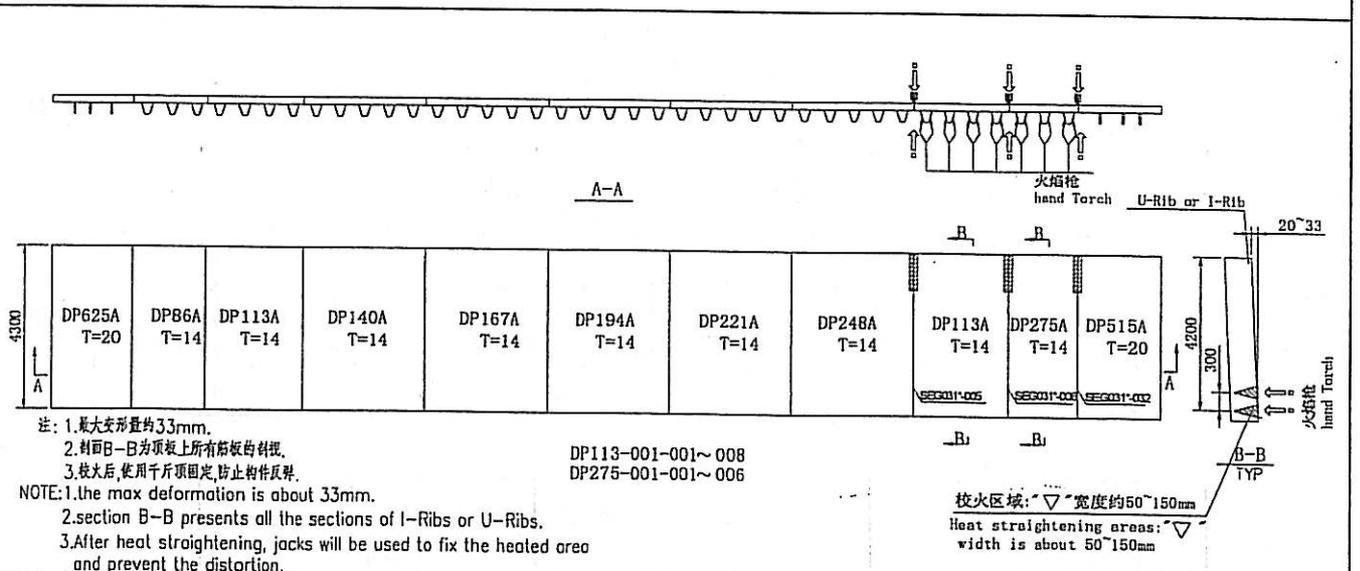
### 简图 Sketch

Cause原因: Welding distortion 焊接变形  
 Type of Defect缺陷类型: Welding distortion 焊接变形  
 Inspection Method检查方法: Visual 目检

Using hand torch and Jack, Jack shall be used in a manner such that all forces are applied passively.  
 使用火焰枪以及千斤顶进行校火,千斤顶只能起到固定作用不能产生塑性变形。

后续NDE(Post-Removal NDE):  
*Jacking shall not be used to plastically deform the flange. The Jack shall only be used as a fixture. After finishing heat straightening, the weld of the heat area shall perform NDT according to the approved shop drawing. 不能使用千斤顶进行塑性变形。千斤顶只能用作固定装置。校火后需按照图纸上的要求对热影响区域进行NDT检测。*

纠正措施(Corrective Action(s)):  
*Increase the flange anti-deformation allowance during the course of fit-up and Control the welding parameters according to associated WPS. 在装配的过程中增加反变形用量。根据相关WPS控制焊接参数。*

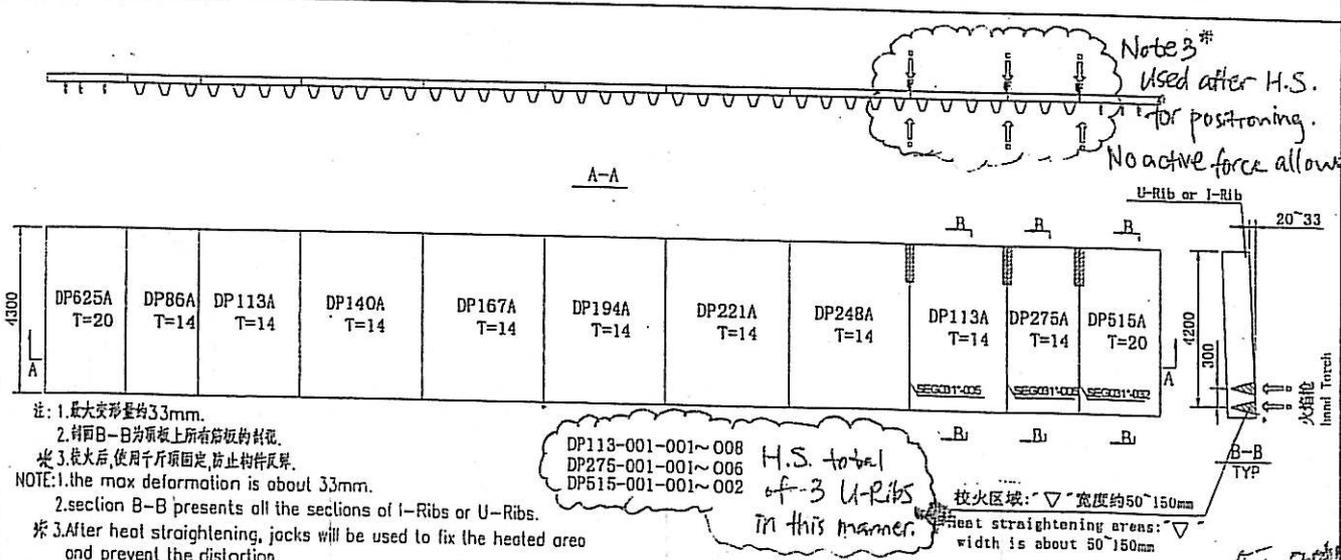
### 简图 Sketch

Cause原因: Welding distortion 焊接变形  
 Type of Defect缺陷类型: Welding distortion 焊接变形

Using hand torch and Jack, Jack shall be used in a manner such that all forces are applied passively.  
 使用火焰枪以及千斤顶进行校火,千斤顶只能起到固定作用不能产生塑性变形。

Jacking shall not be used to plastically deform the flange. The Jack shall only be used as a fixture After finishing heat straightening, the weld of the heat area shall perform NDT according to the approved shop drawing. 不能使用千斤顶进行塑性变形,千斤顶只能用作固定装置。校火后需按照图纸上的要求对热影响区域进行NDT检测。

Increase the flange anti-deformation allowance during the course of fit-up and Control the welding parameters according to associated WPS. 在装配的过程中增加反变形雨量。根据相关WPS控制焊接参数。
