Contract #: 04-0120F4Cty: SF/ALA Rte: 80 PM: 13.2/13.9File #: 69.25B**QUALITY ASSURANCE -- NON-CONFORMANCE REPORT****Location:** Changxing Island, Shanghai, P.R. China**Report No:** NCR-000579**Prime Contractor:** American Bridge/Fluor Enterprises, a JV**Date:** 02-Jan-2010**Submitting Contractor:** Zhenhua Port Machinery Company, Ltd (ZPMC), Changxing Island**NCR #:** ZPMC-0552**Type of problem:**

Reference Description: Joint fit-up offset was observed in Segment 9BW Deck Panel Diaphragm**Description of Non-Conformance:**

Dear: Mr. Charles Kanapicki
Job Name: SAS Superstructure

Subject: NCR No. ZPMC-0552

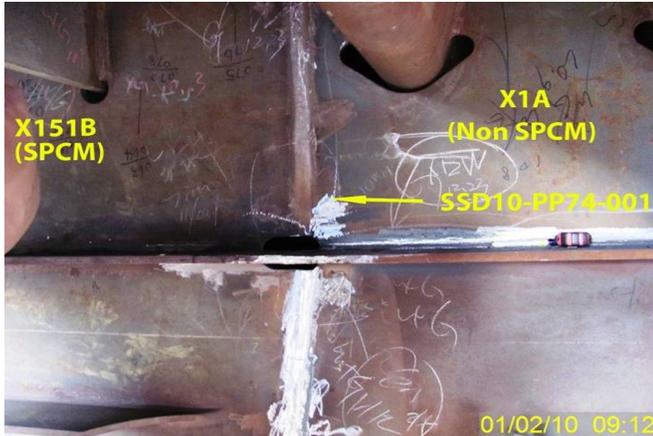
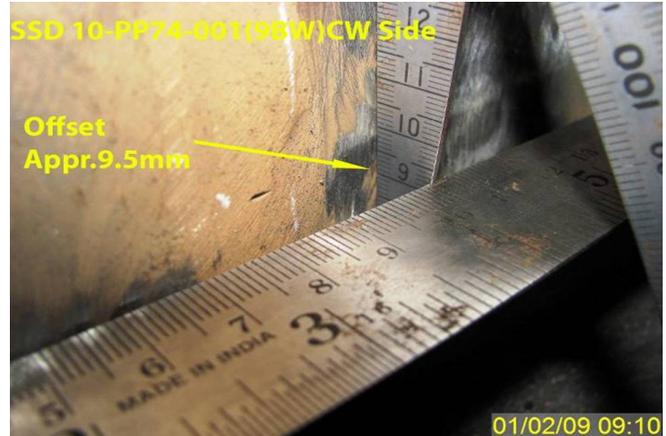
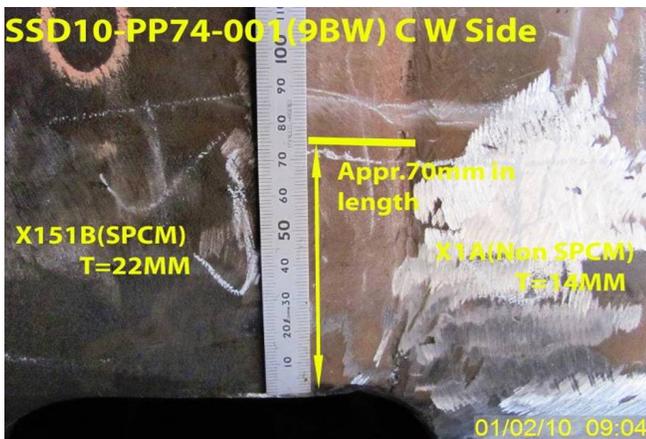
During the Quality Assurance random Visual Inspection of welds located on Orthotropic Box Girder (OBG) segment 9BW, this Quality Assurance Inspector (QA) discovered the following issues.

- One (1) area of misalignment was measured at a transition in thickness Complete Joint Penetration (CJP) butt weld.
- The weld joint is identified as SSD10-PP74-001.
- The weld joint is located in OBG segment 9BW at Panel Point (PP) 074 on the Counter Weight side.
- The Corner Assembly Web (X151B) Seismic Performance Critical Material (SPCM) plate connects to the Deck Panel Diaphragm (X1A).
- The weld joint SSD10-PP74-001 is a transition in thickness from 22mm (X151A) to 14mm (X1A).
- The misalignment/offset was measured at approximately 9.5mm. There should only be an offset of 4mm due to the transition.
- The weld joint is misaligned for 70mm along the axis of the weld.
- The maximum misalignment/offset allowed per American Weld Society (AWS) D1.5 2002 is 1.4mm (10% of the thinner part).
- The OBG Segment 9BW is located outside in front of Bay# 17.

AWS D1.5 (2002) section 3.3.3 "Parts to be joined by groove welds shall be carefully aligned. Where the parts are effectively restrained against bending due to eccentricity in alignment, the offset from theoretical alignment shall not exceed 10 percent of the thickness of the thinner part joined, but in no case shall be more than 3 mm [1/8 in.]".

Submit a repair procedure to the engineer for approval. A response for the resolution of this issue is expected within 7 days.

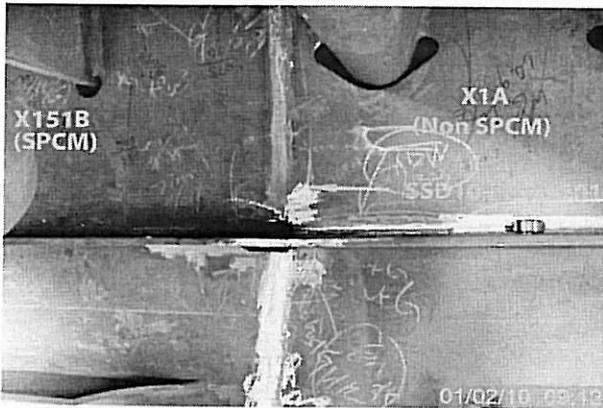
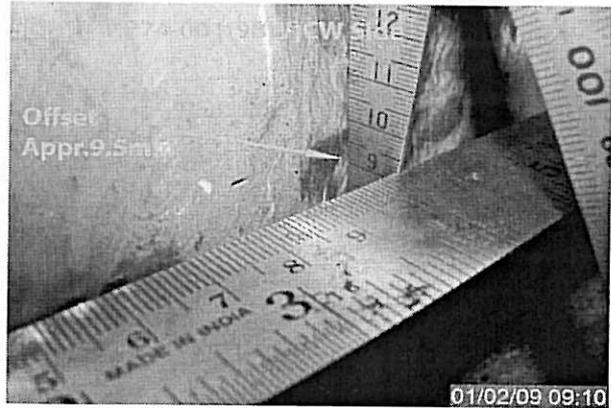
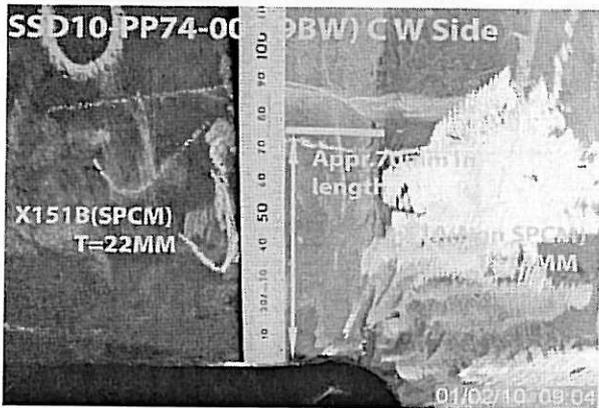
During the Quality Assurance random Visual Inspection of welds located on Orthotropic Box Girder (OBG) segment 9BW, this Quality Assurance Inspector (QA) discovered the following issues.

- One (1) area of misalignment was measured at a transition in thickness Complete Joint Penetration (CJP) butt weld.
- The weld joint is identified as SSD10-PP74-001.
- The weld joint is located in OBG segment 9BW at Panel Point (PP) 074 on the Counter Weight side.
- The Corner Assembly Web (X151B) Seismic Performance Critical Material (SPCM) plate connects to the Deck Panel Diaphragm (X1A).
- The weld joint SSD10-PP74-001 is a transition in thickness from 22mm (X151A) to 14mm (X1A).
- The misalignment/offset was measured at approximately 9.5mm. There should only be an offset of 4mm due to the transition.
- The weld joint is misaligned for 70mm along the axis of the weld.
- The maximum misalignment/offset allowed per American Weld Society (AWS) D1.5 2002 is 1.4mm (10% of the thinner part).
- The OBG Segment 9BW is located outside in front of Bay# 17.

AWS D1.5 (2002) section 3.3.3 "Parts to be joined by groove welds shall be carefully aligned. Where the parts are effectively restrained against bending due to eccentricity in alignment, the offset from theoretical alignment shall not exceed 10 percent of the thickness of the thinner part joined, but in no case shall be more than 3 mm [1/8 in.]".

Submit a repair procedure to the engineer for approval. A response for the resolution of this issue is expected within 7 days.

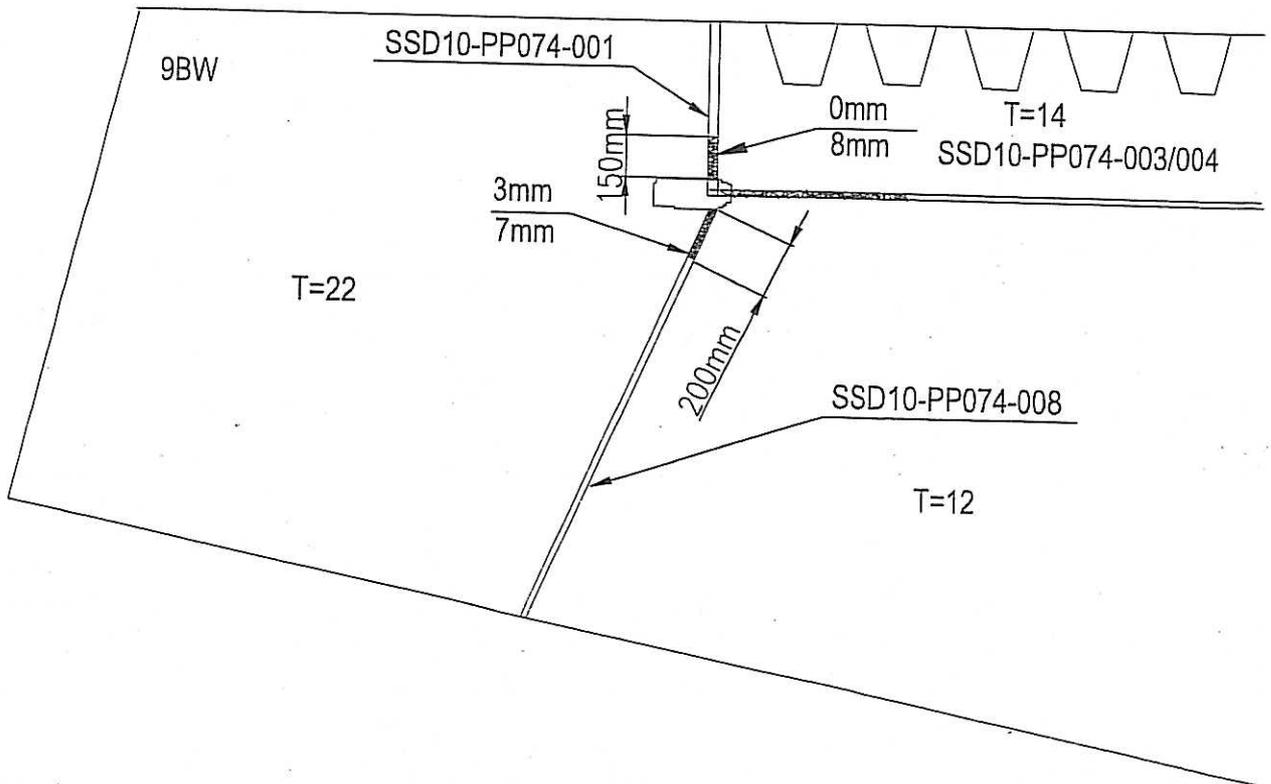
Draft of welding discontinuity:

After inspection corner assembly diaphragm and deck plate connect plate overhand weld, it was 8mm misalignment, 150mm in length, weld ID: SSD10-PP074-001 SSD10-PP074-008, relevant weld ID: SSD10-PP074-003/004.

Weld distortion and fabricate error.

1. Remove a portion from butt weld SSD10-PP074-001(length: L1) and a portion from butt weld SSD10-PP074-008(length: L2), and a portion from fillet weld SSD10-PP074-003/004 and weld in bottom side of flange including near side and far side (namely weld FB011-PP074-003/004) in the same area (length: L3) by flame cutting or gouging. The length L1, L2 and L3 will be decided according to actual situation. Preheat according to the WPS prior to gouging.

2. Prepare the excavations according to the relevant WPS.
3. Adjust diaphragm and FB11B to make the misalignment meet the tolerance by external force. Tack weld the items.

4. Preheat and weld SSD10-PP074-001 and SSD10-PP074-008 according to repair WPS.
5. Check the misalignment after welding, if it is acceptable, preheat and weld SSD10-PP074-003/004 and FB011-PP074-003/004.

6. Grind the welds above flush to the adjacent weld or base metal.
7. Check the weld with relevant NDT according to the work drawings.
