Contract #: 04-0120F4Cty: SF/ALA Rte: 80 PM: 13.2/13.9File #: 69.25B**QUALITY ASSURANCE -- NON-CONFORMANCE REPORT****Location:** Changxing Island, Shanghai, P.R. China**Report No:** NCR-000584**Prime Contractor:** American Bridge/Fluor Enterprises, a JV**Date:** 02-Jan-2010**Submitting Contractor:** Zhenhua Port Machinery Company, Ltd (ZPMC), Changxing Island**NCR #:** ZPMC-0557**Type of problem:****Welding****Concrete****Other****Welding****Curing****Procedural****Bridge No:** 34-0006**Joint fit-up****Coating****Other****Component:** Segment 9BW Deck Plate**Procedural****Procedural****Description:****Reference Description:** Base Metal Repair on Segment 9BW Deck Plate without Engineer's approval**Description of Non-Conformance:**

Job Name: SAS Superstructure

Subject: NCR No. ZPMC-0557

Reference Description: Base Metal Repair on Segment 9BW Deck Plate without Engineer's approval

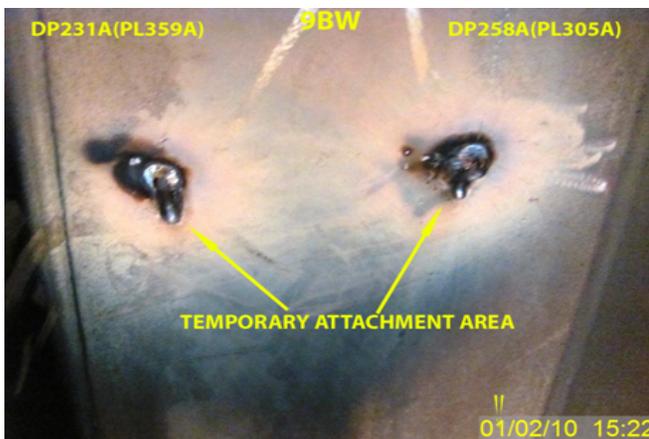
During the Quality Assurance (QA) random in-process visual inspection of Segment 9BW, this QA inspector discovered the following issue:

- Base metal repairs were being performed that were caused by the removal of temporary attachments on two (2) Deck Plates, without the prior approval of the Engineer.
- The Deck Plates are identified as: DP231A (PL359A) and DP258A (PL305A)
- The material is A709M Grade 345 non SPCM:
- OBG Segment 9BW is located in the outside yard north of Bay 17.

Propose a resolution for the identified non-conformance with revised procedures to prevent future occurrences. Notify the engineer prior to performing base metal repair. A response for the resolution of this issue is expected within 14 days.

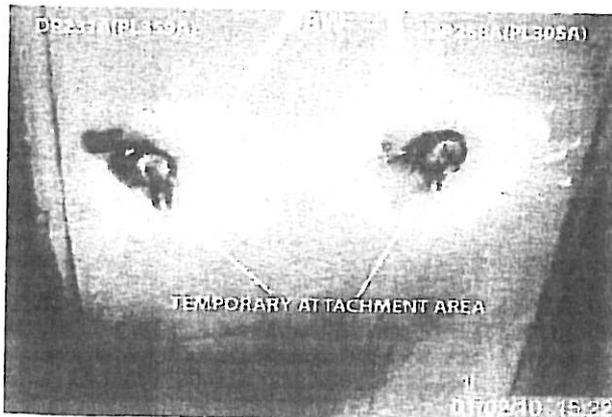
During the Quality Assurance (QA) random in-process visual inspection of Segment 9BW, this QA inspector discovered the following issue:

-Base metal repairs were being performed that were caused by the removal of temporary attachments on two (2) Deck Plates, without the prior approval of the Engineer.

-The Deck Plates are identified as: DP231A (PL359A) and DP258A (PL305A)

-The material is A709M Grade 345 non SPCM:

-OBG Segment 9BW is located in the outside yard north of Bay 17.

Propose a resolution for the identified non-conformance with revised procedures to prevent future occurrences. Notify the engineer prior to performing base metal repair. A response for the resolution of this issue is expected within 14 days.

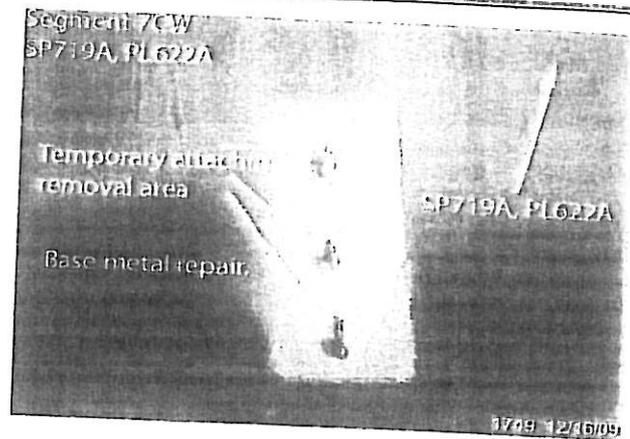
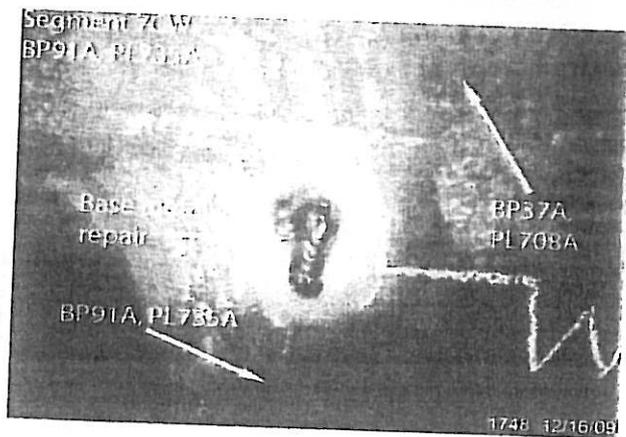
-Base metal repairs being performed in way of temporary attachment removal areas on the bottom and side plates without the prior approval of the engineer.

The plate identifications under repair are identified as:

Submit a repair procedure to the engineer for approval. A response for the resolution of this issue is expected within 7 days.
