Contract #: 04-0120F4
 Cty: SF/ALA Rte: 80 PM: 13.2/13.9
 File #: 69.25B

QUALITY ASSURANCE -- NON-CONFORMANCE REPORT

Report No: NCR-000585

Reference Description: Base Metal Repair on Segment 10AW Deck Panel without Engineer's Approval

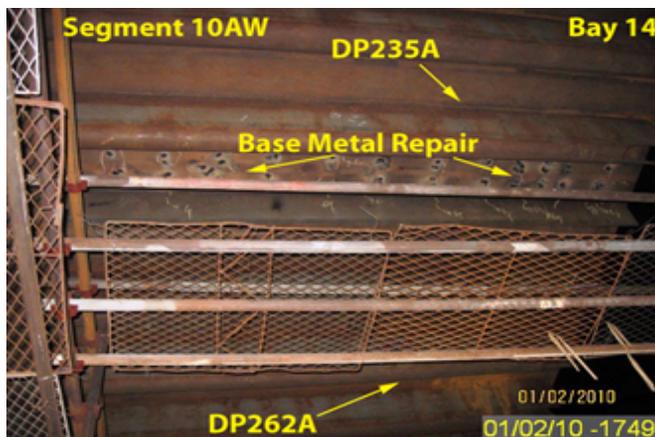
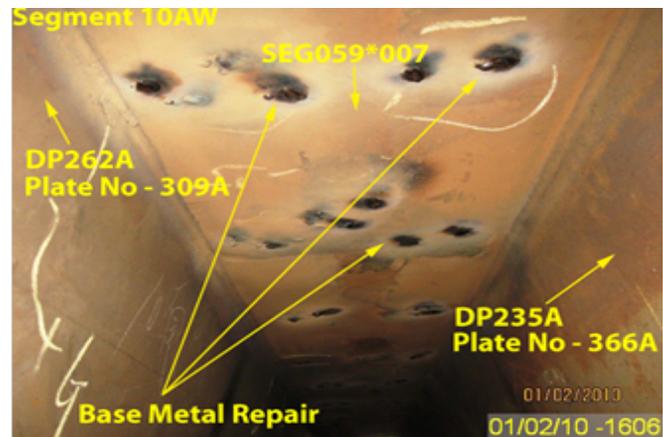
During the Quality Assurance (QA) random in-process visual inspection of Orthotropic Box Girder (OBG) Segment 10AW, this QA inspector discovered the following issue:

-Base metal repairs were being performed that were caused by the removal of temporary attachments on two (2) Deck Plates, without the prior approval of the Engineer.

-The Deck Panels are identified as: DP262A (PL309A) and DP235A (PL366A)

-The weld splice joining Deck Panels DP262A and DP235A are identified as: SEG059*007

-The steel deck material is A709 Grade 345 non SPCM.

Propose a resolution for the identified non-conformance with revised procedures to prevent future occurrences. Notify the engineer prior to starting base metal repair. A response for the resolution of this issue is expected within 7 days.

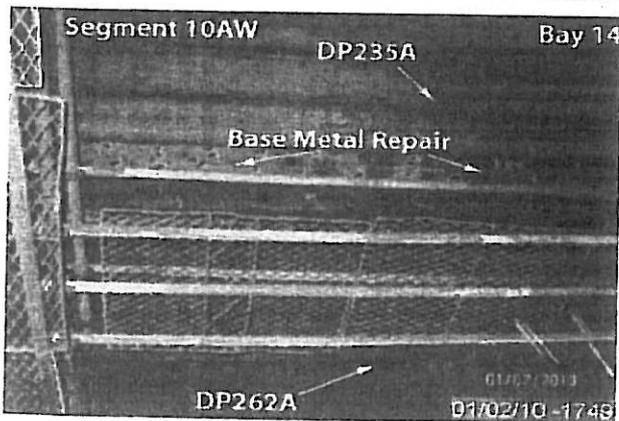
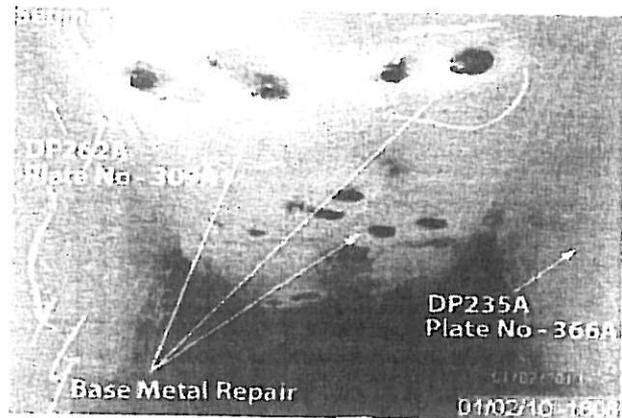
During the Quality Assurance (QA) random in-process visual inspection of Orthotropic Box Girder (OBG) Segment 10AW, this QA inspector discovered the following issue:
 -Base metal repairs were being performed that were caused by the removal of temporary attachments on two (2) Deck Plates, without the prior approval of the Engineer.
 -The Deck Panels are identified as: DP262A (PL309A) and DP235A (PL366A)
 -The weld splice joining Deck Panels DP262A and DP235A are identified as: SEG059*007
 -The steel deck material is A709 Grade 345 non SPCM.

Propose a resolution for the identified non-conformance with revised procedures to prevent future occurrences. Notify the engineer prior to starting base metal repair. A response for the resolution of this issue is expected within 7 days.

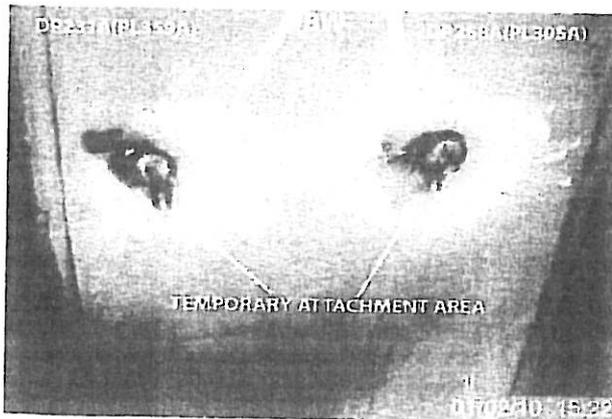
During the Quality Assurance (QA) random in-process visual inspection of Segment 9BW, this QA inspector discovered the following issue:

-Base metal repairs were being performed that were caused by the removal of temporary attachments on two (2) Deck Plates, without the prior approval of the Engineer.

-The Deck Plates are identified as: DP231A (PL359A) and DP258A (PL305A)

-The material is A709M Grade 345 non SPCM:

-OBG Segment 9BW is located in the outside yard north of Bay 17.

Propose a resolution for the identified non-conformance with revised procedures to prevent future occurrences. Notify the engineer prior to performing base metal repair. A response for the resolution of this issue is expected within 14 days.

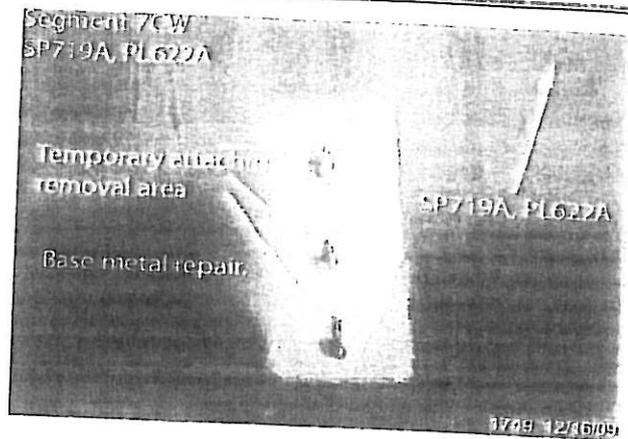
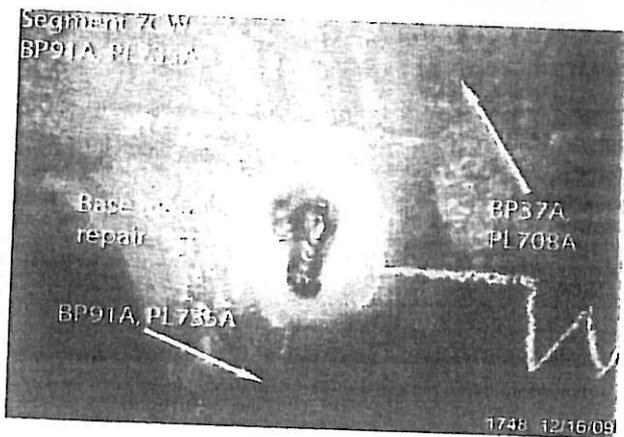
-Base metal repairs being performed in way of temporary attachment removal areas on the bottom and side plates without the prior approval of the engineer.

The plate identifications under repair are identified as:

Submit a repair procedure to the engineer for approval. A response for the resolution of this issue is expected within 7 days.
