Contract #: 04-0120F4
 Cty: SF/ALA Rte: 80 PM: 13.2/13.9
 File #: 69.25B

QUALITY ASSURANCE -- NON-CONFORMANCE REPORT

Report No: NCR-000586

Reference Description: West Tower, Lift 2 to 3, Skin D Interior Splice Plate

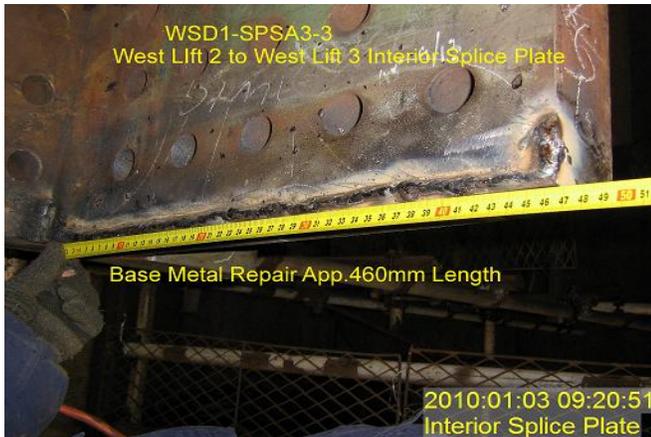
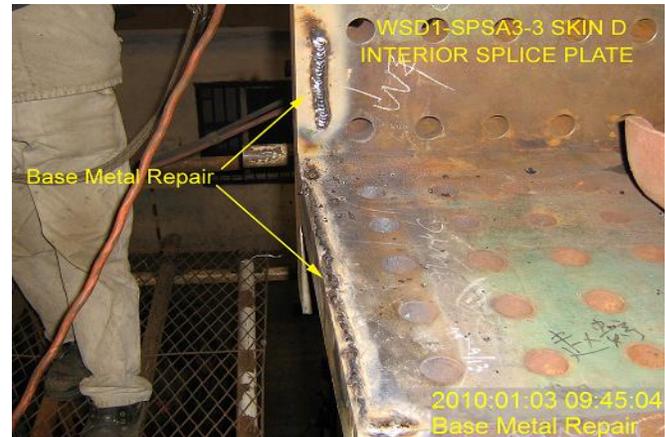
During in-process Visual Testing (VT) of West Tower, Skin D, Interior Splice Plate WSD1-SPSA3-3, QA discovered base metal repairs performed without prior Engineer approval.

AWS D1.5-2002, Section 3.7.4 - "Prior approval of the Engineer shall be obtained for repairs to base metal."

Propose a resolution for the identified non-conformance, documenting that the repaired base metal / welding repair is in compliance with the contract requirements. Documentation provided for the Engineer's review of the acceptability of the weld repair shall at a minimum include the procedure utilized/WRR and the NDT results.

Documentation for the base metal repair and NDT verification was provided (T-WR2904, T787-UT-2617 and T787-MT-7841). The ABF QCM informed ZPMC QA of the CWR requirements pertaining to base metal repairs.

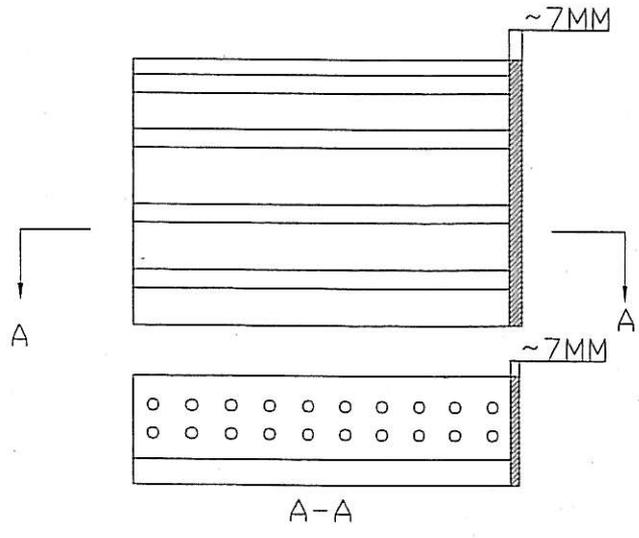
Draft of welding discontinuity:

西二三吊栓接段内部连接板SPSA3-3端部孔边距与工艺要求不符，需要进行堆焊约7MM，如图：
After inspection west tower 2nd 3rd lifting bolt segment connect plate SA3-3 hole distance, it can't meet technology requirement, it needed to build up 7mm, see draft.

注：阴影处为需修补区域。Remark: repair area in shadow.

Weld distortion and fabricate error.

1. QC shall monitor gouging/grinding/welding
2. Grind the building-up area
3. Verify that defects have been removed with VT
4. Preheat and weld passes temperature according to the approved WPS, it should be 2-3mm than the theory size
5. Grind the weld area smoothly after repairin
6. Perform VT, MT, & UT to repaired area.

Enhance supervision in process of fabrication to reduce error.
