QUALITY ASSURANCE -- NON-CONFORMANCE REPORT

Location: Changxing Island, Shanghai, P.R. China**Report No:** NCR-000592**Prime Contractor:** American Bridge/Fluor Enterprises, a JV**Date:** 04-Jan-2010**Submitting Contractor:** Zhenhua Port Machinery Company, Ltd (ZPMC), Changxing Island**NCR #:** ZPMC-0565**Type of problem:**

Reference Description: Critical Weld Repair Performed without Engineer's Approval, Segment 5BE**Description of Non-Conformance:**

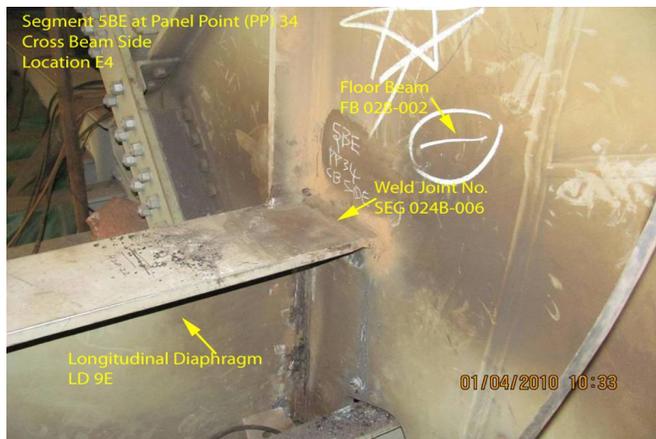
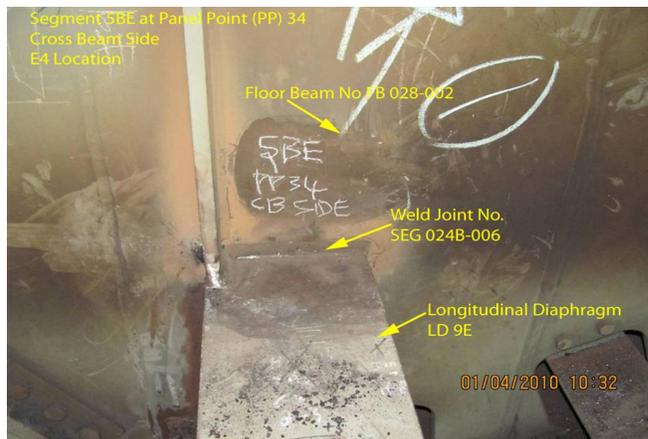
- A critical weld repair being performed without the Engineers approval.
- The weld is a Complete Joint Penetration (CJP) T-joint identified as SEG024B-006 @ Panel Point 034.
- The weld is designated as Seismic Performance Critical Material (SPCM).
- The weld is joining longitudinal diaphragm, LD 9E, top flange identified as X44AE to floor beam, FB028-002, web identified as X94H (SPCM).

- The weld thickness is 25mm.
- The weld was excavated to a depth of approximately 25mm.
- The maximum depth of a non-critical weld repair shall not exceed 65% of the weld thickness.
- OBG Segment 5BE is located in the OBG trial assembly area.

ZPMC acknowledges that this repair required Engineer approval and has issued an internal NCR to notify the Production department to prevent future occurrences of unapproved repairs. The repair is complete and has been removed from the punchlist, attached is documentation showing that the weld is acceptable. Based on this ZPMC requests closure of this NCR.

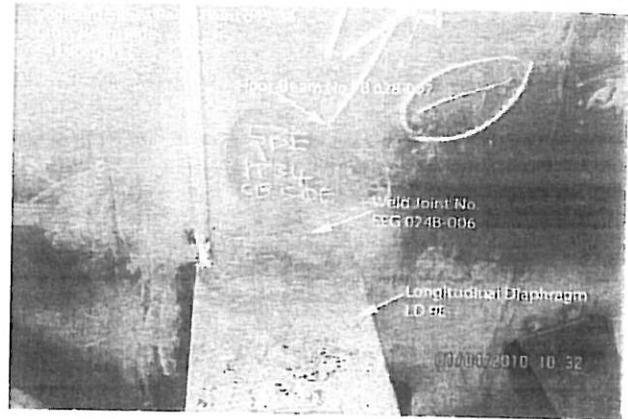
-The weld is a Complete Joint Penetration (CJP) T-joint identified as SEG024B-006 @ Panel Point 034.

-The weld was excavated to a depth of approximately 25mm.

Contractor repaired weld defects and submitted subsequent NDT documentation verifying the weld is in conformance with Contract specifications.
