DEPARTMENT OF TRANSPORTATION

Contract #: 04-0120F4Cty: SF/ALA Rte: 80 PM: 13.2/13.9File #: 69.25B**QUALITY ASSURANCE -- NON-CONFORMANCE REPORT****Location:** Changxing Island, Shanghai, P.R. China**Report No:** NCR-000594**Prime Contractor:** American Bridge/Fluor Enterprises, a JV**Date:** 04-Jan-2010**Submitting Contractor:** Zhenhua Port Machinery Company, Ltd (ZPMC), Changxing Island**NCR #:** ZPMC-0567**Type of problem:**

Reference Description: Missed UT Indication by QC in Crossbeam 16 Deck Plate to Side Plate Joint**Description of Non-Conformance:**

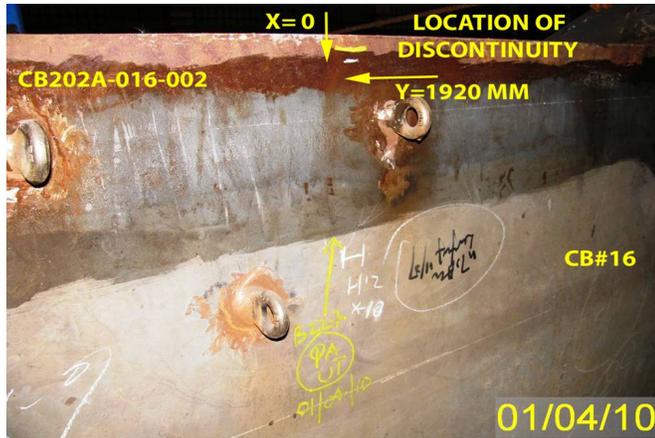
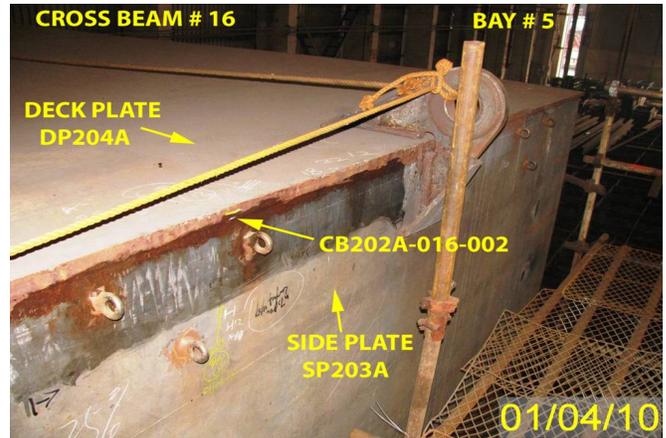
During random 10% verification Ultrasonic Testing (UT) of OBG Crossbeam 16, this Quality Assurance Inspector (QA) discovered the following issue:

One (1) Class "A" non conforming longitudinal indication measuring approximately 30 mm in length.

-The weld is a complete joint penetration (CJP) corner joint, joining Side Plate SP203A to Deck Plate DP204A and is identified as CB202A-016-002.

-The discontinuity rating is +3, Class "A" reject

-Depth of the discontinuity from face A is approximately 13 mm, and Y location was 1920mm when measured from the north end of the crossbeam.

-The Material thickness is 18 mm.

-The indication is in an area previously tested and accepted by ZPMC QC UT technicians.

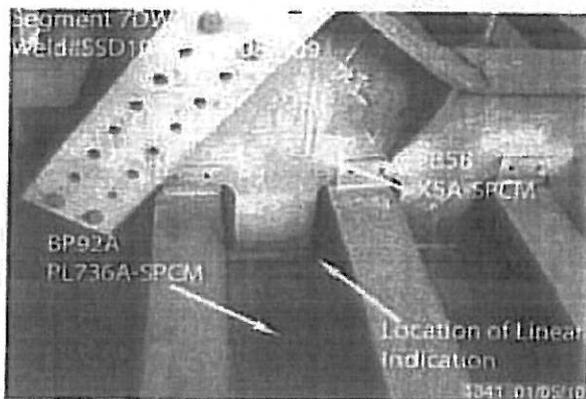
在对 7DW 进行 MT 随机检验时, 加州检验员发现以下问题:
一条纵向线性缺陷长度将近 20mm。
该焊缝是: SSD10-PP56-108,109
这条焊缝是角焊缝连接底板 (BP92A) 至隔板 (FB5B) 腹板。
这些焊缝被认为是在 SPCM 板上。
预约单编号是 004993. 这些缺陷之前已经被 ZPMC MT 人员所检验并接收。

-The OBG segment 7DW is located outside in the Trial Assembly area.

The Notice of Witness Inspection Number (NWIT) is 004993. The indication is located inside the area that has been previously tested and accepted by ZPMC Quality Control (QC) personnel. ZPMC's QC personnel are required to perform twenty five (25%) percent MT inspection of this weld.

Propose a resolution for the identified non-conformance with revised procedures to prevent future occurrences. Provide the training and equipment required for the ZPMC MT technician such that these indications are found. A response for the resolution of this issue is expected within 7 days.
