Contract #: 04-0120F4
 Cty: SF/ALA Rte: 80 PM: 13.2/13.9
 File #: 69.25B

QUALITY ASSURANCE -- NON-CONFORMANCE REPORT

Report No: NCR-000595

Reference Description: Inadequate preheat on South Tower, Lift 2, Skin C Temporary Lifting Eye

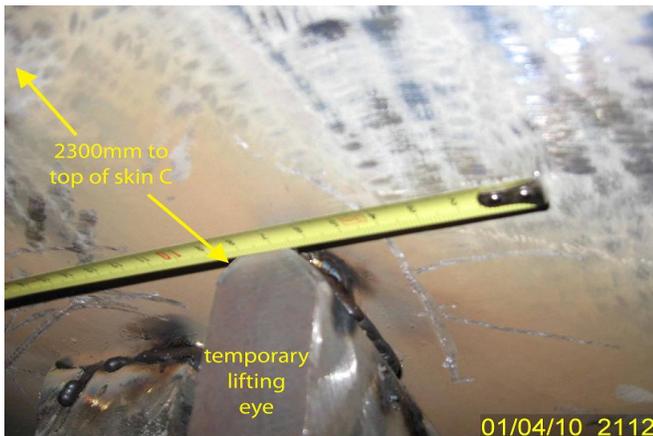
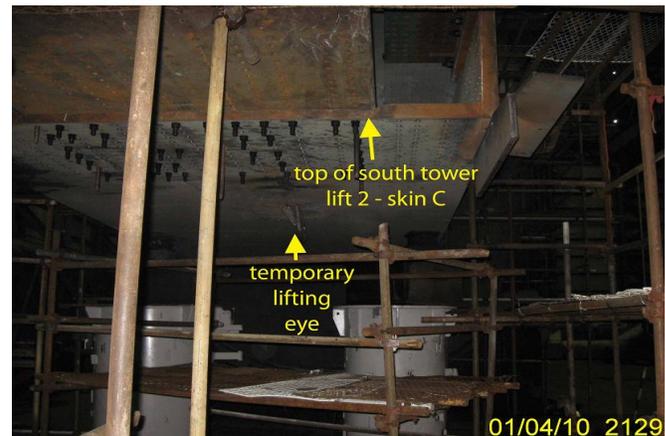
During in-process Visual Testing (VT) of South Tower, Lift 2, Skin C, QA observed ZPMC personnel performing Shielded Metal Arc Welding (SMAW) of partial joint penetration weld attaching a temporary lifting eye plate without sufficient base material preheat. A 110 degree Celsius Tempilstik temperature indicator mark applied to the adjacent base material within approximately 30mm from the point of welding did not melt.

Welding Procedure Specification WPS-B-T-2314-TC-P5, designated as the applicable WPS by ZPMC QC, requires a minimum preheat temperature of 110° Celsius.

AWS D1.5-2002, Section 4.2.7 requires the base metal material to be at or above the specified minimum temperature for a distance not less than 75mm in all directions from the point of welding.

Propose a resolution for this systematic non-conformance including documentation that the welds placed are in compliance with the contract requirements. In addition to addressing Production’s failure to perform the required preheat of the material, address the failure of Quality Control to identify the inadequate preheat. Provide documentation of the steps/actions taken by Production and Quality Control to prevent future occurrences. Also detail what steps/actions are being taken by ABFJV to address the quality control failures of ABFJV’s fabricator/ZPMC.

ZPMC is providing NDT documentation of the temporary weld to show that it is acceptable. In this specific case, ZPMC has discussed the importance of applying the same preheating requirements to temporary attachments as permanent welds with the production foreman. The production foreman has acknowledged that the area should have been preheated prior to welding. ABFJV has discussed this with ZPMC and in the future ZPMC will have a welding repair report for repairs of temporary attachments so that the parameters of the weld are clear to the production and QC personnel. Based on these actions and the NDT documentation, ZPMC requests closure of the NCR.

Documentation for MT verification of the temporary weld was provided (T787-MT-7883). ZPMC will submit WRRs for future repairs of temporary welds.

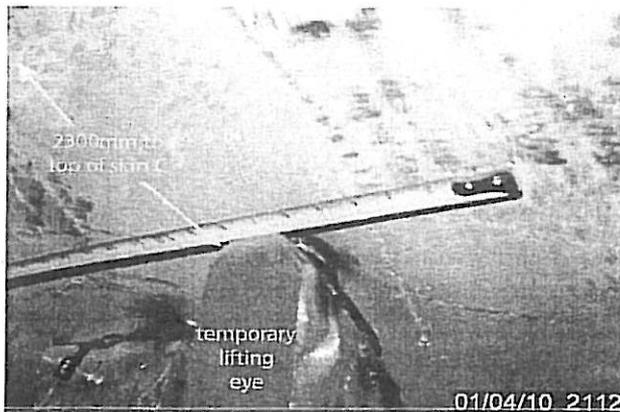
During in-process Visual Testing (VT) of South Tower, Lift 2, Skin C, QA observed ZPMC personnel performing Shielded Metal Arc Welding (SMAW) of partial joint penetration weld attaching a temporary lifting eye plate without sufficient base material preheat. A 110 degree Celsius Tempilstik temperature indicator mark applied to the adjacent base material within approximately 30mm from the point of welding did not melt.

Welding Procedure Specification WPS-B-T-2314-TC-P5, designated as the applicable WPS by ZPMC QC, requires a minimum preheat temperature of 110° Celsius.

AWS D1.5-2002, Section 4.2.7 requires the base metal material to be at or above the specified minimum temperature for a distance not less than 75mm in all directions from the point of welding.

Verify welds are acceptable, incorporate temporary welds into the scope of WRR documentation so that welding parameters are clear to production and QC staff.
