QUALITY ASSURANCE -- NON-CONFORMANCE REPORT

Report No: NCR-000596

NCR #: ZPMC-0569

Welding	Concrete	Other	
Welding	Curing	Procedural	Bridge No: 34-0006
Joint fit-up	Coating	Other	Component: Cross beam 14 Floorbeam
Procedural	Procedural	Description:

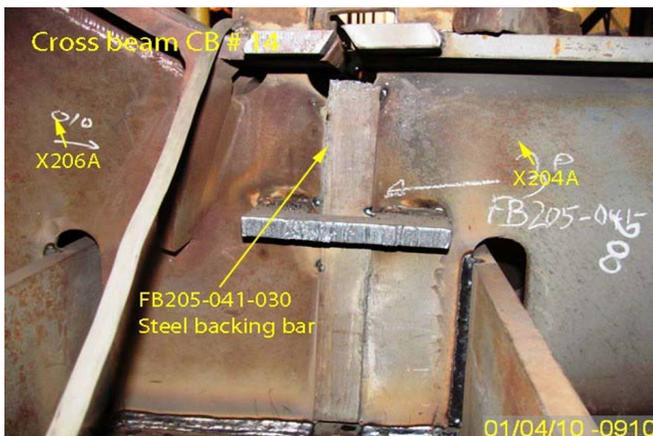
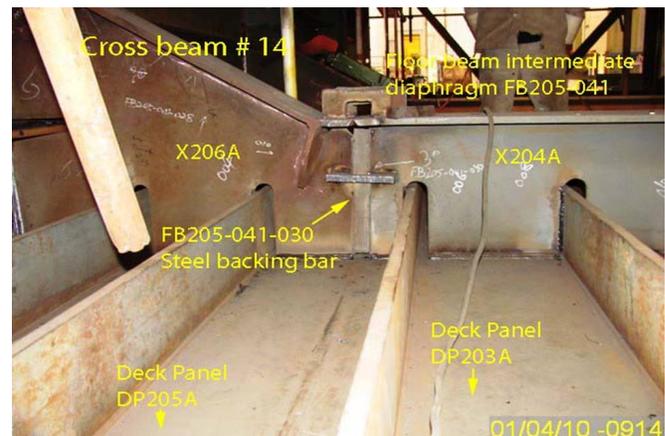
During the Quality Assurance (QA) random in-process visual inspection of Orthotropic Box Girder (OBG) Crossbeam CB14, this QA inspector discovered the following issue:

- The fabrication has deviated from the weld joint design specified on the approved drawings.
- The specified weld detail, WD60M, does not indicate the use of steel backing.
- Steel backing bar was added without approval of the Engineer.
- The measured root openings for these joints are between 7mm and 15mm.
- The WPS used for welding specified a maximum root gap of 6mm + 2mm.
- The weld joints affected are identified as: FB205-042-029, FB205-042-030, FB205-041-029, FB205-043-029, FB205-043-030, FB205-044-029, FB205-044-030, FB204-042-054, FB204-042-088, FB204-042-058, FB204-042-049, FB204-043-087, FB204-043-054, FB204-043-088, FB204-044-054, FB204-044-088, FB204-044-053, and FB204-044-087.
- The material is A709 Grade 345 Non Seismic Performance Critical Member (Non SPCM).
- OBG Cross beam CB14 is located in the Bay 3.-OBG Cross beam CB14 is located in the Bay 3.

AWS D1.5/2002, Section 3.7.4: "Prior approval of the Engineer shall be obtained for repairs to base metal (other than those required by 3.2), repair of major or delayed cracks, repairs to ESW and EGW welds with internal defects, or for a revised design to compensate for deficiencies".

Approved Show Drawings WD60M: CJP with no steel backing

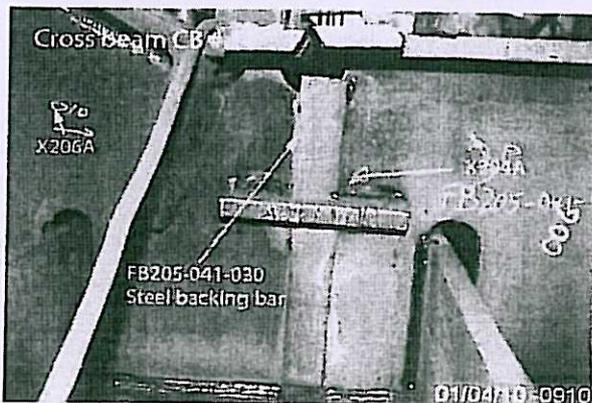
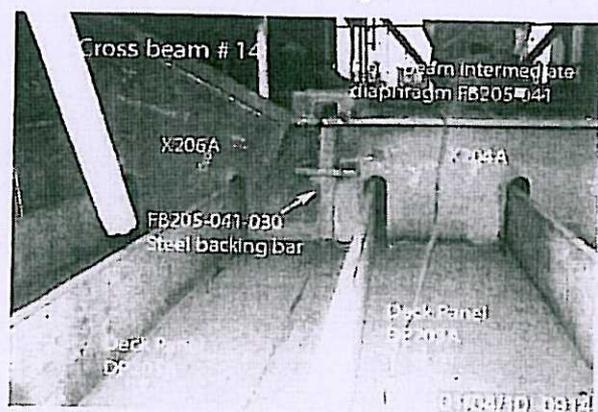
During the Quality Assurance (QA) random in-process visual inspection of Orthotropic Box Girder (OBG) Crossbeam CB14, this QA inspector discovered the following issue:

- The fabrication has deviated from the weld joint design specified on the approved drawings.
- The specified weld detail, WD60M, does not indicate the use of steel backing.
- Steel backing bar was added without approval of the Engineer.
- The measured root openings for these joints are between 7mm and 15mm.
- The WPS used for welding specified a maximum root gap of 6mm + 2mm.
- The weld joints affected are identified as: FB205-042-029, FB205-042-030, FB205-041-029, FB205-043-029, FB205-043-030, FB205-044-029, FB205-044-030, FB204-042-054, FB204-042-088, FB204-042-058, FB204-042-049, FB204-043-087, FB204-043-054, FB204-043-088, FB204-044-054, FB204-044-088, FB204-044-053, and FB204-044-087.
- The material is A709 Grade 345 Non Seismic Performance Critical Member (Non SPCM).
- OBG Cross beam CB14 is located in the Bay 3.-OBG Cross beam CB14 is located in the Bay 3.

AWS D1.5/2002, Section 3.7.4: "Prior approval of the Engineer shall be obtained for repairs to base metal (other than those required by 3.2), repair of major or delayed cracks, repairs to ESW and EGW welds with internal defects, or for a revised design to compensate for deficiencies".

Approved Show Drawings WD60M: CJP with no steel backing

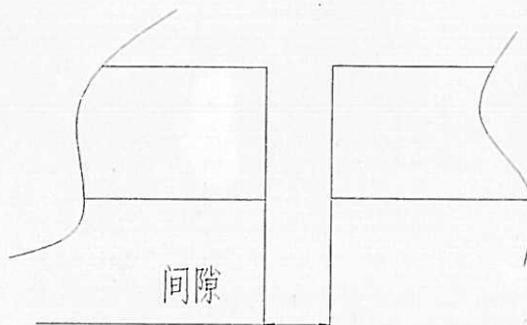
Draft of welding discontinuity:

Butt weld gap exceeded requirement during assembly CB14, the relevant size:

Relevant weld 涉及焊缝	Gap 间隙mm	Relevant weld 涉及焊缝	Gap 间隙mm	Relevant weld 涉及焊缝	Gap 间隙mm
FB204-042-054	12	FB204-043-087	9	FB204-044-054	10
FB204-042-088	6	FB204-043-054	11.5	FB204-044-088	8
FB204-042-058	11	FB204-043-088	10.5	FB204-044-053	10
FB204-042-049	8			FB204-044-087	11
FB205-042-029	9	FB205-043-029	11	FB205-044-029	15
FB205-042-030	7	FB205-043-030	13	FB205-044-030	15
FB205-041-029	9

Weld distortion and fabricate error.

1. Grind the edge of the repair area cleanly
2. Prepare an right joint according to the approved WPS;
3. Perform 100%VT and 100%MT, and add steel backing according to the attached drawing 1;
4. Preheat and weld according to the relevant WPS;
5. Gouge off the steel backing and grind the weld flush with base metal after welding;
6. Perform NDT inspection(VT, MT and UT) of the weld according to the working drawings.
