Contract #: 04-0120F4
 Cty: SF/ALA Rte: 80 PM: 13.2/13.9
 File #: 69.25B

QUALITY ASSURANCE -- NON-CONFORMANCE REPORT

Report No: NCR-000597

Reference Description: ZPMC performed base metal repairs without the Engineer's approval in Segment 6AW Deck Plate

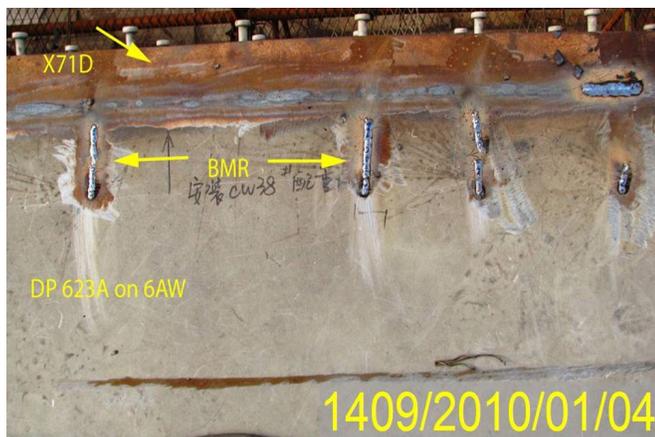
During the Quality Assurance (QA) random in-process visual inspection of the OBG segments in the Trial Assembly area, this QA inspector discovered the following issue:

- Base metal repairs (BMR) were being performed that were discovered from the removal of temporary attachments on a Deck Plate, without the prior approval of the Engineer.
- There are a total of 22 locations of these base metal repairs.
- The approximate length of the BMR is random. They are running adjacent to the X71D Counter Weight attachment plate.
- The Counterweight side of Deck Plate is identified as: DP623A
- The Counterweight attachment plate is identified as X71D.
- The material is A709M Grade 345 non SPCM.
- Deck Plate is located on top of Segment 6AW in the Trial Assembly area.

CT/ABF and ZPMC have established a procedure in which non-SPCM temporary attachment removal base metal repairs are performed in accordance with procedure TA100 supplemented with a WRR that contains a pre-established weld repair disposition as agreed to by CT, ABF and ZPMC. The WRR will reference the location and number of areas to be weld repaired. The QA inspector will be notified prior to weld repairs for the purposes of performing QA verification if of the areas prepared for welding. The QA inspector will also be notified when the finished weld repair has been accepted by ZPMC and ABF for QA verification. The WRR and applicable weld procedure must be available on site during the welding operation.
