Contract #: 04-0120F4Cty: SF/ALA Rte: 80 PM: 13.2/13.9File #: 69.25B**QUALITY ASSURANCE -- NON-CONFORMANCE REPORT****Location:** Changxing Island, Shanghai, P.R. China**Report No:** NCR-000598**Prime Contractor:** American Bridge/Fluor Enterprises, a JV**Date:** 05-Jan-2010**Submitting Contractor:** Zhenhua Port Machinery Company, Ltd (ZPMC), Changxing Island**NCR #:** ZPMC-0571**Type of problem:**

**Bridge No:** 34-0006**Component:** Cross beam CB12 Side Panel

**Reference Description:** ZPMC performed base metal repairs on Cross Beam 12 Side Panel without the Engineer's approval

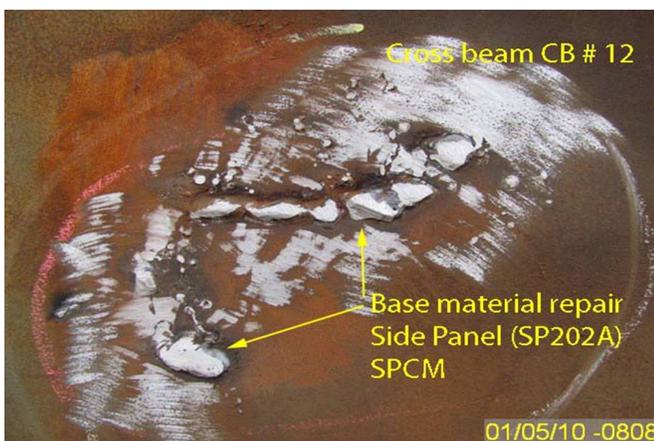
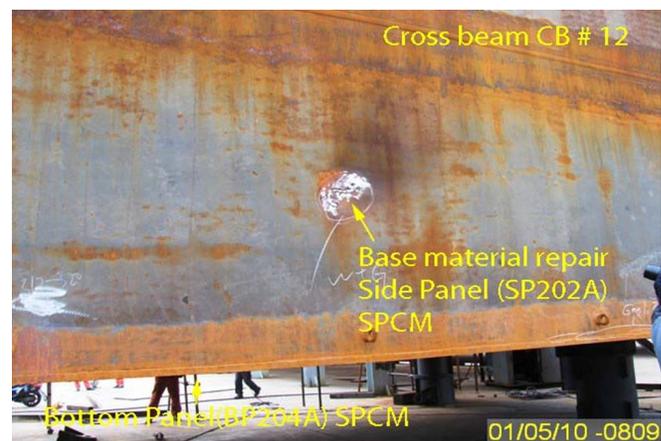
During the Quality Assurance (QA) random in-process visual inspection of OBG Crossbeam CB12, this QA inspector discovered the following issue:

-Base metal repairs being performed in way of Mechanical damage areas on the Side Panel without prior approval of the engineer.

-The Side panel identifications under repair is identified as Side Panel (SP202A).

-The material is A709 Grade 345 Seismic Performance Critical Member (SPCM).

OBG Cross beam CB12 is located in the open yard west side of Bay 19.

Propose a resolution for the identified non-conformance with revised procedures to prevent future occurrences. Do not perform base metal repairs with out notifying the engineer prior to starting the work. A response for the resolution of this issue is expected within 7 days.

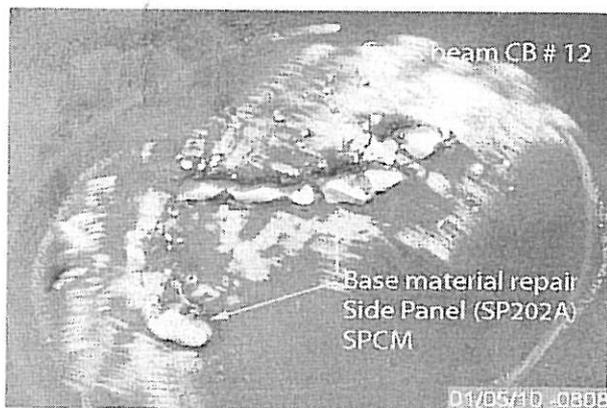
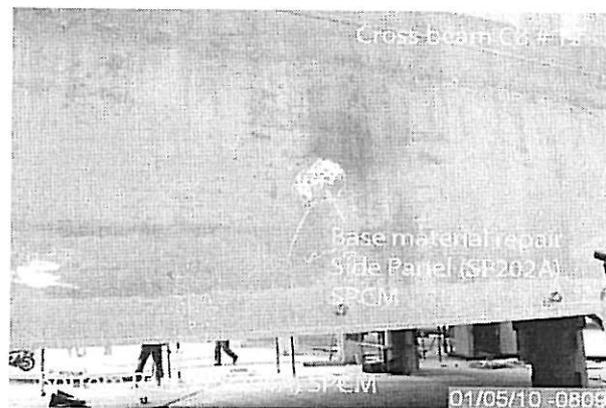
During the Quality Assurance (QA) random in-process visual inspection of OBG Crossbeam CB12, this QA inspector discovered the following issue:

-Base metal repairs being performed in way of Mechanical damage areas on the Side Panel without prior approval of the engineer.

-The Side panel identifications under repair is identified as Side Panel (SP202A).

-The material is A709 Grade 345 Seismic Performance Critical Member (SPCM).

OBG Cross beam CB12 is located in the open yard west side of Bay 19.

Perform NDT required to verify weld quality and reiterate the importance of obtaining Engineer's approval prior to performing base metal repairs on SPCM members.

Contractor submitted WRR used to perform repairs along with subsequent NDT documentation verifying the welds are in conformance with Contract requirements.

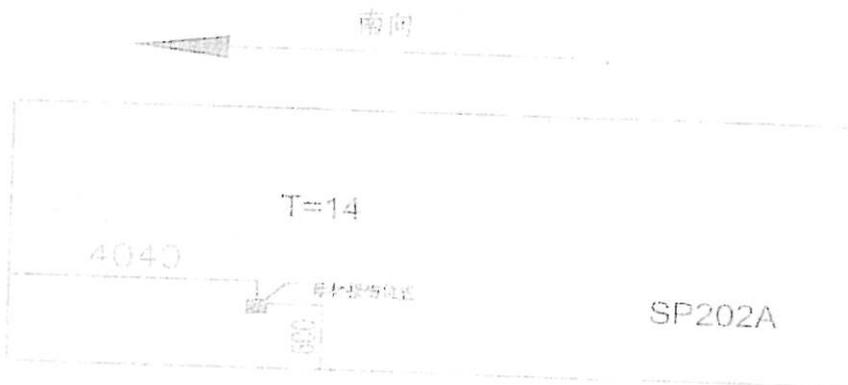
#### Draft of Welding Discontinuity:

CB12 fabricated by work team: Liu Zhenjie, the base metal was gouged at east edge plate SP202A (SPCM), 3mm in depth, the detail sees the following draft.

Worker operated error caused base metal gouged.

1. QC and CWI should be present to witness the repair, direct and supervise all repair operations during the repair to ensure the repair is per the disposition requirements, and the AWS D1.5 code requirements.
2. Grind the repair area to a smooth finish according to the approved repair WPS.
3. Prepare the joint according to the approved WPS.
4. Notify QA verbally prior to NDT. Perform 100%MT and 100%VT of the repair area.
5. Remove all defects by grinding to ensure all defects are completely removed if defects still exist, and repeat "step 4" to assure complete removal of all defects if necessary.
6. Clean the repair area of all loose debris including MT powder.
7. Preheat and weld according to the approved WPS.
8. Grind the weld flush after welding.
9. Notify QA verbally prior NDT. Perform 100%MT and 100%VT of the repair area.

Train and educate operator to improve operation skill
