Contract #: 04-0120F4
 Cty: SF/ALA Rte: 80 PM: 13.2/13.9
 File #: 69.25B

QUALITY ASSURANCE -- NON-CONFORMANCE REPORT

Report No: NCR-000599

Reference Description: ZPMC performed weld repair on 3 Transverse Indications without the Engineer's approval in Segment 5BE

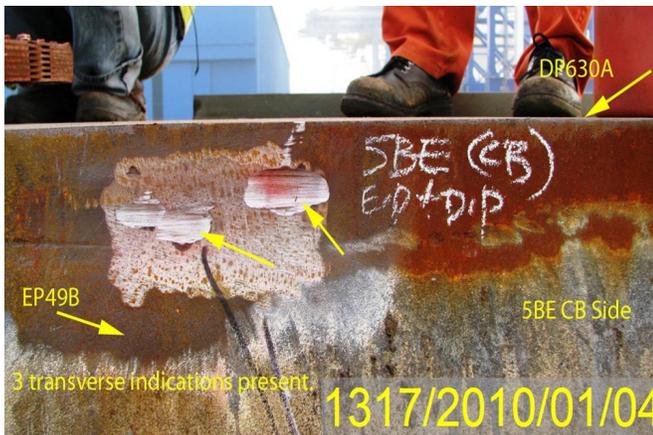
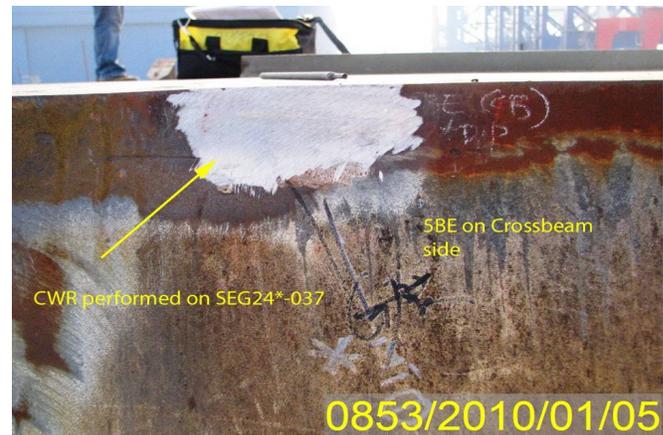
During the Quality Assurance (QA) random in-process visual inspection of the OBG segments in the Trial Assembly area, this QA inspector discovered the following issue:

- ZPMC discovered three (3) transverse indications utilizing the Magnetic Particle (MT) method.
- Y location is approximately between 650~710mm measured from weld splice OBE5-006 on Cross Beam (CB) side.
- The Weld Joint is identified as: SEG24*-037 in Segment 5BE.
- The Edge Plate (EP) on the CB side of segment is identified as: EP49B
- The Deck Plate (DP) is identified as: DP630A.
- The steel material is designated as: A709 Grade 345 Seismic Performance Critical Member (SPCM).
- No approved welding procedure specification (WPS) was on site during the welding repair process.
- These excavation areas were repaired today without the prior approval of the Engineer.

AWS D1.5-2002 Section 3.7.4; Prior approval of the Engineer shall be obtained for repairs to base metal, repairs of major or delayed cracks.

Submit the correct WPS for these repairs. Do not initiate repairs without first notifying the engineer. A response for the resolution of this issue is expected within 7 days.
