Contract #: 04-0120F4Cty: SF/ALA Rte: 80 PM: 13.2/13.9File #: 69.25B**QUALITY ASSURANCE -- NON-CONFORMANCE REPORT****Location:** Changxing Island, Shanghai, PRC**Report No:** NCR-000600**Prime Contractor:** American Bridge/Fluor Enterprises, a JV**Date:** 05-Jan-2010**Submitting Contractor:** Zhenhua Port Machinery Company, Ltd (ZPMC), Changxing Island**NCR #:** ZPMC-0573**Type of problem:****Welding****Concrete****Other****Welding****Curing****Procedural****Bridge No:** 34-0006**Joint fit-up****Coating****Other****Component:** Tower Strut**Procedural****Procedural****Description:** Tower Strut SD1-STSA3-1-99M-1**Reference Description:** Missed MT indication on Tower Strut SD1-STSA3-1-99M-1**Description of Non-Conformance:**

**Report No:** NCR-000600

**NCR #:** ZPMC-0573

**Reference Description:** Missed MT indication on Tower Strut SD1-STSA3-1-99M-1

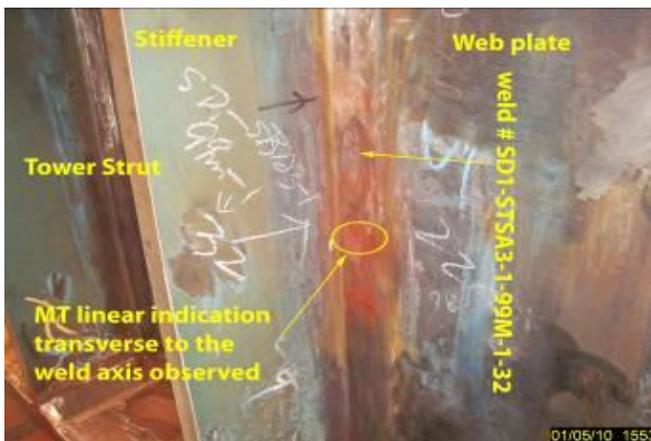
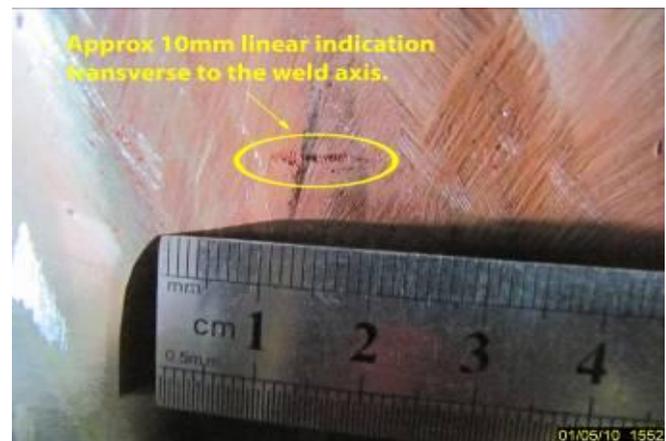
During Magnetic Particle Testing (MT) of Tower Strut Web to Stiffener weld SD1-STSA3-1-99M-1-32, QA discovered one linear indication, transverse to the weld axis, approximately 10mm in length. Notice of Witness Inspection (NWIT) # 004999 indicates that ZPMC previously completed their 100% MT review on the affected weld.

**Reference Resolution:** ZPMC has repaired this defect and subsequently re-MT'd and found acceptable. The ABF QCM has conducted MT refresher training regarding MT missed indications.

ZPMC has reviewed this NCR with the MT technician and acknowledged this missed indication as per ZPMC attached letter. ZPMC has repaired this defect and subsequently re-MT'd and found acceptable. The ABF QCM has conducted MT refresher training regarding MT missed indications. See attachment for training agenda and training roster.

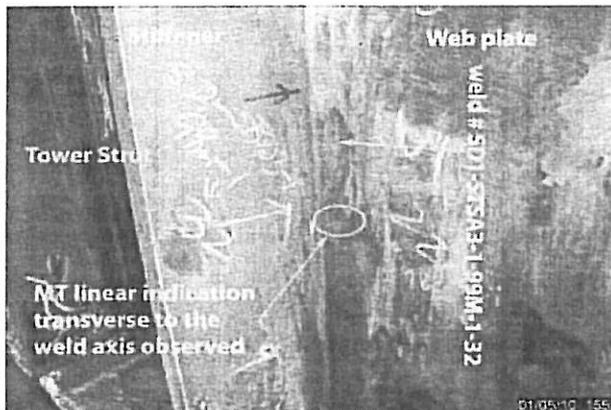
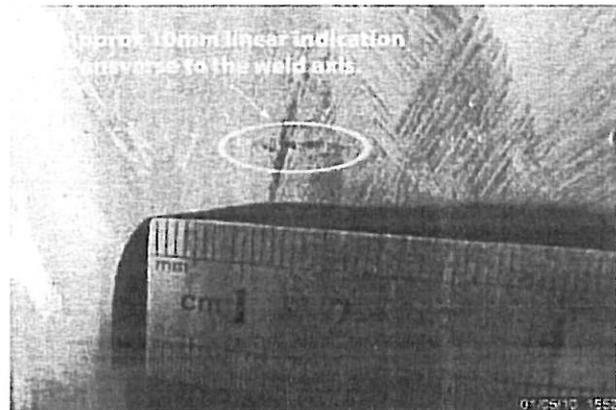
During Magnetic Particle Testing (MT) of Tower Strut Web to Stiffener weld SD1-STSA3-1-99M-1-32, QA discovered one linear indication, transverse to the weld axis, approximately 10mm in length. Notice of Witness Inspection (NWIT) # 004999 indicates that ZPMC previously completed their 100% MT review on the affected weld.

Weld repair was performed and verified by MT (T-WR3001 and T787-MT-7851). MT refresher training was conducted on 12/22/09.

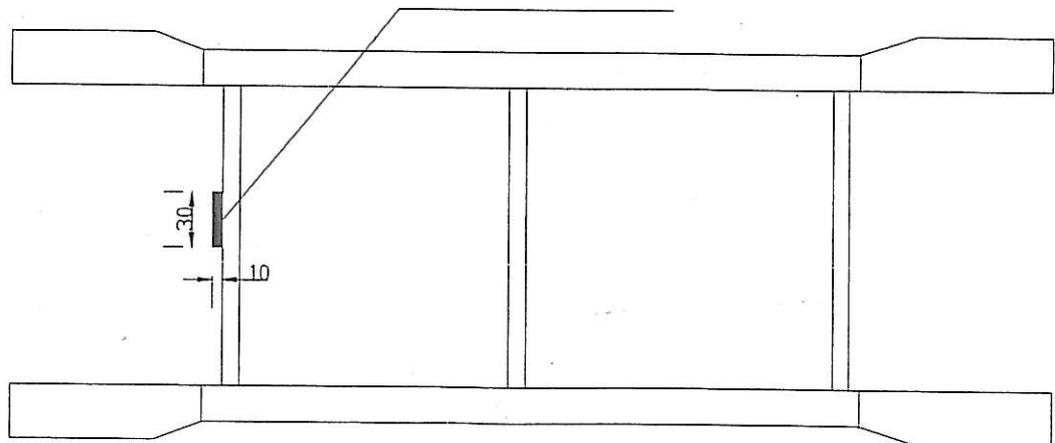
### SD1-STSA3-1-99M-1-32

The defect was found at third lifting strut plate by use of MT and needed to build up, the detail see the following draft.

Remark: repair area in shadow.

1. 火焰加热时, 水汽没有完全的去掉或者这个区域预热不够;
1. Moisture wasn't completely removed during drying operation (preheating) or the area wasn't preheated sufficiently.

1. QC shall monitor gouging/grinding/welding
2. Gouge defects & grind smoothly
3. Verify that defects have been removed with VT
4. Welding shall be in accordance with WPS
5. QC shall ensure all slag is removed prior to deposition of subsequent weld passes
6. Blend repair area with adjacent base metal
7. Perform VT, MT, & UT to repaired area

1. QC shall verify sufficient preheat has been applied, to remove moisture, prior to welding.
