QUALITY ASSURANCE -- NON-CONFORMANCE REPORT

Location: Changxing Island, Shanghai, P.R. China **Report No:** NCR-000601
Prime Contractor: American Bridge/Fluor Enterprises, a JV **Date:** 05-Jan-2010
Submitting Contractor: Zhenhua Port Machinery Company, Ltd (ZPMC), Changxing Island **NCR #:** ZPMC-0574

Welding	Concrete	Other	
Welding	Curing	Procedural	Bridge No: 34-0006
Joint fit-up	Coating	Other	Component: Bikepath BK4 Assembly
Procedural	Procedural	Description:

Reference Description: Contractor performed heat straightening of Bikepath Platform BK7A Plate with Engineer's approval

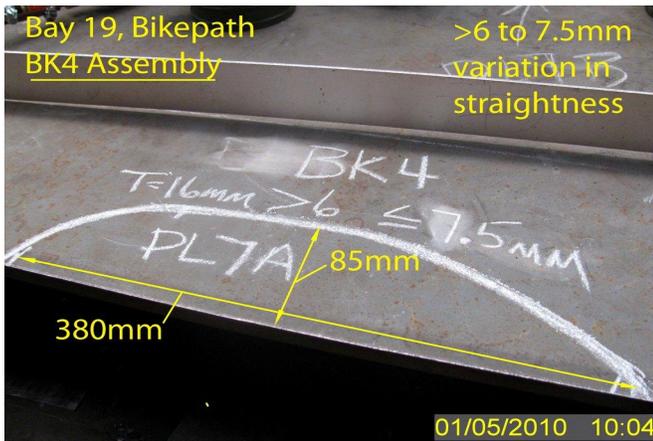
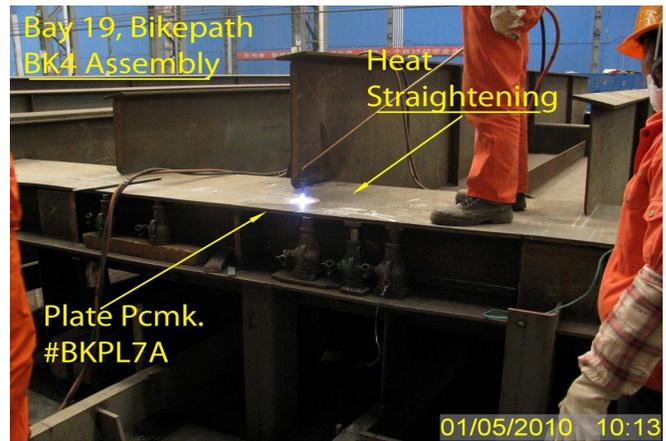
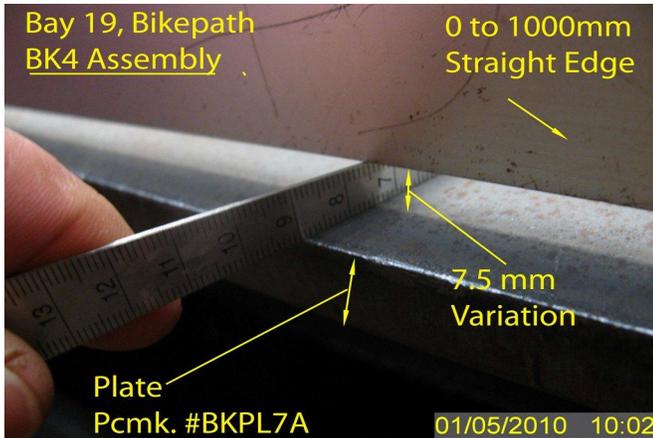
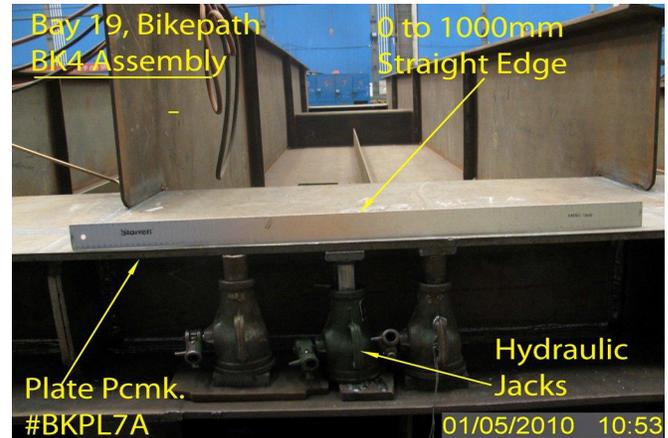
- During the Caltrans Quality Assurance in-process observations of the fabrication of the bike path components in assembly bay 19 this Quality Assurance Inspector (QA) discovered the following issue:
- ZPMC heat straightening an area of material distorted by welding without the Engineers approval.
 - The bike path segment is identified as BK4.
 - The part is identified as BKPL7A.
 - The deviation from flat as measured by this QA was 7.5mm per 1000mm.
 - Material thickness is 16mm.
 - ZPMC QC was not present during the time of the heat straightening process.

AWS D1.5/2002 Section 3.7.3: Members distorted by welding shall be heat straightened by mechanical means or by carefully supervised application of a limited amount of localized heat as approved by the engineer.

Caltrans Special Provisions Section 8-3: For material less than or equal to 16 mm thick, the Contractor shall not heat straighten members more than 6 in 1000 without prior approval of the Engineer.

Propose a resolution for the identified non-conformance with revised procedures to prevent future occurrences. Do not perform HS without prior notification of the engineer. A response for the resolution of this issue is expected within 7 days.
