**DEPARTMENT OF TRANSPORTATION**

Contract #: 04-0120F4Cty: SF/ALA Rte: 80 PM: 13.2/13.9File #: 69.25B**QUALITY ASSURANCE -- NON-CONFORMANCE REPORT****Location:** Changxing Island, Shanghai, P.R. China**Report No:** NCR-000602**Prime Contractor:** American Bridge/Fluor Enterprises, a JV**Date:** 05-Jan-2010**Submitting Contractor:** Zhenhua Port Machinery Company, Ltd (ZPMC), Changxing Island**NCR #:** ZPMC-0575**Type of problem:**

**Reference Description:** Missed MT Indication by QC on 7DW on FB to BP joint**Description of Non-Conformance:**

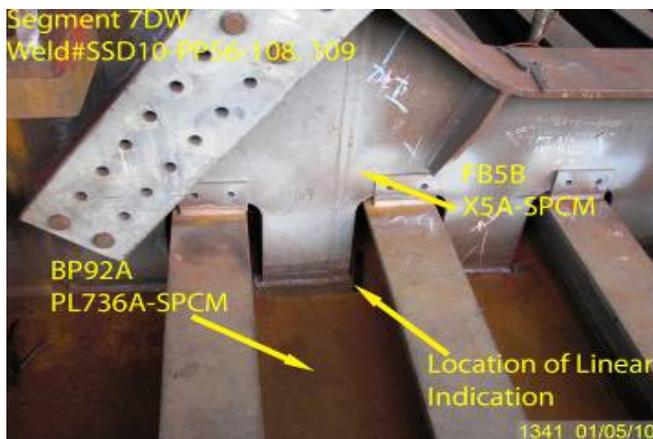
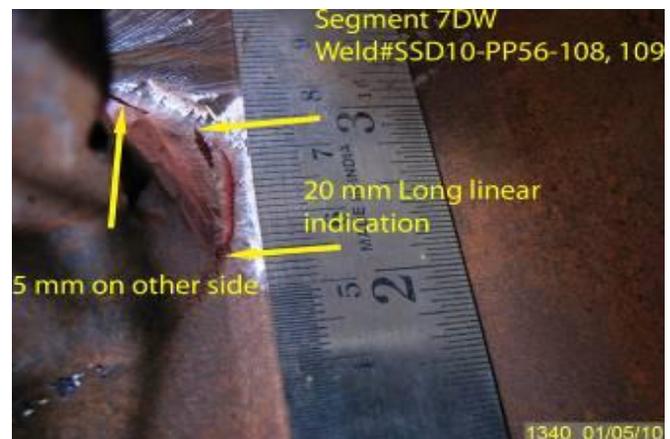
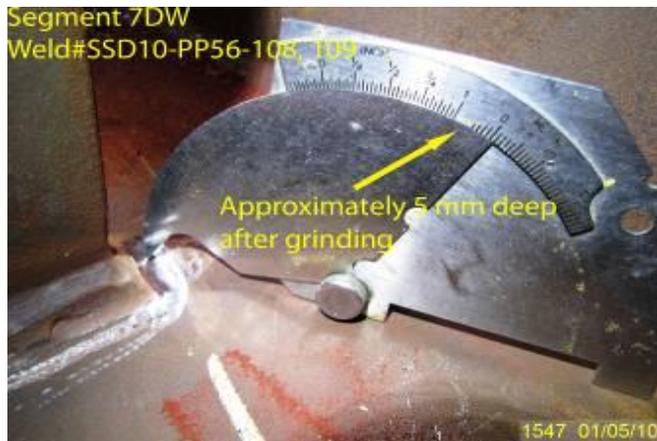
During the Quality Assurance Magnetic Particle Testing (MT) review of welds located on Segment 7DW, this Quality Assurance Inspector (QA) discovered the following issues:

- One (1) Longitudinal linear indication measuring approximately 20mm in length.
- The welds are identified as: SSD10-PP56-108, 109.
- These welds are a Fillet Weld type joining the Bottom Plate (BP92A) to Floor Beam (FB5B) web plate.
- These welds are designated as Seismic Performance Critical Member (SPCM) on the approved drawing (SEGSD10).
- The OBG segment 7DW is located outside in the Trial Assembly area.

The Notice of Witness Inspection Number (NWIT) is 004993. The indication is located inside the area that has been previously tested and accepted by ZPMC Quality Control (QC) personnel. ZPMC's QC personnel are required to perform twenty five (25%) percent MT inspection of this weld.

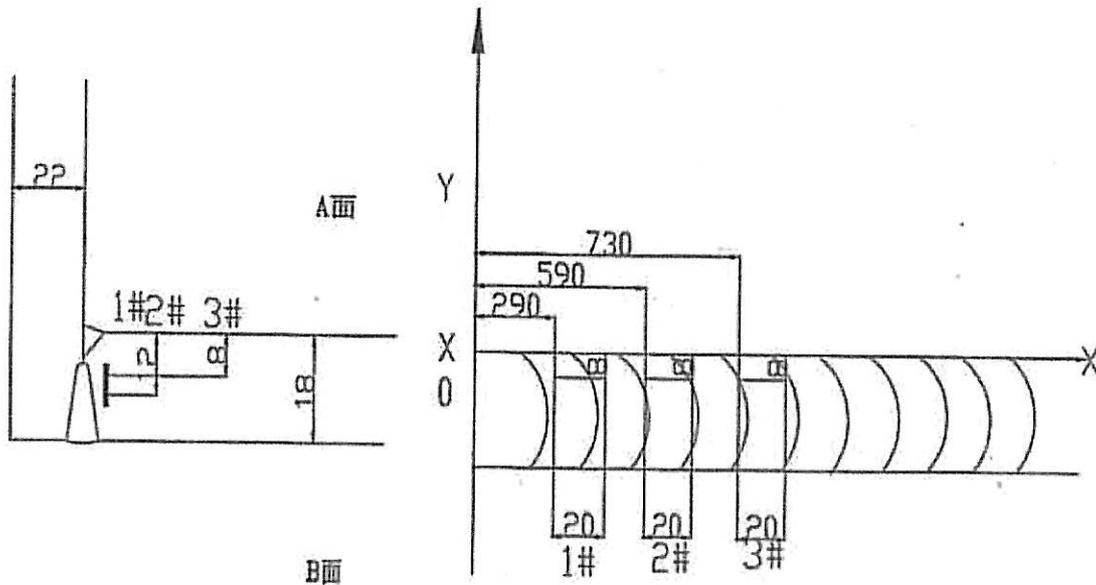
WELD NUMBER: CB202A-016-002

Rejected indication found by ultrasonic inspection is less than the maximum allowance aggregate length.

1. 从缺陷距离端面较近一侧 ( $D \leq 0.65T$ , D为缺陷深度, T为板厚) 采用碳锉或打磨的方法去除焊缝缺陷;
  2. 参照返修焊接工艺规程 (WPS) 准备正确的接头型式, 预热和焊接;
  3. 焊前对修补区域进行VT检测保证缺陷完全被清除;
  4. 将修补区域打磨到与母材或邻近焊缝平齐;
  5. 根据批准的车间图纸检查焊缝.
- 
1. Gouge or grind from nearer side from metal edge ( $D \leq 0.65T$ , "D" is depth of defects, "T" is thickness of metal) to remove all defects;
  2. Follow repair WPS for joint preparation, preheat, and weld deposit;
  3. Verify with VT no defects remain in the weld joint prior to welding;
  4. Grind the repaired area flush with base metal or the adjacent weld;
  5. Check the welds according to the working drawings;

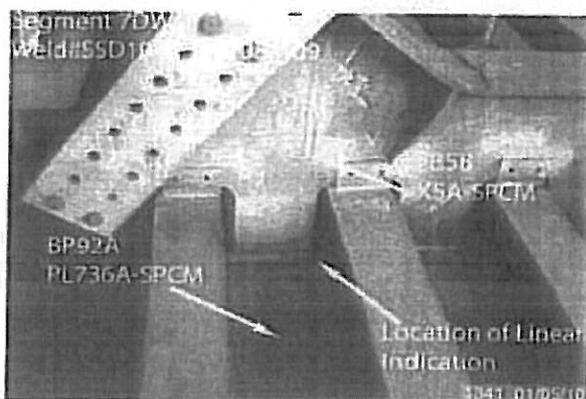
- The OBG segment 7DW is located outside in the Trial Assembly area.

The Notice of Witness Inspection Number (NWIT) is 004993. The indication is located inside the area that has been previously tested and accepted by ZPMC Quality Control (QC) personnel. ZPMC's QC personnel are required to perform twenty five (25%) percent MT inspection of this weld.

Propose a resolution for the identified non-conformance with revised procedures to prevent future occurrences. Provide the training and equipment required for the ZPMC MT technician such that these indications are found. A response for the resolution of this issue is expected within 7 days.

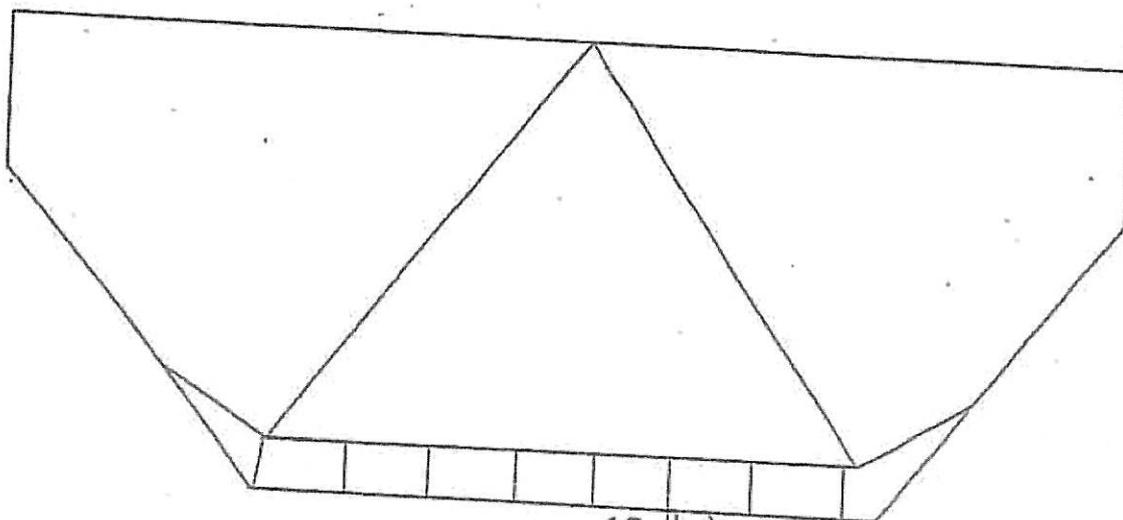
WELD NUMBER:SSD10-PP56-108

One longitudinal crack was found by use of MT on SSD10-PP56-108.

- 1. 火焰加热时, 水汽没有完全的去掉或者这个区域预热不够;
- 1. Moisture wasn't completely removed during drying operation (preheating) or the area wa sn't preheated sufficiently.

- 1. QC and a Lead CWI shall be present, direct and supervise all grinding and welding operations during this repair to ensure the repair is per the disposition requirements

- 2. QC and a Lead CWI shall have an approved copy of the CWR in hand prior to the repair.
- 3. Remove paint ≥25mm in all direction of HAZ prior to MT.
- 4. Clean the excavation area of all loose debris including MT powder. Preheat to 65° C before removing cracks by grinding, repair area shall extend a minimum of 50mm beyond each end of single crack repairs.

- 5. If base metal is damaged by grinding, the damaged area shall be ground clean prior to performing weld repair. If gap > 5mm is found during or after grinding, comply with the notification on changing fillet weld to CJP which is submitted for Engineer's review and approval form.

- 6. Prepare excavation in accordance with the New Repair Procedure prior to welding.
- 7. Before this repair, Verify with VT and MT repair areas are defects free, and also MT shall be performed on the base metal laying abroad cracks to ensure that no cracks were propagated to the base metal. Separate CWR approval is needed if cracks are found in the base metal, and only after this new CWR's approval can continue the repair.

- 8. Clean excavation area of all loose debris including MT powder after excavation. Preheat and weld according to repair WPS, the preheat shall between 160° C-230° C.

- 9. Perform post weld heating according to repair WPS, the postheat shall between 230° C-315° C and for on a hour minimum.
- 10. Allow the weld to cool to ambient temperature gradually. Control cooling rate after PWHT to no more than 50° C per hour.

- 11. Grind the repaired area flush with base metal or the adjacent weld after post weld heating.
- 12. Wait 48 hours at least after the repair area has cooled to ambient temperature before performing NDT.

- 13. Perform MT inspection to all repair area according to Contract Drawings along with all additional NDT required by the applicable notes Special Provision Section 10-1.59 'Steel Structure', subsection 'Inspection testing'. NDT include VT, MT and UT if it is a CJP weld.

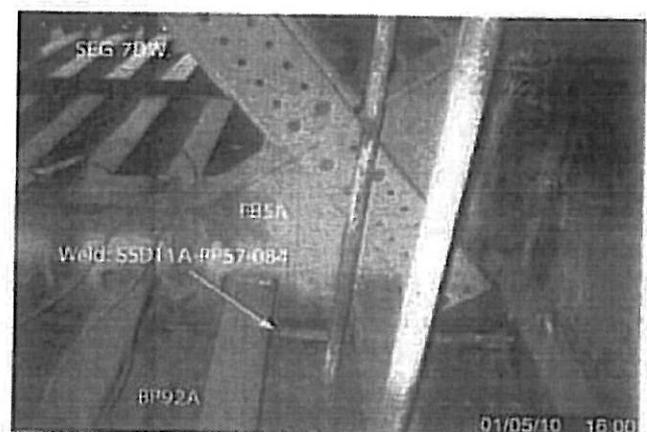
-The approved shop drawings, detail this weld as a Fracture Critical Weld (FCW).

-Segment 7DW is located at outside yard, north end of bays 13 and 14.

The Notice of Witness Inspection Number (NWIT) is 004993. The indication is located within the area that has been previously tested and accepted by ZPMC Quality Control (QC) personnel. ZPMC's QC personnel are required to perform twenty five (25%) percent MT inspection of this weld.

Propose a resolution for the identified non-conformance with revised procedures to prevent future occurrences. Provide the required training and equipment to the ZPMC MT technician such that indications such as this are found. A response for the resolution of this issue is expected within 7 days.

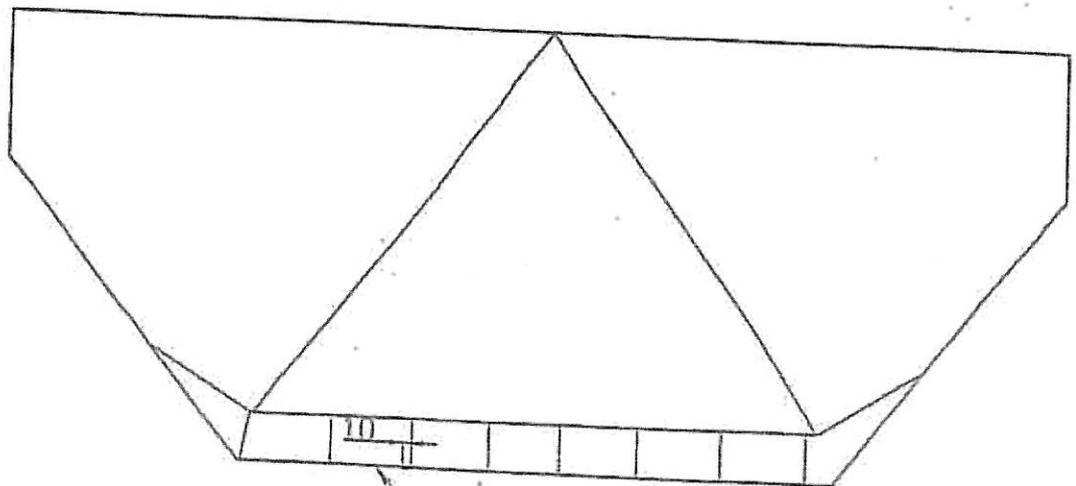
WELD NUMBER: SSD11-PP57-0B4

One longitudinal crack was found by use of MT on SSD11-PP57-0B4.

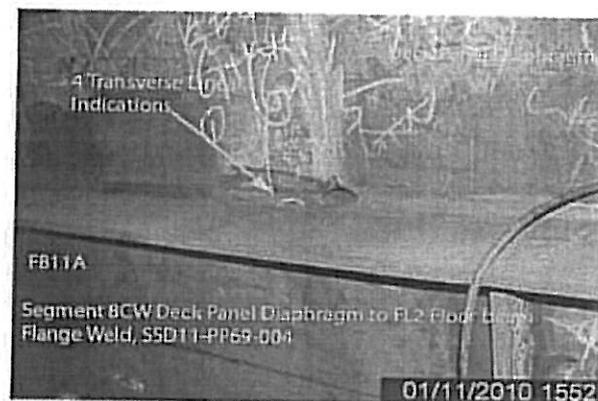
-The Notice of Witness Inspection Number (NWIT) is 005037.

-The indication is located in an area that has been previously tested and accepted by ZPMC Quality Control (QC) personnel. According to the contract documents ZPMC Quality Control (QC) is required to perform 100% Magnetic particle Testing (MT) of this weld.

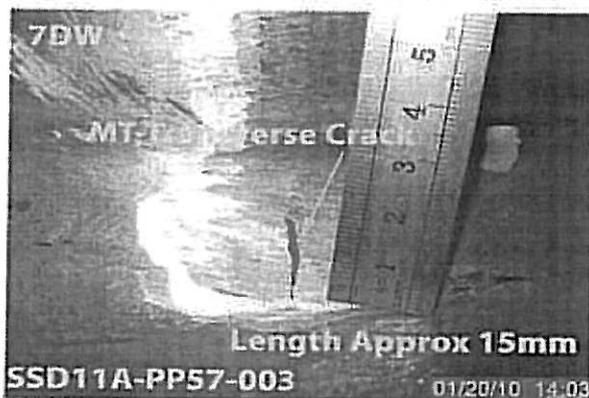
- One (1) Transverse linear crack measuring approximately 15mm in length.
- The Y location is 4500mm from corner of the Panel Point PP57 at Cross Beam side.
- The indication is clearly marked on the material near the weld.
- The weld is identified as: SSD11A-PP57-003.
- This weld is a Complete Joint Penetration (CJP) weld joining the Deck Panel Diaphragm (X1H) to Floor Beam Flange (X7G).
- The Deck Panel Diaphragm (X1H) is identified as Non-Seismic Performance Critical Member (SPCM).
- The Floor Beam Flange (X7G) is identified as Non-SPCM.
- OBG segment 7DW is located outside North side of Bay 13.

The Notice of Witness Inspection Number (NWIT) is 005086. The indication is located inside an area that has been previously tested 100% and accepted by ZPMC Quality Control (QC) personnel.

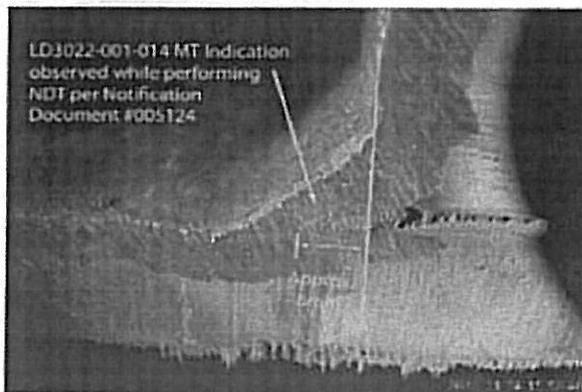
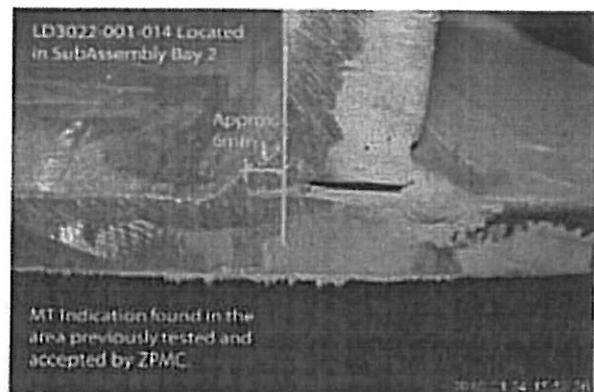
During the Quality Assurance Magnetic Particle Testing (MT) review of welds located on LD3022-001, this Quality Assurance Inspector (QA) discovered the following issues:

- One (1) linear indication measuring approximately 6mm in length.
- The weld is identified as: LD3022-001-014 for Lift 12.
- The area was previously repaired by ZPMC using Critical Weld Repair (CWR) 1151.
- The fillet weld size is 12mm.
- This Fillet Weld joins longitudinal diaphragm stiffener to longitudinal diaphragm web plate.
- This weld is designated as Non-Seismic Performance Critical Member.
- The Notice of Witness Inspection Number (NWIT) is 005124. The indication is located inside the area that has been previously tested and accepted by ZPMC Quality Control (QC) personnel. ZPMC Quality Control (QC) has performed 100% Magnetic particle Testing (MT) of this weld.
