QUALITY ASSURANCE -- NON-CONFORMANCE REPORT

Report No: NCR-000605

Component: Bike path Cantilever Bracket BK001-046

Reference Description: Heat Straightening re-performed without approval on Bike path Cantilever Bracket BK001-046

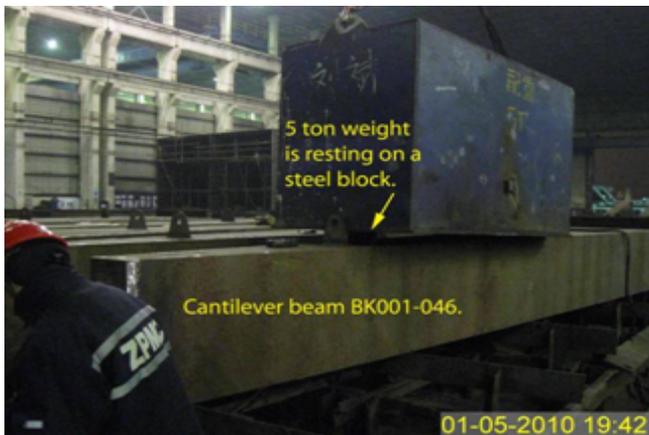
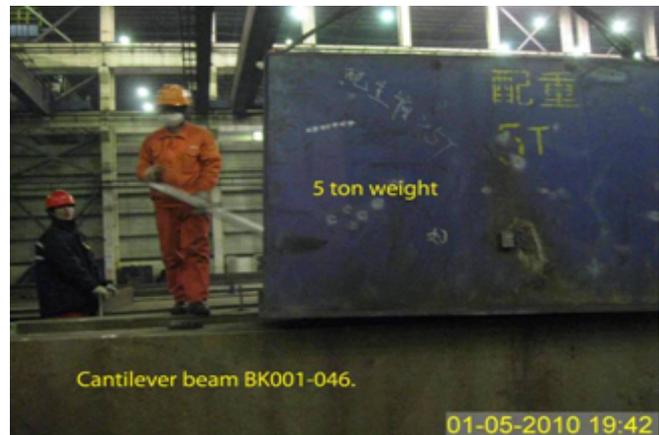
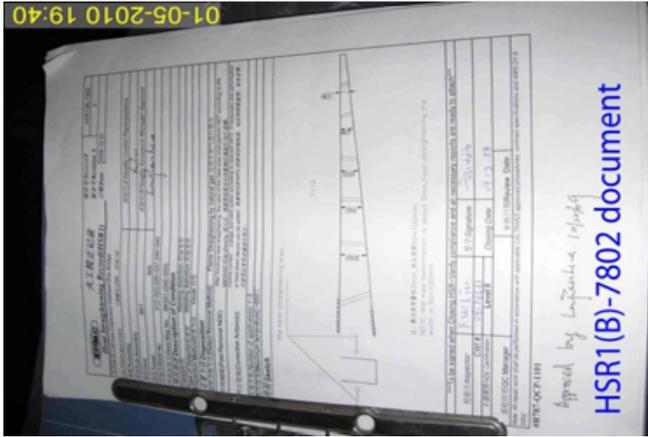
- ZPMC personnel heat straightening bike path cantilever bracket identified as BK001-046.
- ZPMC had placed a 5 ton weight on BK001-046 10 mm thick side plate during the heat straightening process.
- Heat straightening document HSR1 (B)-7802 revision 0 was referenced as being the controlling document by ZPMC QC CWI Mr. Li Jia.
- The referenced document does not indicate any weight and/or mechanical force being used during this process.
- Document HSR1(B)-7802 showed that the work has been completed and was signed off by Mr. Liu on 12-28-2009.

AWS D1.5/2002 Section 3.7.3; “Members distorted by welding shall be straightened by mechanical means or by carefully supervised application of a limited amount of localized heat as approved by the engineer...The part to be heated for straightening shall be substantially free of stress and from external forces...”

ZPMC QC provided the incorrect HSR at this time. Attached is the correct HSR which shows the use of the outside force. Per discussion in China, ZPMC has issued an internal NCR to the QC to reiterate the importance of verifying that the correct documents are on hand prior to beginning work to prevent future occurrences of this. Based on this ZPMC requests closure of this NCR.

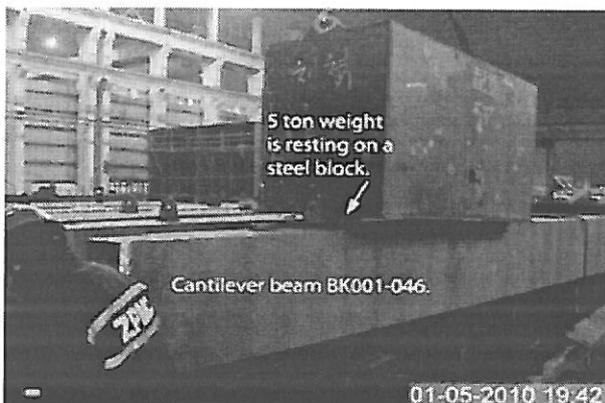
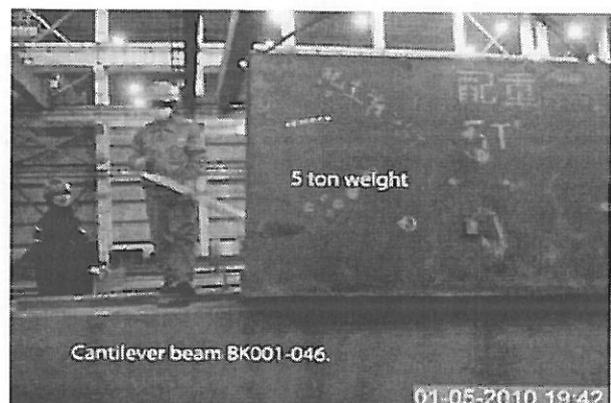
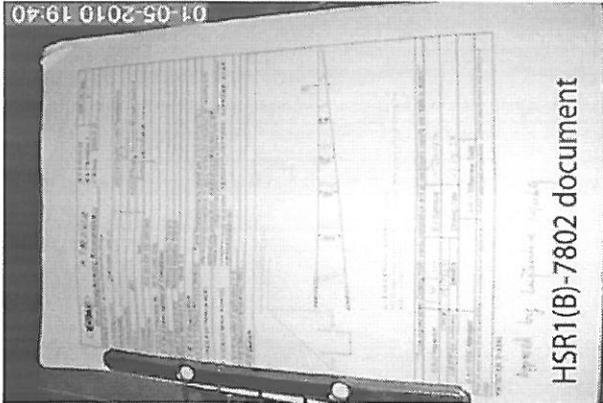
- ZPMC personnel heat straightening bike path cantilever bracket identified as BK001-046.
- ZPMC had placed a 5 ton weight on BK001-046 10 mm thick side plate during the heat straightening process.
- Heat straightening document HSR1 (B)-7802 revision 0 was referenced as being the controlling document by ZPMC QC CWI Mr. Li Jia.
- The referenced document does not indicate any weight and/or mechanical force being used during this process.
- Document HSR1(B)-7802 showed that the work has been completed and was signed off by Mr. Liu on 12-28-2009.

AWS D1.5/2002 Section 3.7.3; "Members distorted by welding shall be straightened by mechanical means or by carefully supervised application of a limited amount of localized heat as approved by the engineer... The part to be heated for straightening shall be substantially free of stress and from external forces..."

Contractor has submitted an updated version of the HSR detailing the work that was performed.

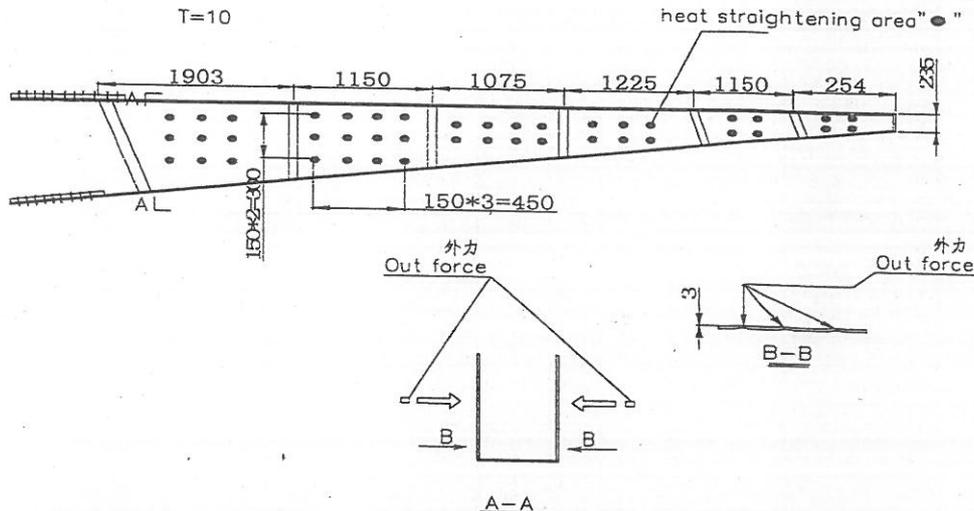
简图 Sketch

Welding distortion 焊接变形

NOTE: the max deformation is about 3mm, heat straightening the width is 50~100mm.

Flame Straightening by natural gas 运用天然气进行校火
