Contract #: 04-0120F4Cty: SF/ALA Rte: 80 PM: 13.2/13.9File #: 69.25B

QUALITY ASSURANCE -- NON-CONFORMANCE REPORT

Location: Changxing Island, Shanghai, P.R. China**Report No:** NCR-000608**Prime Contractor:** American Bridge/Fluor Enterprises, a JV**Date:** 06-Jan-2010**Submitting Contractor:** Zhenhua Port Machinery Company, Ltd (ZPMC), Changxing Island**NCR #:** ZPMC-0581**Type of problem:**

Reference Description: ZPMC performed Base Metal Repairs without the Engineer's approval in Segment 6AW

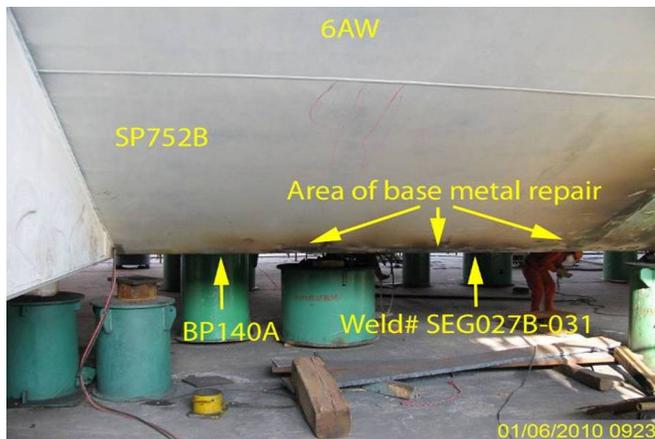
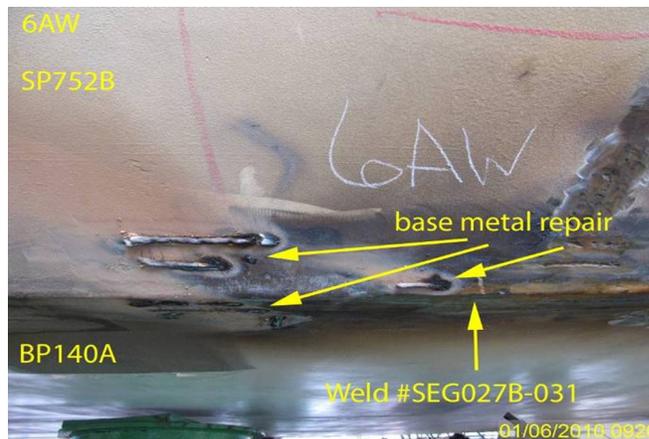
- Base metal repairs (BMR) were being performed without prior approval of the Engineer at locations of removed temporary attachments.
- These BMR's were located on the east end of the segment on the Bottom Plate (BP140A) and Side Plate (SP752B), Cross Beam side.
- The Bottom Plate is identified as: BP140A
- The Side Plate is identified as: SP572B
- This complete joint penetration (CJP) weld # SEG027B-031 joins panels BP140A to SP752B.
- The approximate lengths of the BMR's range from 10mm to 150mm on BP140A and 30mm to 150mm on SP752B.
- A total of nine (9) repairs were in-process on BP140A and seven (7) repairs on SP752B.
- Theses repairs begin at the 6AW/6BW segment splice progressing west approximately 3100mm.
- The material is A709M Grade 345 SPCM.

Reference Resolution: ZPMC has held internal training with the CWIs and production regaining base metal repairs without Engineer approval. NDT of base metal repaired areas will be provided when available.

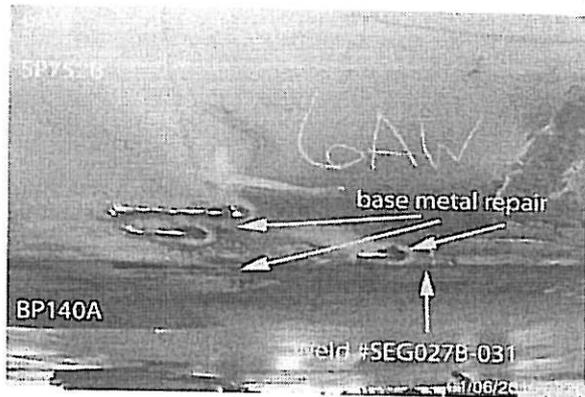
- Base metal repairs (BMR) were being performed without prior approval of the Engineer at locations of removed temporary attachments.
- These BMR's were located on the east end of the segment on the Bottom Plate (BP140A) and Side Plate (SP752B), Cross Beam side.
- The Bottom Plate is identified as: BP140A
- The Side Plate is identified as: SP572B
- This complete joint penetration (CJP) weld # SEG027B-031 joins panels BP140A to SP752B.
- The approximate lengths of the BMR's range from 10mm to 150mm on BP140A and 30mm to 150mm on SP752B.
- A total of nine (9) repairs were in-process on BP140A and seven (7) repairs on SP752B.
- Theses repairs begin at the 6AW/6BW segment splice progressing west approximately 3100mm.
- The material is A709M Grade 345 SPCM.

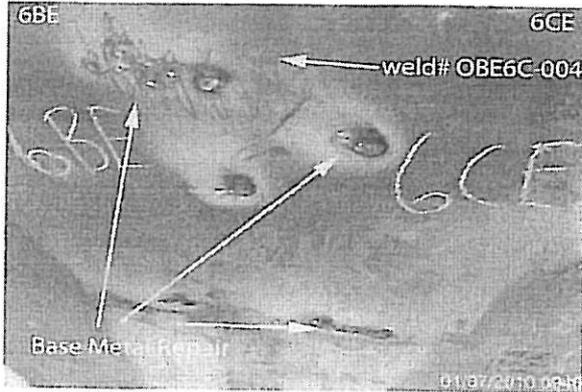
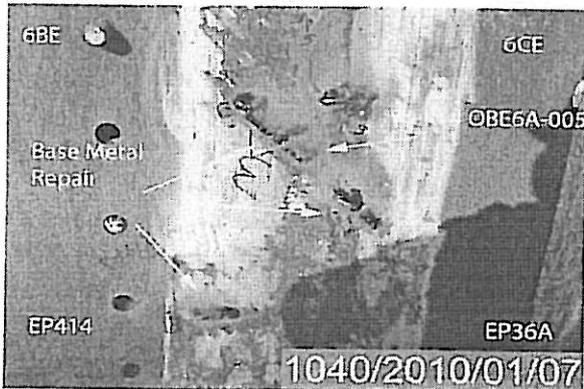
- Base metal repairs (BMR) were being performed without prior approval of the Engineer at locations of removed temporary attachments.
- These BMR's were located along the 6BE/6CE Bottom Plate Complete Joint Penetration (CJP) Splice.
- The Bottom Plates on 6BE are identified as: BP168A, BP60A, BP114A
- The Bottom Plates on 6CE are identified as: BP169A, BP61A, BP115A
- The CJP splice weld # is designated OBE6C-004.
- The approximate lengths of the BMR's range from 10mm to 150mm.
- A total of seventeen (17) repairs were in-process on 6BE and twenty-two (22) repairs on 6CE throughout the length of the Bottom Plate splice.
- The material is A709M Grade 345 Non-SPCM.

- Base metal repairs (BMR) were being performed without prior approval of the Engineer at locations of temporary attachments.
- These BMR's were located along the 6BE+6CE Edge Plate Complete Joint Penetration (CJP) Splice.
- The Edge Plate on 6BE is identified as: EP41A
- The Edge Plate on 6CE is identified as: EP36A.
- The CJP splice weld # is designated OBE6A-005.
- The Approximate lengths of the BMR's range from 15mm to 125mm.
- A total of eleven (11) repairs were in-process on 6BE and four (4) repairs on 6CE throughout the length of the

Edge Plate splice.

-Both EP panels EP36A and EP41A are A709 Grade 345 Seismic Performance Critical Members (SPCM) material.
