Contract #: 04-0120F4Cty: SF/ALA Rte: 80 PM: 13.2/13.9File #: 69.25B**QUALITY ASSURANCE -- NON-CONFORMANCE REPORT****Location:** Changxing Island, Shanghai, P.R. China**Report No:** NCR-000609**Prime Contractor:** American Bridge/Fluor Enterprises, a JV**Date:** 06-Jan-2010**Submitting Contractor:** Zhenhua Port Machinery Company, Ltd (ZPMC), Changxing Island**NCR #:** ZPMC-0582**Type of problem:**

Reference Description: ZPMC performed welding repair of an MT Transverse Indication without the prior approval of the Engineer for a Lift 12 LD

Subject: NCR No. ZPMC-0582

关键焊缝返修报告
Critical Welding Repair Report (CWR)

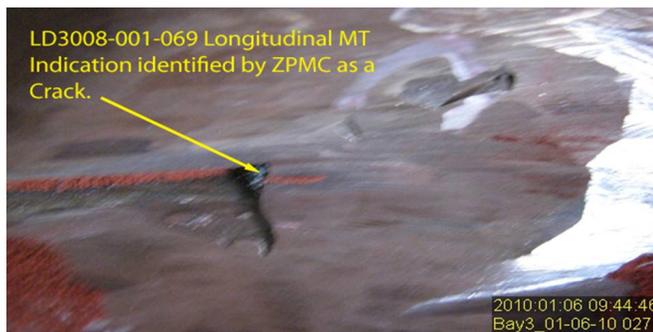
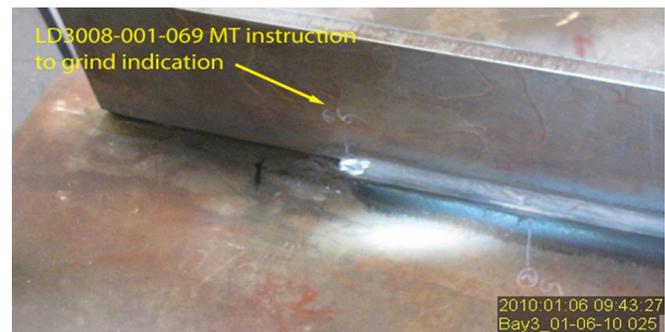
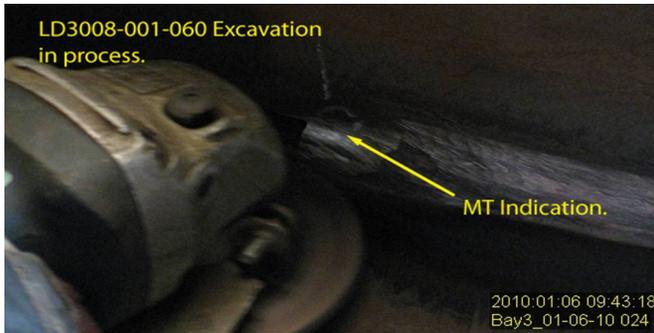
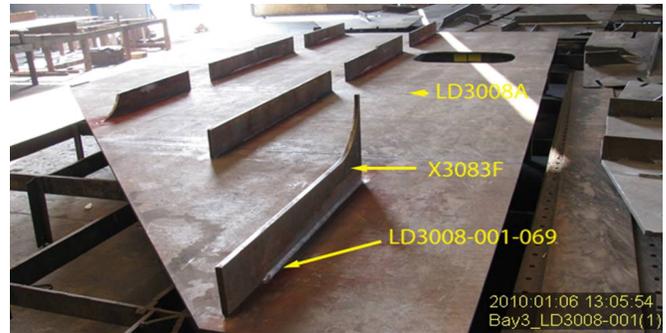
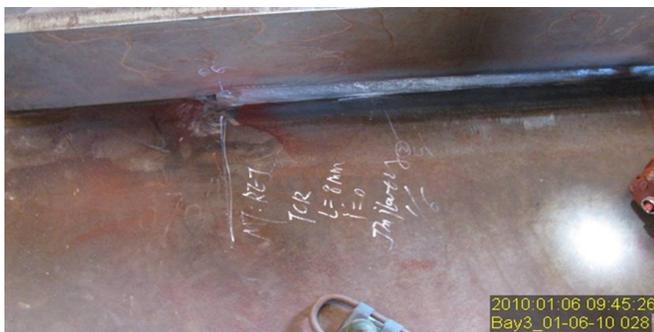
- ZPMC Production Personnel was observed excavating a Longitudinal Linear MT Indication identified by ZPMC's MT Technician as a transverse crack, without having a Critical Weld Repair (CWR).
- One (1) Longitudinal linear indication measuring approximately 8mm in length.
- The weld is identified as: LD3008-001-069.
- These welds are a Fillet Weld type joining the Longitudinal Diaphragm Stiffener (X3083F) to Longitudinal Diaphragm (LD3008A) web plate.
- The Longitudinal Diaphragm is located in the Sub-Assembly Bay 3.

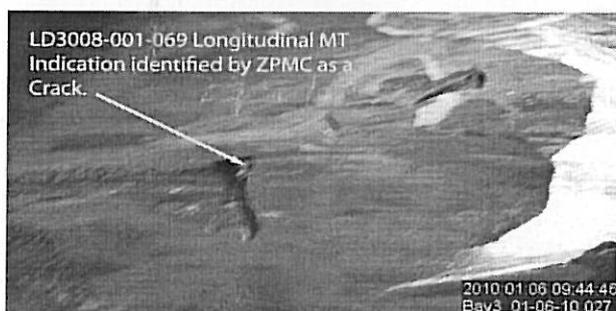
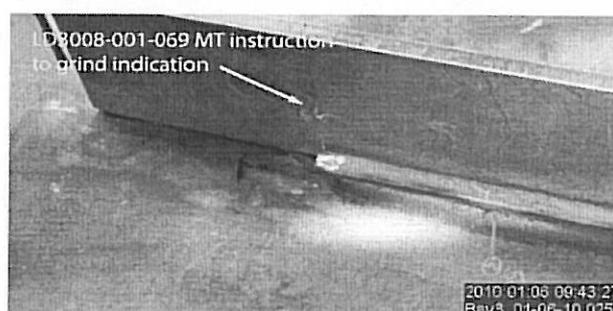
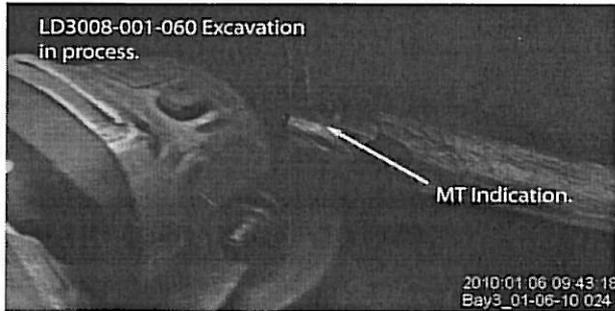
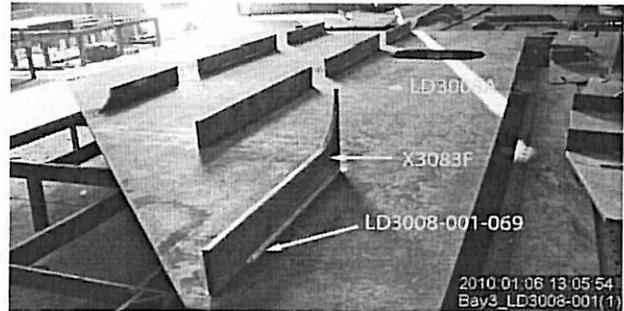
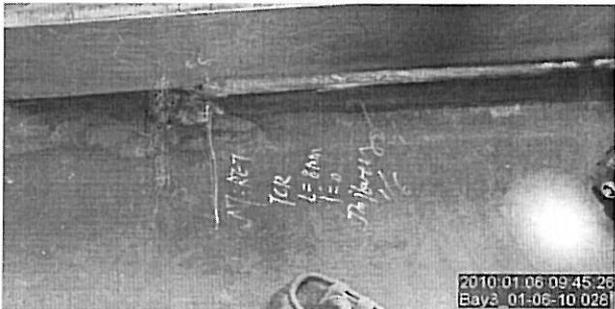
- ZPMC Production Personnel was observed excavating a Longitudinal Linear MT Indication identified by ZPMC's MT Technician as a transverse crack, without having a Critical Weld Repair (CWR).
- One (1) Longitudinal linear indication measuring approximately 8mm in length.
- The weld is identified as: LD3008-001-069.
- These welds are a Fillet Weld type joining the Longitudinal Diaphragm Stiffener (X3083F) to Longitudinal Diaphragm (LD3008A) web plate.
- The Longitudinal Diaphragm is located in the Sub-Assembly Bay 3.

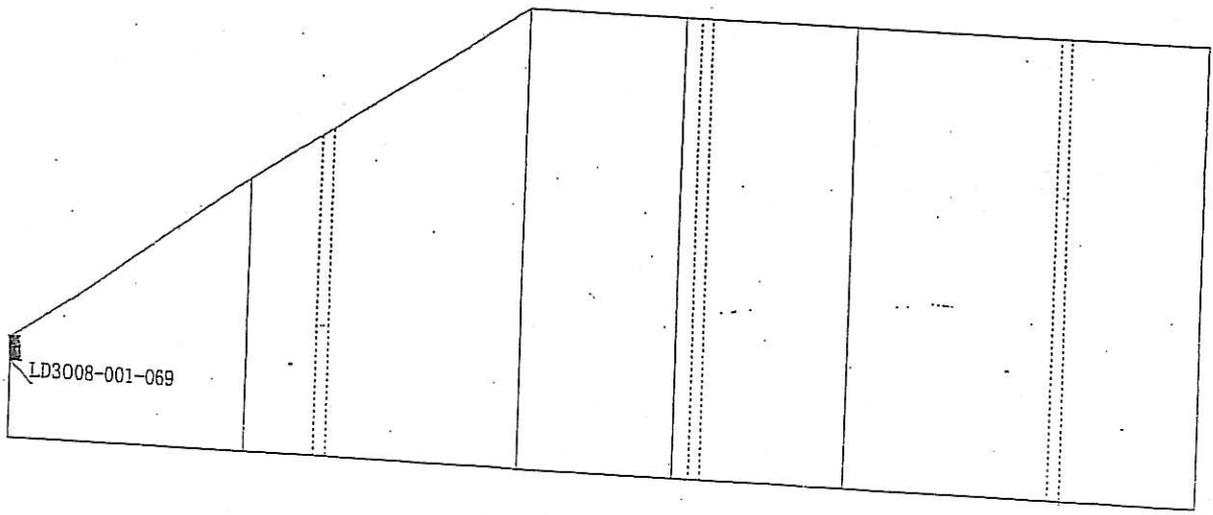
Draft of Welding Discontinuity:

One transverse crack was found by use of MT on LD3008-001-069

1. 火焰加热时,水汽没有完全的去除了或者这个区域预热不够;
1. Moisture wasn't completely removed during drying operation (preheating) or the area wasn't preheated sufficiently.

1. QC and a Lead CWI shall be present, direct and supervise all grinding and welding operations during this repair to ensure the repair is per the disposition requirements.

2. QC and a Lead CWI shall have an approved copy of the CWR in hand prior to the repair.
3. Remove paint ≥ 25 mm in all direction of HAZ prior to MT.
4. Clean the excavation area of all loose debris including MT powder. Preheat to 65° C before removing cracks by grinding and it applied to all the repair process. Repair area shall extend a minimum of 50mm beyond each end of single crack repairs.

5. If base metal is damaged by grinding, the damaged area shall be ground clean prior to performing weld repair.
6. Prepare excavation in accordance with the New Repair Procedure prior to welding.

7. Before this repair, Verify with VT and MT repair areas are defects free, and also MT shall be performed on the base metal laying abroad cracks to ensure that no cracks were propagated to the base metal. Separate CWR approval is needed if cracks are found in the base metal, and only after this new CWR's approval can continue the repair.

8. Clean excavation area of all loose debris including MT powder after excavation. Preheat and weld according to repair WPS, the preheat shall between 160° C-230° C.

9. If a crack still present and excavation have reached (2/3T+2)mm maximum, the grinding work shall be ceased. Prepare excavation that all metal is ground clean to a smooth, shiny metal finish and starts and stops are tapered to a 1:1 slope. Weld first side of repair according to approved WPS, and the preheat temperature be 160° C at least. Grind from the opposite side until sound weld metal is reached and perform 100% MT of excavation to ensure no crack exists. Prepare excavation that all metal is ground-clean to a smooth, shiny metal finish and starts and stops are tapered to a 1:1 slope. Weld opposite side of repair according to approved WPS.

10. Perform post weld heating according to repair WPS, the postheat shall between 230° C-315° C and for one hour minimum.
11. Allow the weld to cool to ambient temperature gradually. Control cooling rate after PWHT to no more than 50° C per hour.

12. Grind the repaired area flush with base metal or the adjacent weld after post weld heating.
13. Wait 48 hours at least after the repair area has cooled to ambient temperature before performing NDT.

14. Perform VT, UT and MT inspection to all repair area according to Contract Drawings along with all additional NDT required by the applicable notes Special Provision Section 10-1.59 'Steel Structure', subsection 'Inspection testing'.
