Contract #: 04-0120F4Cty: SF/ALA Rte: 80 PM: 13.2/13.9File #: 69.25B**QUALITY ASSURANCE -- NON-CONFORMANCE REPORT****Location:** Changxing Island, Shanghai, P.R. China**Report No:** NCR-000610**Prime Contractor:** American Bridge/Fluor Enterprises, a JV**Date:** 07-Jan-2010**Submitting Contractor:** Zhenhua Port Machinery Company, Ltd (ZPMC), Changxing Island**NCR #:** ZPMC-0583**Type of problem:**

Reference Description: ZPMC performed Base Metal Repairs without the prior approval of the Engineer in Segment 6BE/6CE

Job Name: SAS Superstructure

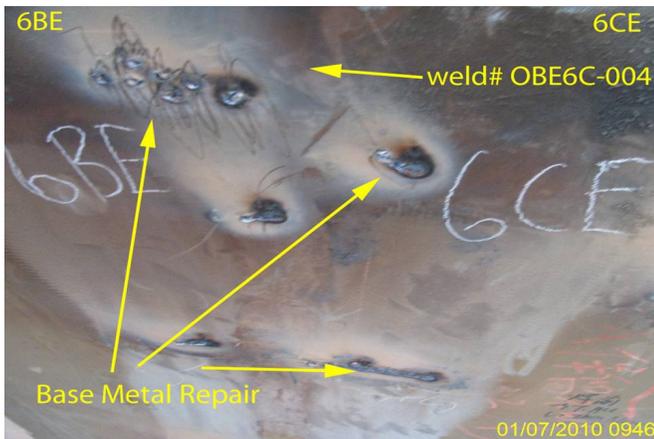
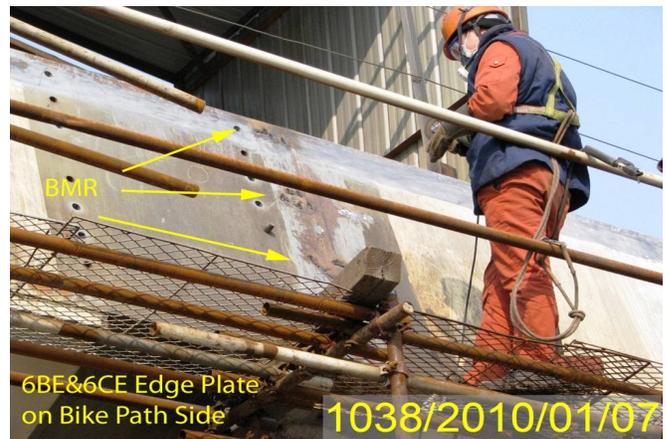
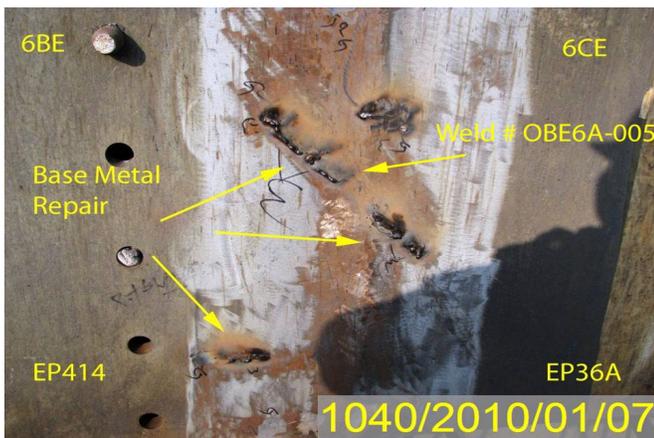
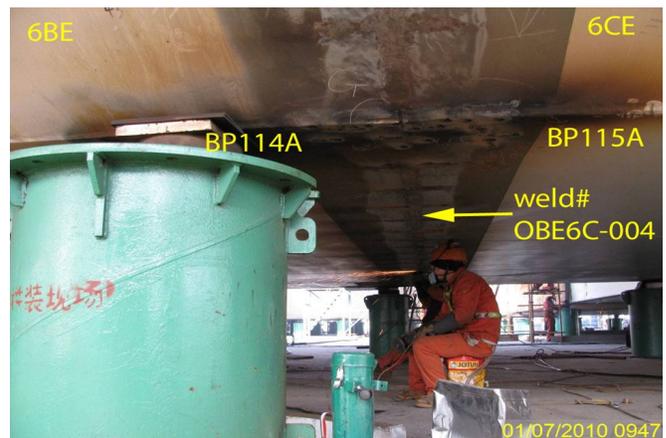
ISSUE FOR THE BOTTOM PLATES:

- Base metal repairs (BMR) were being performed without prior approval of the Engineer at locations of removed temporary attachments.
- These BMR's were located along the 6BE/6CE Bottom Plate Complete Joint Penetration (CJP) Splice.
- The Bottom Plates on 6BE are identified as: BP168A, BP60A, BP114A
- The Bottom Plates on 6CE are identified as: BP169A, BP61A, BP115A
- The CJP splice weld # is designated OBE6C-004.
- The approximate lengths of the BMR's range from 10mm to 150mm.
- A total of seventeen (17) repairs were in-process on 6BE and twenty-two (22) repairs on 6CE throughout the length of the Bottom Plate splice.
- The material is A709M Grade 345 Non-SPCM.

ISSUE FOR THE EDGE PLATES:

- Base metal repairs (BMR) were being performed without prior approval of the Engineer at locations of temporary attachments.
- These BMR's were located along the 6BE+6CE Edge Plate Complete Joint Penetration (CJP) Splice.
- The Edge Plate on 6BE is identified as: EP41A
- The Edge Plate on 6CE is identified as: EP36A.
- The CJP splice weld # is designated OBE6A-005.
- The Approximate lengths of the BMR's range from 15mm to 125mm.
- A total of eleven (11) repairs were in-process on 6BE and four (4) repairs on 6CE throughout the length of the

Edge Plate splice.

-Both EP panels EP36A and EP41A are A709 Grade 345 Seismic Performance Critical Members (SPCM) material.

Propose a resolution for both the identified non-conformance with revised procedures to prevent future occurrences. A response for the resolution of this issue is expected within 7 days.

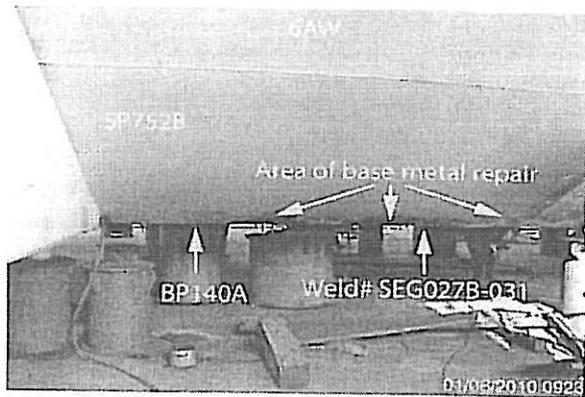
Reference Description: ZPMC performed Base Metal Repairs without the Engineer's approval in Segment 6AW

- Base metal repairs (BMR) were being performed without prior approval of the Engineer at locations of removed temporary attachments.
- These BMR's were located on the east end of the segment on the Bottom Plate (BP140A) and Side Plate (SP752B), Cross Beam side.
- The Bottom Plate is identified as: BP140A
- The Side Plate is identified as: SP572B
- This complete joint penetration (CJP) weld # SEG027B-031 joins panels BP140A to SP752B.
- The approximate lengths of the BMR's range from 10mm to 150mm on BP140A and 30mm to 150mm on SP752B.
- A total of nine (9) repairs were in-process on BP140A and seven (7) repairs on SP752B.
- Theses repairs begin at the 6AW/6BW segment splice progressing west approximately 3100mm.
- The material is A709M Grade 345 SPCM.

Propose a resolution for the identified non-conformance with revised procedures to prevent future occurrences. A response for the resolution of this issue is expected within 7 days.

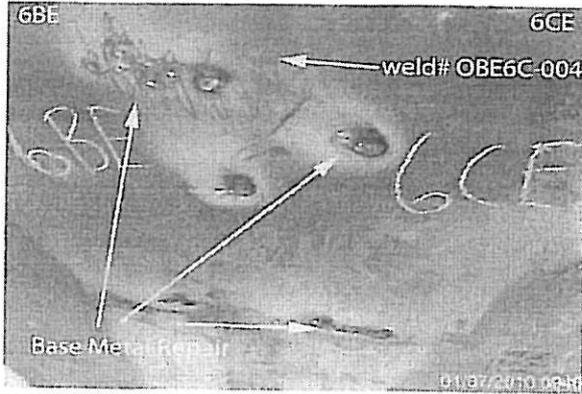
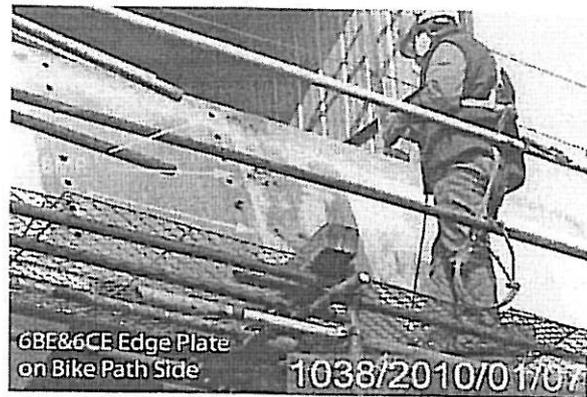
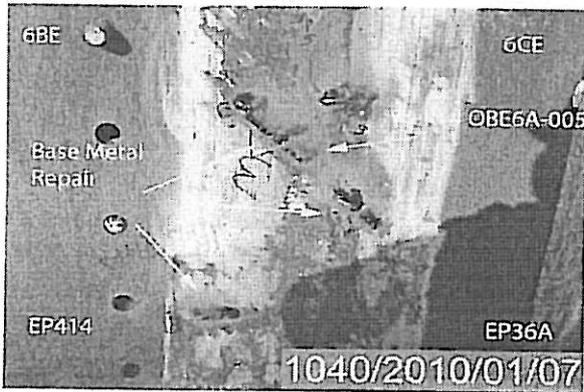
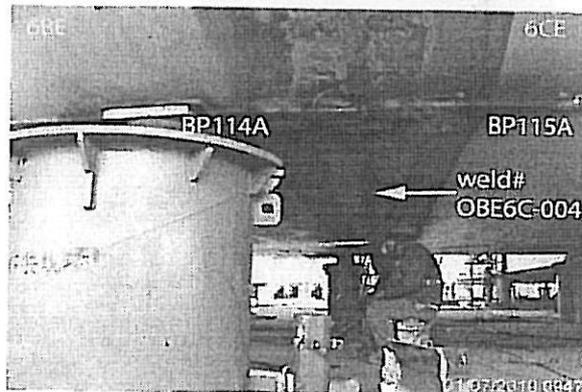
- Base metal repairs (BMR) were being performed without prior approval of the Engineer at locations of removed temporary attachments.
- These BMR's were located along the 6BE/6CE Bottom Plate Complete Joint Penetration (CJP) Splice.
- The Bottom Plates on 6BE are identified as: BP168A, BP60A, BP114A
- The Bottom Plates on 6CE are identified as: BP169A, BP61A, BP115A
- The CJP splice weld # is designated OBE6C-004.
- The approximate lengths of the BMR's range from 10mm to 150mm.
- A total of seventeen (17) repairs were in-process on 6BE and twenty-two (22) repairs on 6CE throughout the length of the Bottom Plate splice.
- The material is A709M Grade 345 Non-SPCM.

- Base metal repairs (BMR) were being performed without prior approval of the Engineer at locations of temporary attachments.
- These BMR's were located along the 6BE+6CE Edge Plate Complete Joint Penetration (CJP) Splice.
- The Edge Plate on 6BE is identified as: EP41A
- The Edge Plate on 6CE is identified as: EP36A.
- The CJP splice weld # is designated OBE6A-005.
- The Approximate lengths of the BMR's range from 15mm to 125mm.
- A total of eleven (11) repairs were in-process on 6BE and four (4) repairs on 6CE throughout the length of the

Edge Plate splice.

-Both EP panels EP36A and EP41A are A709 Grade 345 Seismic Performance Critical Members (SPCM) material.

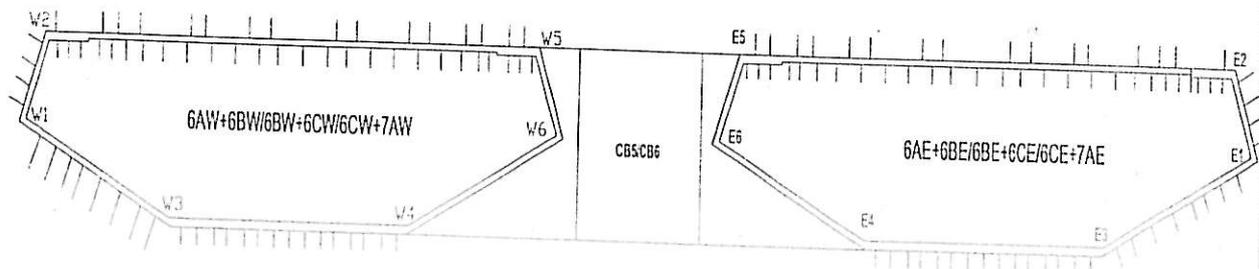
Draft of welding discontinuity:

工人操作失误, 导致母材损伤。

Worker operator error caused base metal gouged.

6. 将杂物以及MT检测遗留的残留物清理干净;
 7. 根据批准的焊接返修工艺规程(WPS)进行预热及焊接;
 8. 将焊接区域打磨至与母材平齐;
 9. 在NDT检测前口头通知QA。对返修区域作100%MT和100%VT检查。
-
1. QC and CWI should be present to witness the repair, direct and supervise all repair operations during this repair to ensure the repair is per the disposition requirements, and the AWS D1.5 code requirements.

2. Grind the repair area to a smooth finish according to the approved repair WPS.
 3. Prepare the joint according to the approved WPS.
 4. Notify QA verbally prior to NDT. Perform 100%MT and 100%VT of the repair area.

5. Remove all defects by grinding to ensure all defects are completely removed if defects still exist, and repeat "step 4" to assure complete removal of all defects if necessary.

6. Clean the repair area of all loose debris including MT powder.
 7. Preheat and weld according to the approved WPS.
 8. Grind the weld flush after welding.

9. Notify QA verbally prior NDT. Perform 100%MT and 100%VT of the repair area.
