Contract #: 04-0120F4Cty: SF/ALA Rte: 80 PM: 13.2/13.9File #: 69.25B**QUALITY ASSURANCE -- NON-CONFORMANCE REPORT****Location:** Changxing Island, Shanghai, P.R. China**Report No:** NCR-000612**Prime Contractor:** American Bridge/Fluor Enterprises, a JV**Date:** 07-Jan-2010**Submitting Contractor:** Zhenhua Port Machinery Company, Ltd (ZPMC), Changxing Island**NCR #:** ZPMC-0585**Type of problem:**

QUALITY ASSURANCE -- NON-CONFORMANCE REPORT

NON-CONFORMANCE REPORT TRANSMITTAL

Reference Description: Inadequate Preheat/ West Tower Lift 4/ Fit Lug

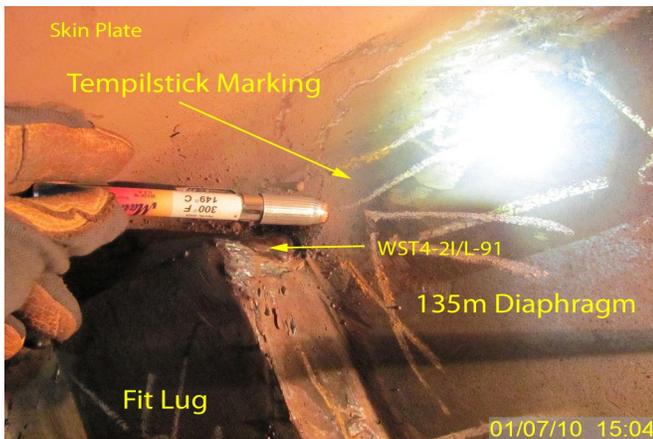
Caltrans Quality Assurance (QA) observed ZPMC personnel performing Shielded Metal Arc Welding (SMAW) of weld no: WST4-2I/L-91 attaching to diaphragm to fit lug inside of West tower, lift 4, skin D (75 mm thickness), without sufficient base material preheat. This work was observed at the 135m double diaphragm. CT QA observed a 149 degree Celsius Tempilstick temperature indicator mark applied to the adjacent base material within approximately 30mm from the point of welding did not melt. The applicable WPS No: 345-SMAW-1G(1F) Repair requires minimum temperature of 160 degree Celsius.

Welding Procedure Specification WPS-345-SMAW-1G (1F) Repair, designated as the applicable WPS by ZPMC QC, requires a minimum preheat temperature of 160° Celsius. AWS D1.5 (2002), Section 4.2.7 requires the base metal material to be at or above the specified minimum temperature for a distance not less than 75mm in all directions from the point of welding.

Propose a resolution for this systematic non-conformance including documentation that the welds placed are in compliance with the contract requirements. In addition to addressing Production’s failure to perform the required preheat of the material, address the failure of Quality Control to identify the inadequate preheat. Provide documentation of the steps/actions taken by Production and Quality Control to prevent future occurrences. Also detail what steps/actions are being taken by ABFJV to address the quality control failures of ABFJV’s fabricator/ZPMC.

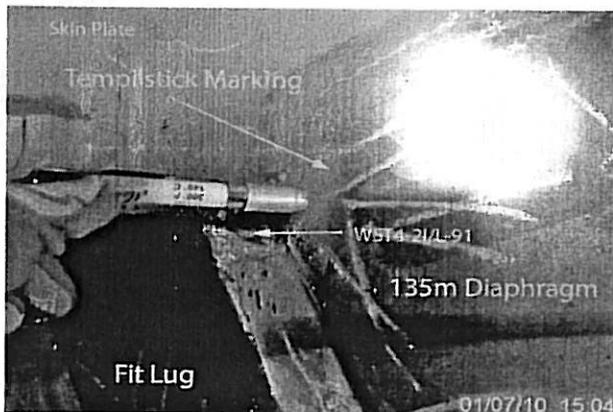
Caltrans Quality Assurance (QA) observed ZPMC personnel performing Shielded Metal Arc Welding (SMAW) of weld no: WST4-2/L-91 attaching to diaphragm to fit lug inside of West tower, lift 4, skin D (75 mm thickness), without sufficient base material preheat. This work was observed at the 135m double diaphragm. CT QA observed a 149 degree Celsius Tempilstick temperature indicator mark applied to the adjacent base material within approximately 30mm from the point of welding did not melt. The applicable WPS No: 345-SMAW-1G(1F) Repair requires minimum temperature of 160 degree Celsius.

Welding Procedure Specification WPS-345-SMAW-1G (1F) Repair, designated as the applicable WPS by ZPMC QC, requires a minimum preheat temperature of 160° Celsius. AWS D1.5 (2002), Section 4.2.7 requires the base metal material to be at or above the specified minimum temperature for a distance not less than 75mm in all directions from the point of welding.

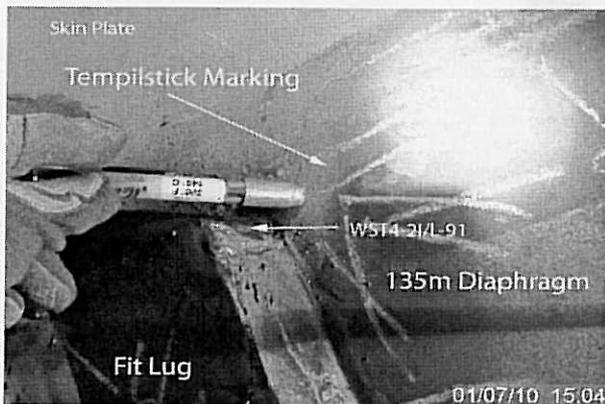
Caltrans Quality Assurance (QA) observed ZPMC personnel performing Shielded Metal Arc Welding (SMAW) of weld no: WST4-2I/L-91 attaching to diaphragm to fit lug inside of West tower, lift 4, skin D (75 mm thickness), without sufficient base material preheat. This work was observed at the 135m double diaphragm. CT QA observed a 149 degree Celsius Tempilstick temperature indicator mark applied to the adjacent base material within approximately 30mm from the point of welding did not melt. The applicable WPS No: 345-SMAW-1G(1F) Repair requires minimum temperature of 160 degree Celsius.

Welding Procedure Specification WPS-345-SMAW-1G (1F) Repair, designated as the applicable WPS by ZPMC QC, requires a minimum preheat temperature of 160° Celsius. AWS D1.5 (2002), Section 4.2.7 requires the base metal material to be at or above the specified minimum temperature for a distance not less than 75mm in all directions from the point of welding.

The original NCR references the incorrect weld no. The correct weld is WSTL4-2I/L-132 instead of WSTL4-2I/L-91. NDT reports provided confirming the weld was unaffected.
